# National Transportation Safety Board

ERA26FA035

## **WRECKAGE EXAM**

Location: Gallatin, Tennessee  
Date: November 8, 2025  
Time: 1341 CST  
1941 UTC  
Helicopter: EC-130T2

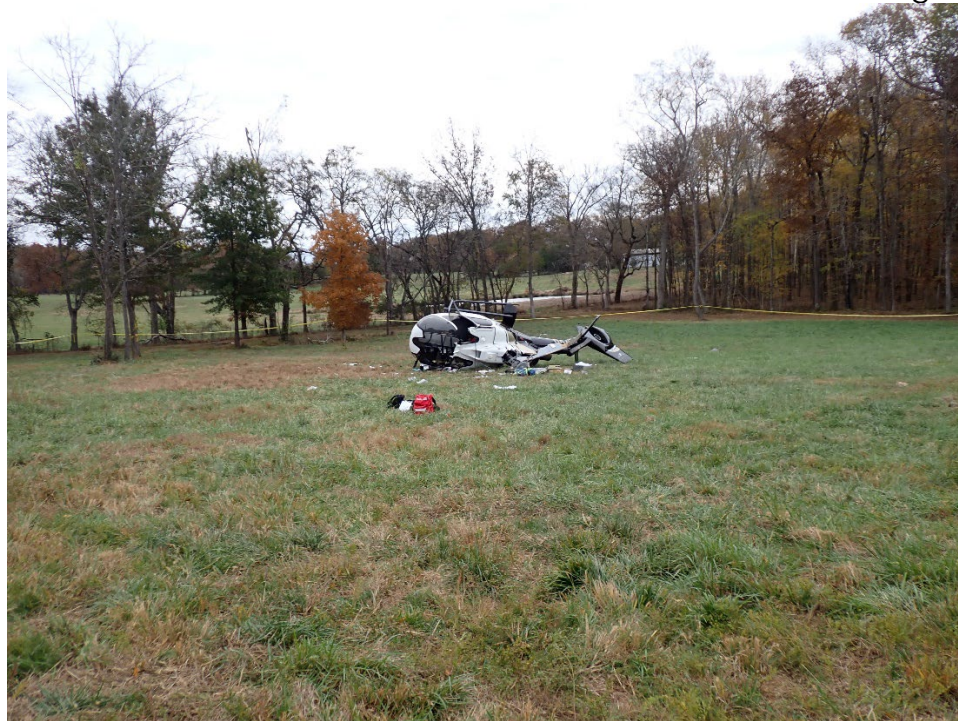
The helicopter came to rest in an open field just off an east/west running tree line approximately 5.2 miles from the helicopter's base of operation. The top of the tree line showed signs of main rotor impact consistent with right bank. The initial impact point was about 20 ft from the final resting point on a heading of 240°. Ground scarring indicated the helicopter impacted near level with a left slipping motion. The wreckage was oriented to a magnetic heading of 275° and an elevation of 460 ft mean sea level lying on its left side. All major components remained attached to the helicopter with main rotor debris contained within an area of about 200 ft radius from the main wreckage site.

**Figure 1. N107VU Accident Site (Source: NTSB)**

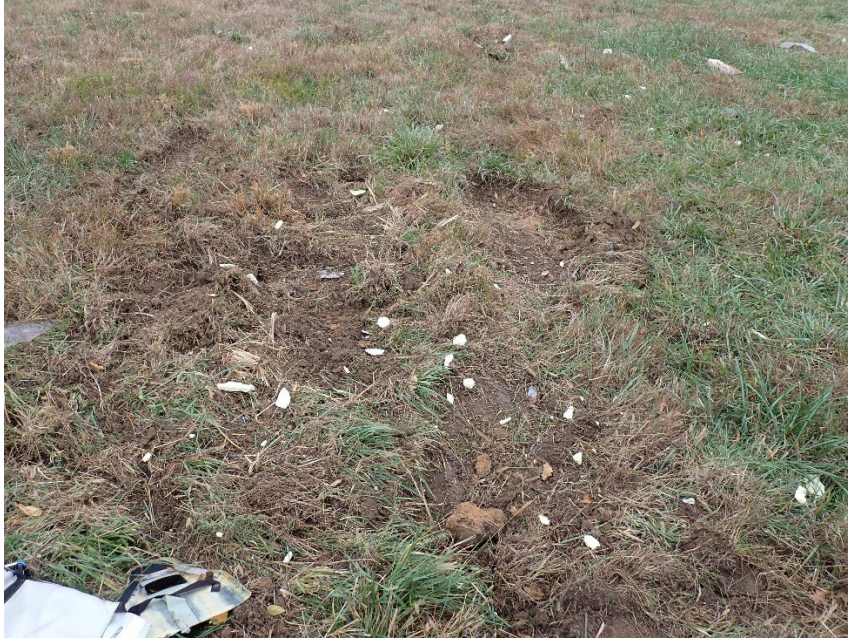
**Figure 2. Initial Impact Point (Source: NTSB)**

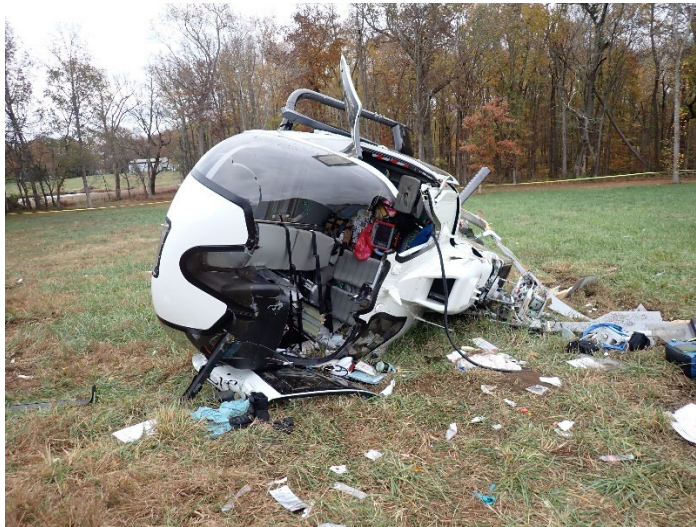
The crew and passenger compartment were intact. With the forward windshield removed by first responders. The left door was open and bent back 180° with the last one third of the door folded inward on itself. The right door was still intact but could not be opened due to crush damage by the skid step. The right sliding door was intact but unable to open due to the right skid step crush damage.

**Figure 3. Fuselage Damage (Source: NTSB)**

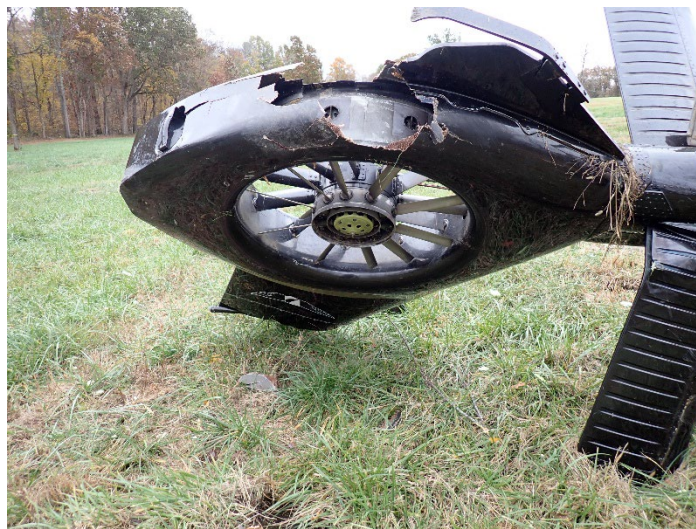
**Figure 4. Fenestron Damage (Source: NTSB)**

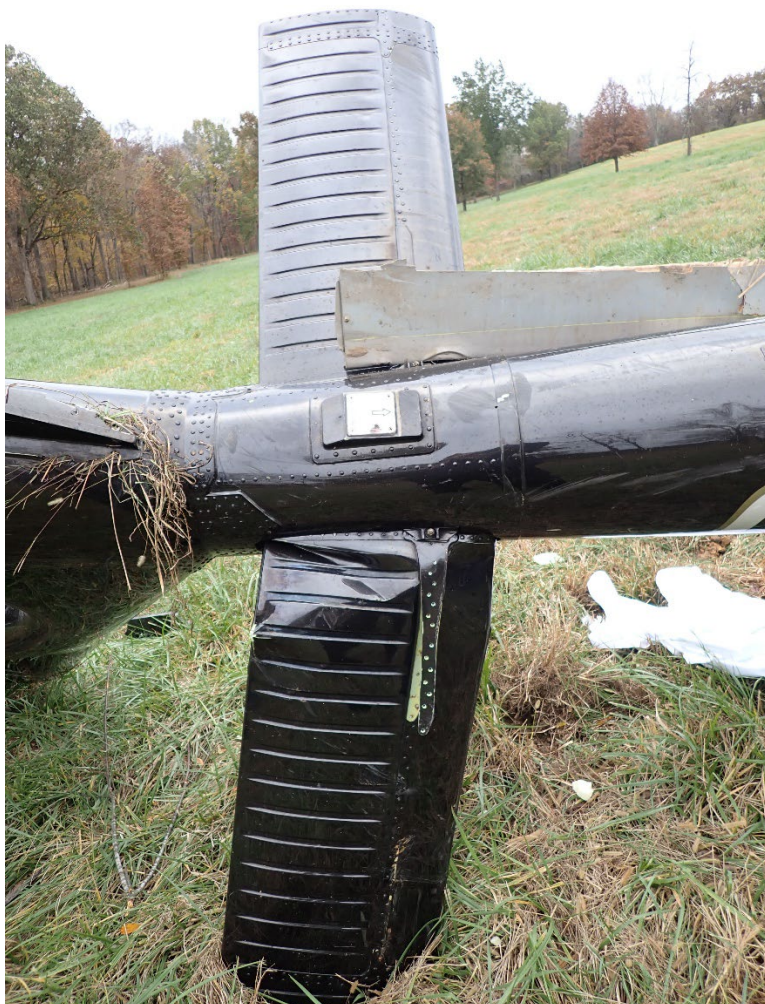
**Figure 4. Horizontal Stabilizer Damage (Source: NTSB)**

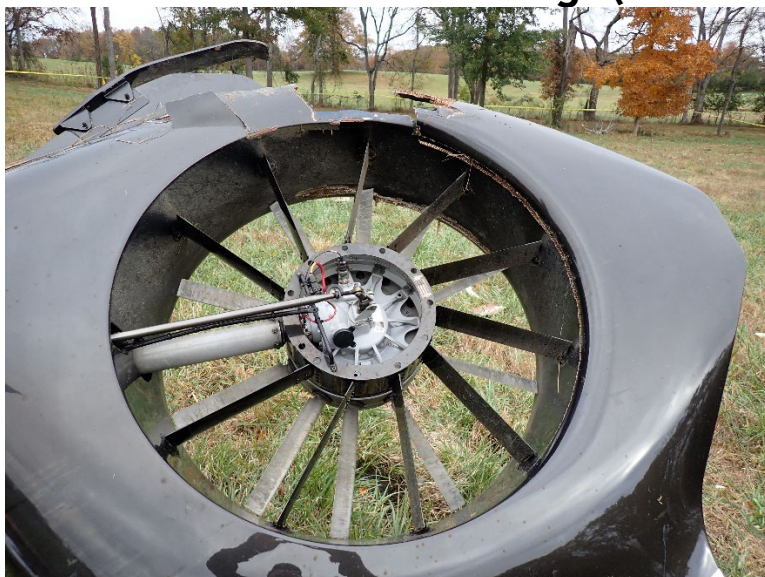
**Figure 5. Fenestron Damage (Source: NTSB)**

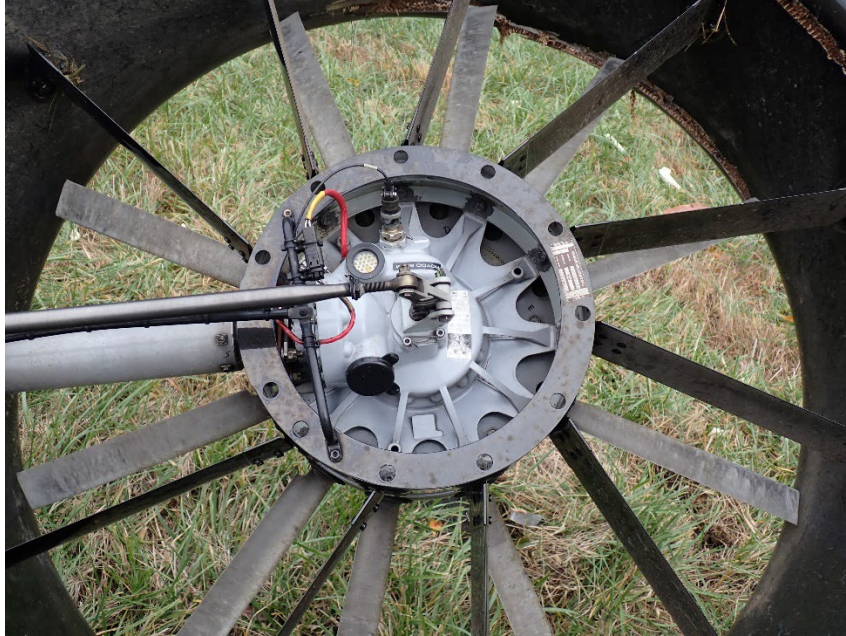
**Figure 6. Gear Box (Source: NTSB)**

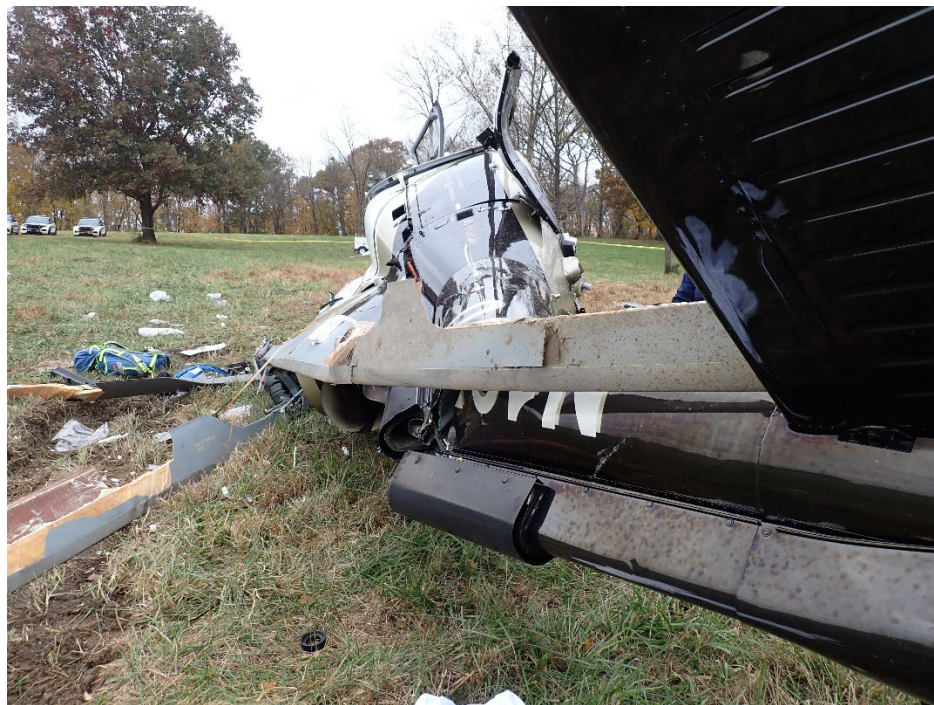
The empennage remained attached to the fuselage. The center portion of the empennage had impact damage compromising the structural integrity. The tail rotor drive shaft was sheared in two and the middle hanger bearing was dislodged. The right horizontal stabilizer showed no signs of damage. The left horizontal stabilizer pushed upwards approximately 30°. The vertical stabilizer exhibited no signs of damage. The Fenestron blades exhibited minimal damage from the impact, however they had made rotational cuts into the Fenestron housing. The lower stinger skid was bent up. The rear short, driveshaft spline coupling was separated from the rear driveshaft, and the cowling exhibited rotational scoring signature from the short driveshaft. The Fenestron had damage to the underside of the Fenestron housing consistent with a vertical impact. All variable pitch rotor blades and fixed blades were attached and showed no signs of impact damage. The tail rotor gear box showed no signs of damage.

**Figure 7. Empennage Damage (Source: NTSB)**

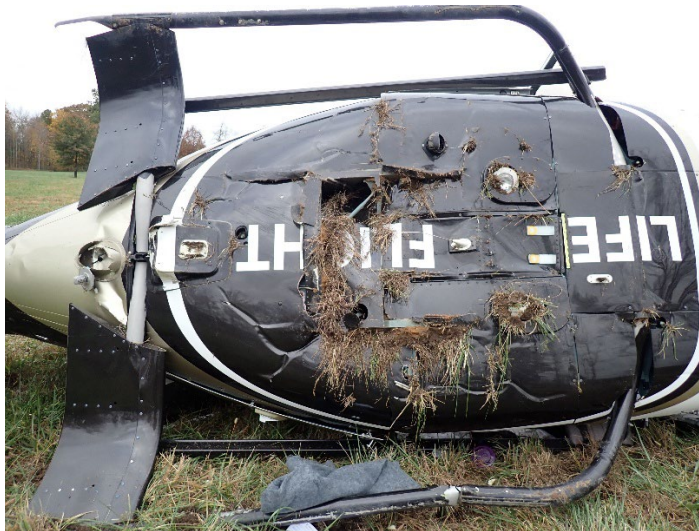
Both skids were still attached to the helicopter, compressed and spread evenly and level with the bottom of the fuselage. The skids were bent at the rear cross tube, the front left cross tube was broken from the impact. Turf was found pushed up into the belly panel seams consistent with forward left yaw and right wing-low impact.

**Figure 9. Damage to Skids and Underside (Source: NTSB)**

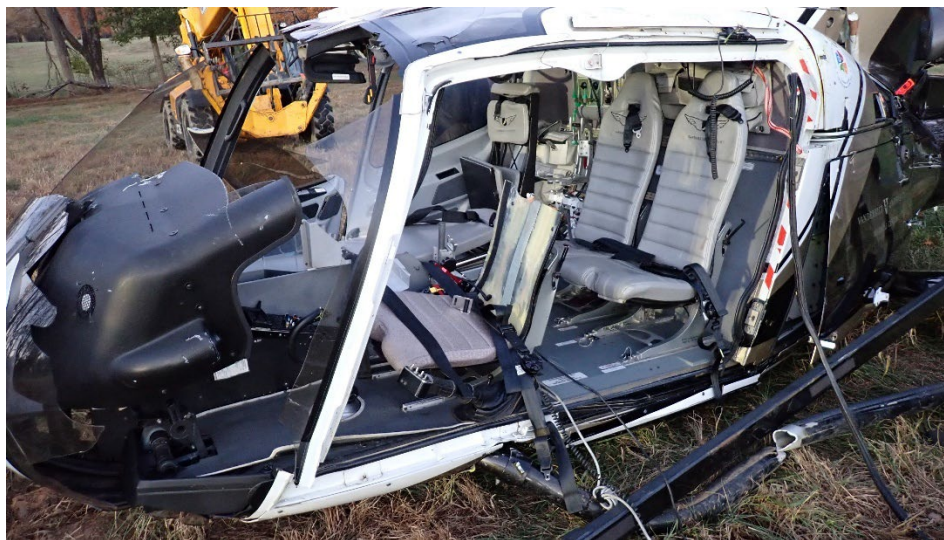
The pilot seat was intact and showed signs of deformation to the left with the seat back remaining upright. The pilot seat also showed signs of stroking downward by design. The pilot's lap belt appeared to be unbuckled with the shoulder straps being cut by first responders. The collective was attached but bent approximately  $15^{\circ}$  outwards. The left rear seat shows no signs of deformation or stroking with the lap belt still buckled and the shoulder harness retracted. The middle seat showed signs of deformation downward to the front right with the seat back remaining upright. The lap belt was unbuckled with the shoulder harness retracted. The back right Fisher Raap Steinert seat showed signs of deformation to bottom seat with seat being bent down and the left. The seat could not be opened to inspect for further damage.

**Figure 10. Damage to Cabin (Source: NTSB)**

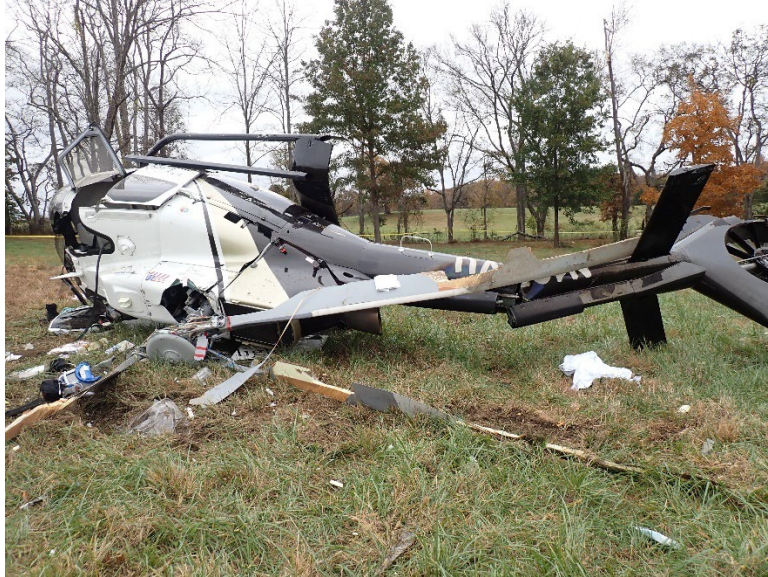
All three of the main rotor star arms, on the starflex, were broken, two of the blades exhibited diagonal separation signatures. All the blade sleeves were broken but remained attached with fractures to the hub. All the pitch change links remained attached. All three main rotor blades remained attached to the hu and the blades all exhibited length and chord-wise powered impact damage from the tree and ground. The main rotor transmission chip plug appeared clean. Tail rotor transmission chip plug appeared clean. Main transmission mounts were fractured and displaced from their attachment points. All three hydraulic servos remained attached to their lower attachment points and to the non-rotating swashplate.

**Figure 11. Main rotor Damage (Source: NTSB)**

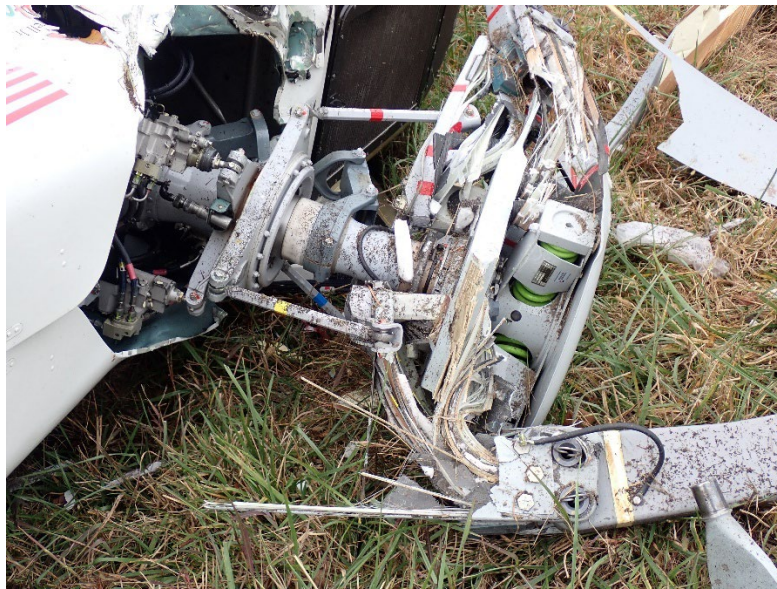
**Figure 12. Main rotor Damage (Source: NTSB)**
