**Subject:** ERA26LA009, FAA Wreckage Examination

N1998X Cessna 182H SN 18256098

Inspection for accident investigation ERA26LA009 conducted on 10/10/2025 at North Central, RI; Boston Skydive Center

Damage assessment:

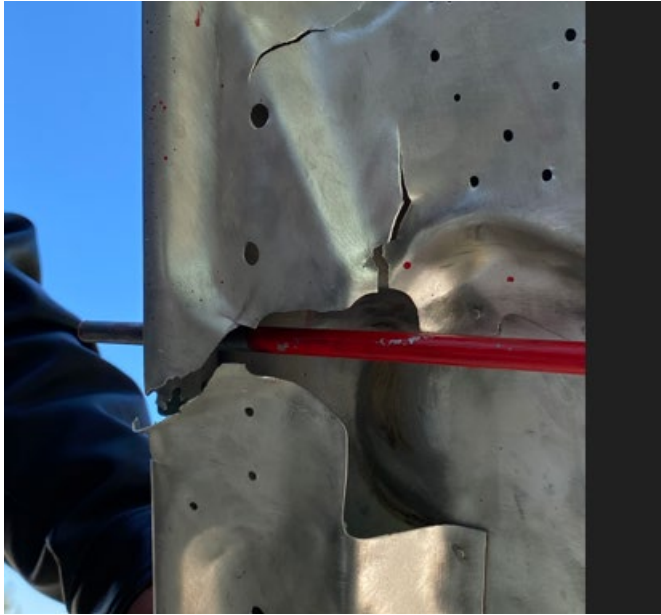
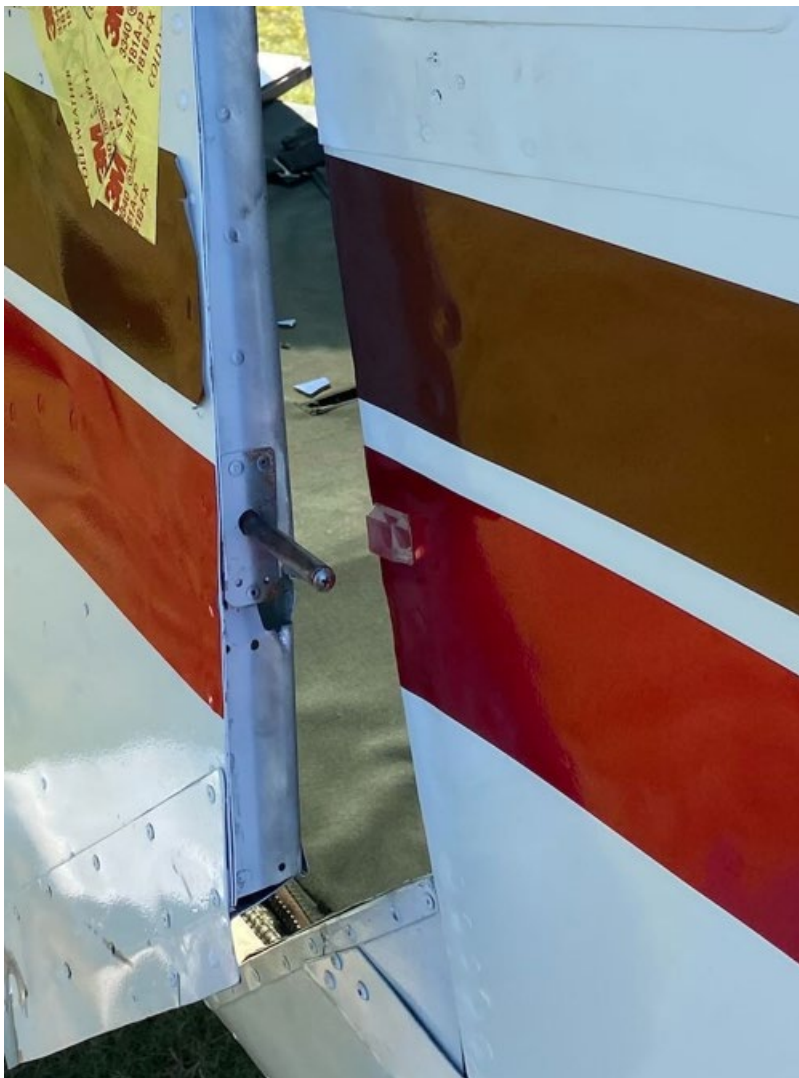
Door Assembly Frame Structure Cracks

1. The Jump door assembly was installed by FAA Form 337 Dated November 5, 1992 (page 23 of AW Registry Documents).
2. Cabin Jump door assembly and interior door frame locking mechanism has misalignment. Multiple cracks are present in the "formed aluminum" supporting door structure and in the area where the locking mechanism attaches. (there are minimum of 10 significant cracks with the airframe also cracked at a locking hole).

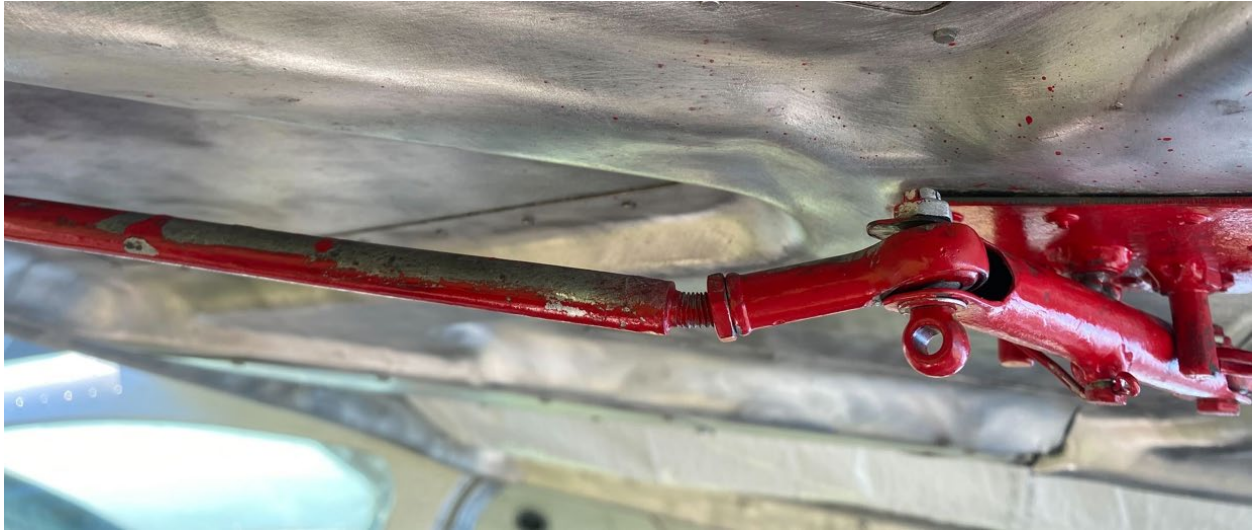
Aft Locking rod bent: Noted that this is the location required to be pulled, to close the door.

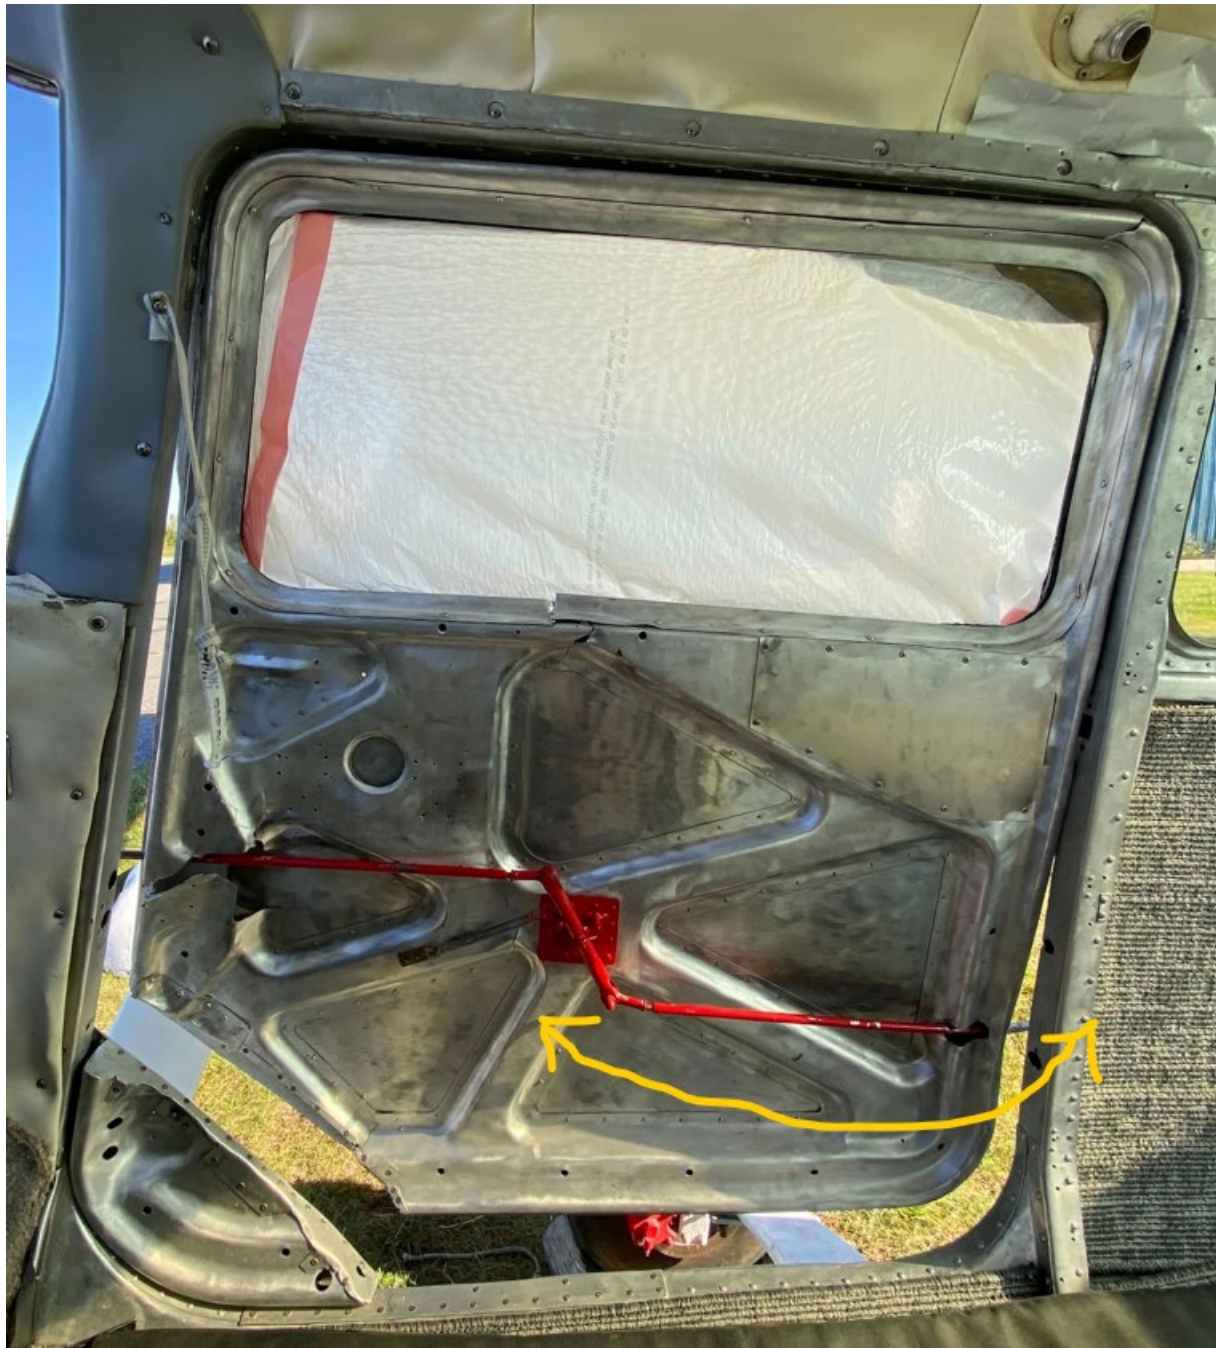
The locking rod is bowed as noted in these photographs.

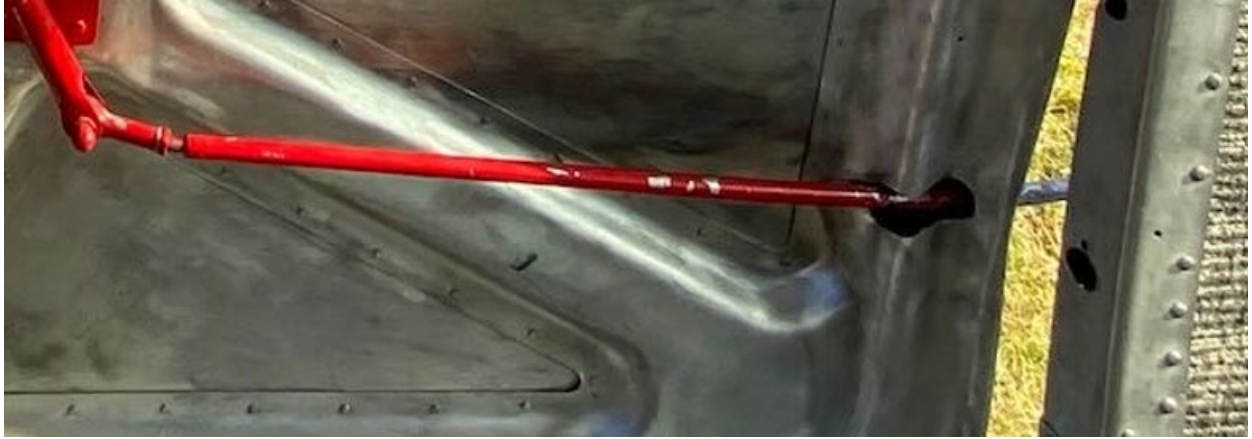
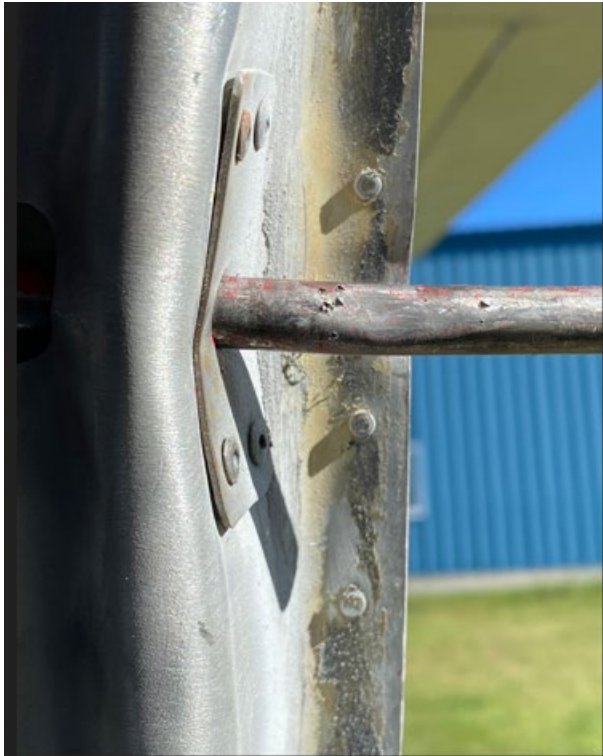
Damaged Locking Rod and Door Structure located at the Trailing Edge of Door.

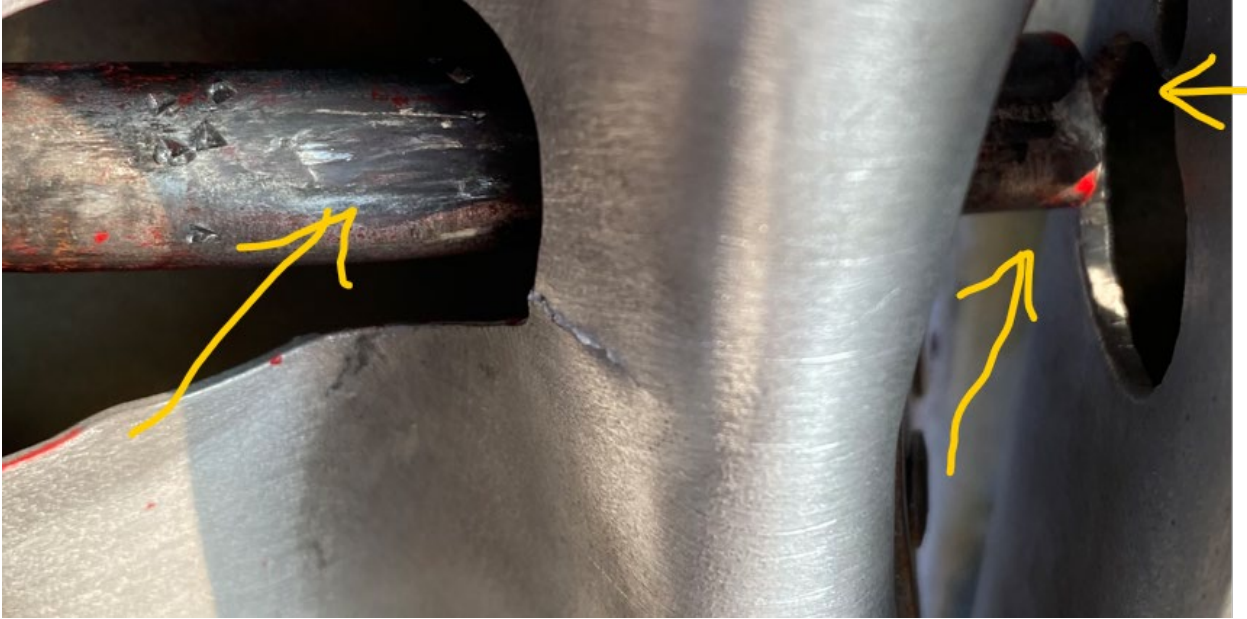
Trailing edge Alignment with the door pulled firmly closed, the locking rod does not align with airframe locking rod receptacle (hole) in the fuselage door frame. The locking rod is bowed inboard toward the pilot causing the locking rod extending beyond the edge of the door assembly, to bow outboard. Additionally, repeated striking of the locking rod against the fuselage door from attempting to close the door with the rod extended also contributes to the bending of the rod outboard. The damage on the outside of the fuselage door frame indicates occurrence of this action repeatedly. The door supporting structure can also be seen cracked in this location.

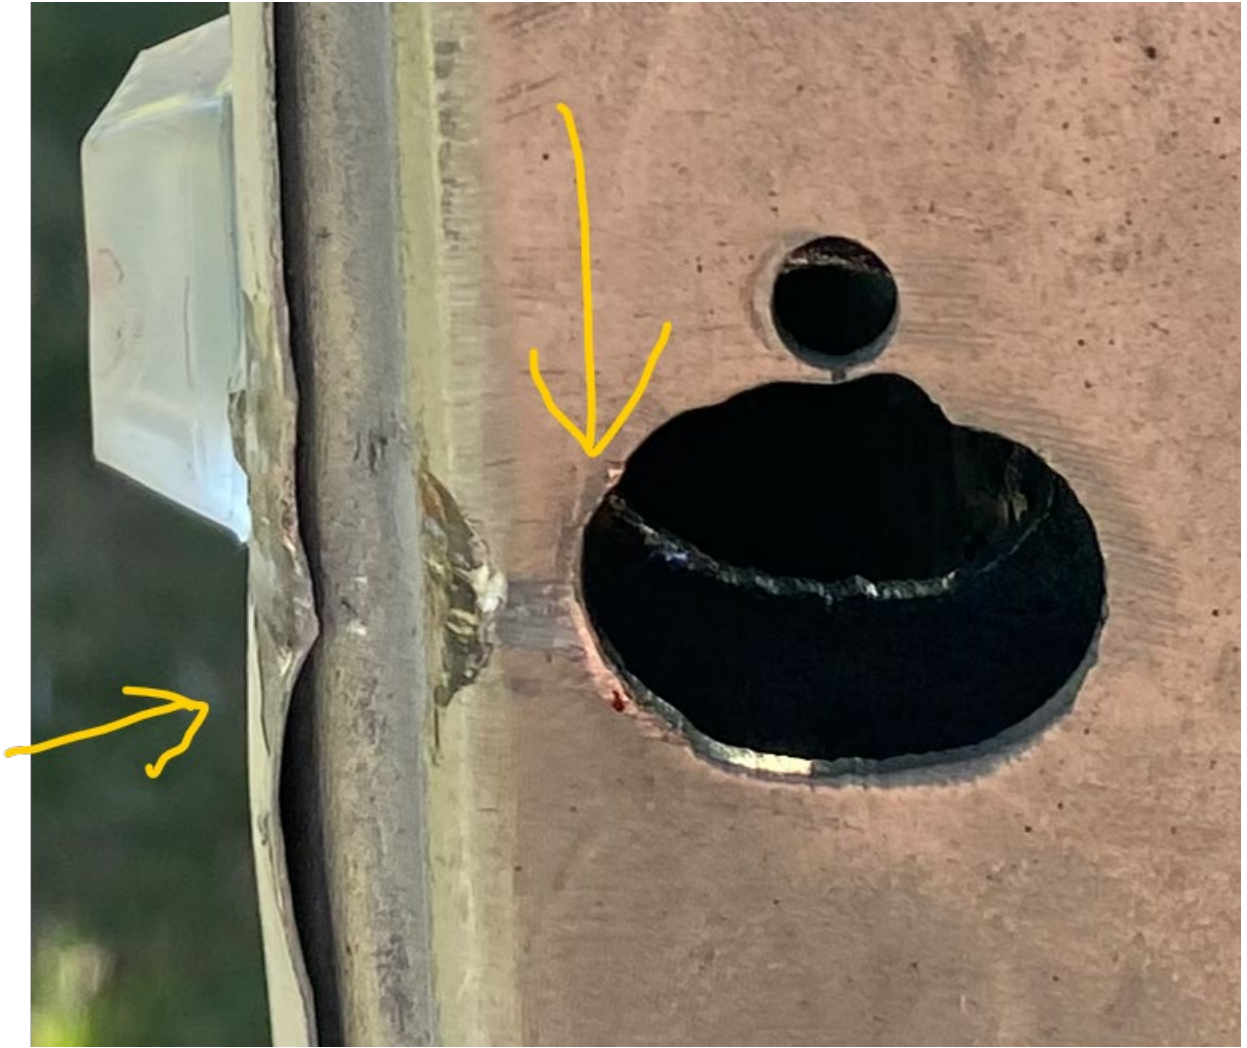
Fuselage door frame looking aft: Damaged airframe skin and door frame with elongated hole caused by misalignment of locking rod.

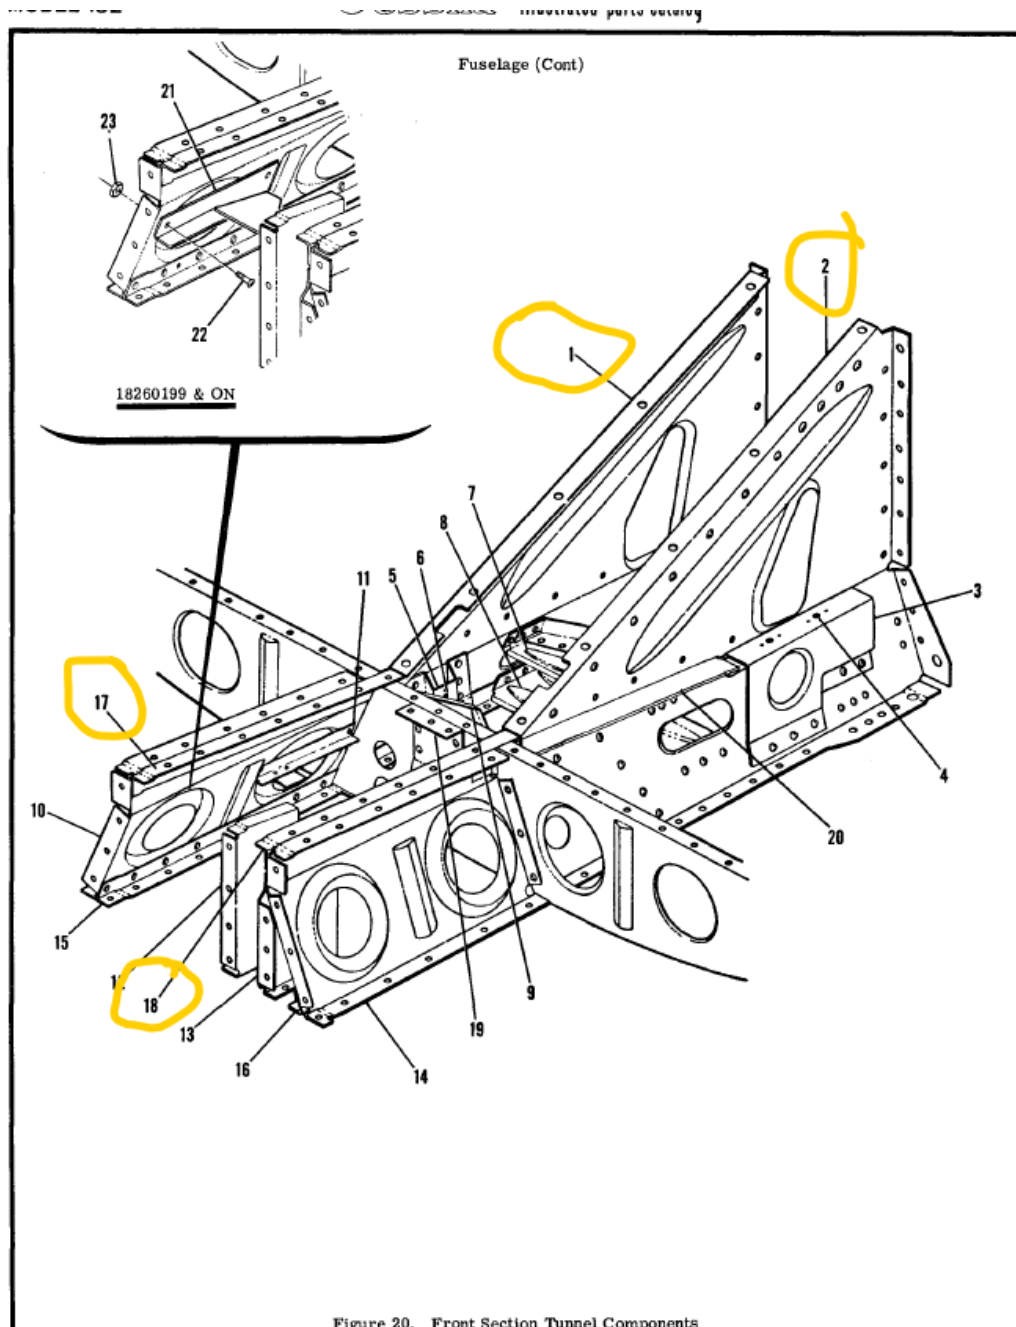
Tunnel support structure replaced during this maintenance event.

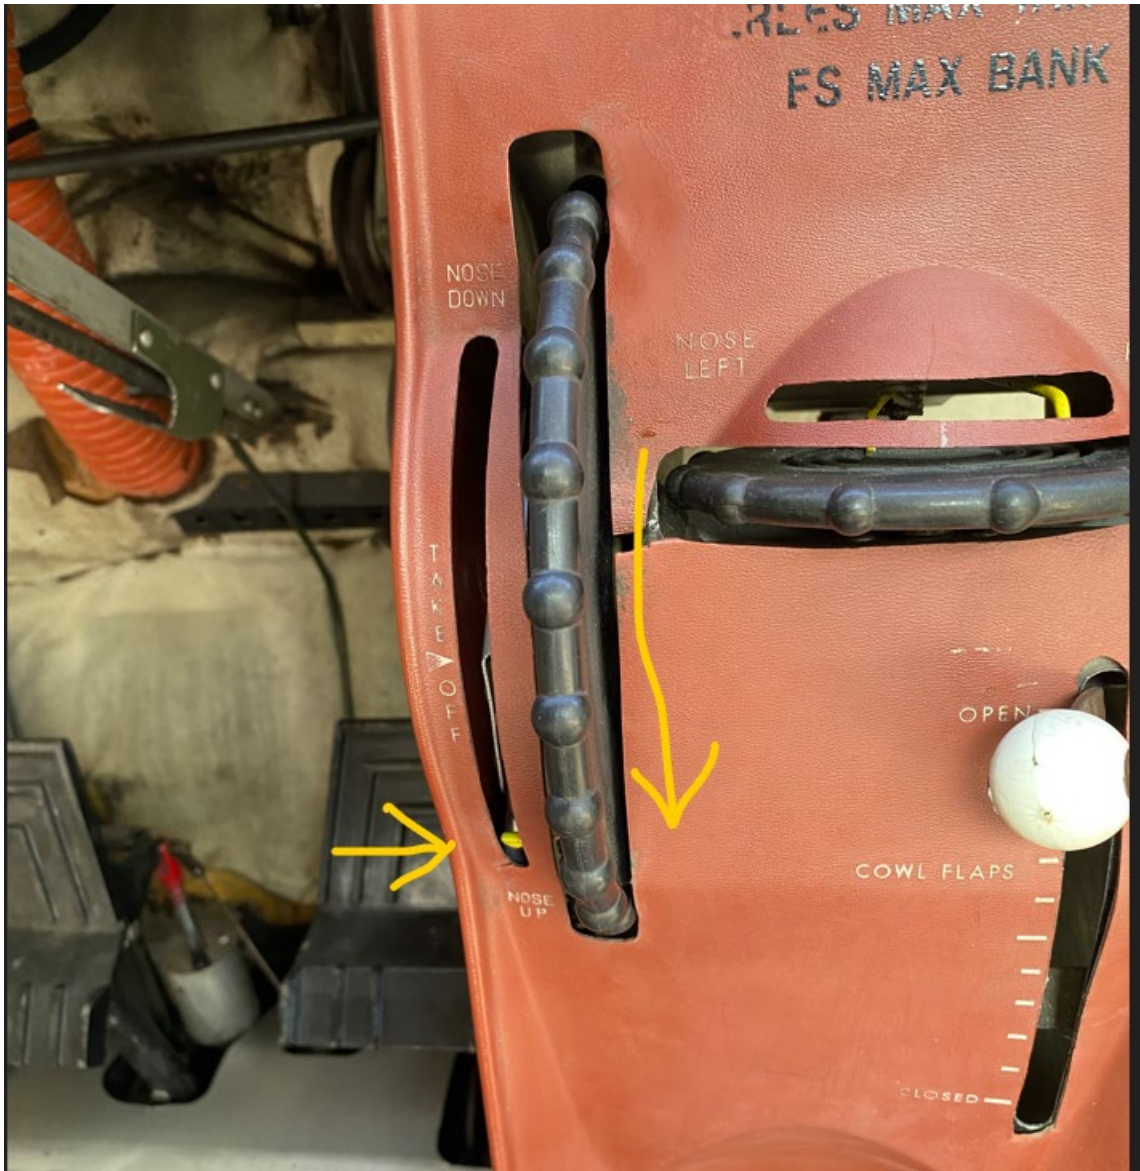
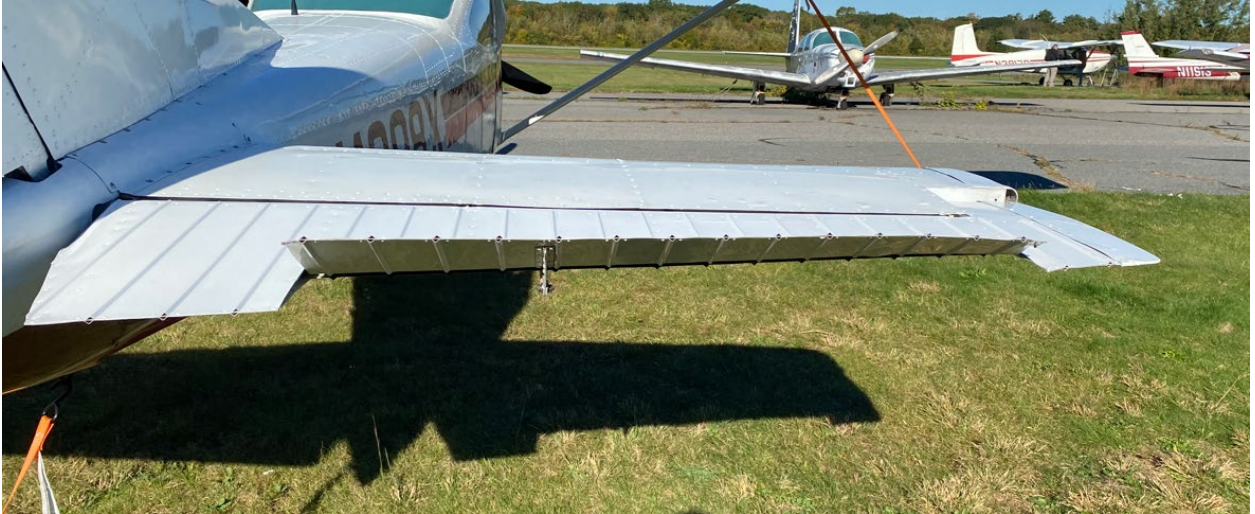
6. The Elevator trim system was found to have reversed function. Rotation of the elevator trim wheel, nose up (trim wheel rotated down) causes the trim tab to move up. Rotation of the elevator trim wheel, nose down (trim wheel rotated up), causes the trim tab to move down.

Trim tab with control wheel in the nose up position.

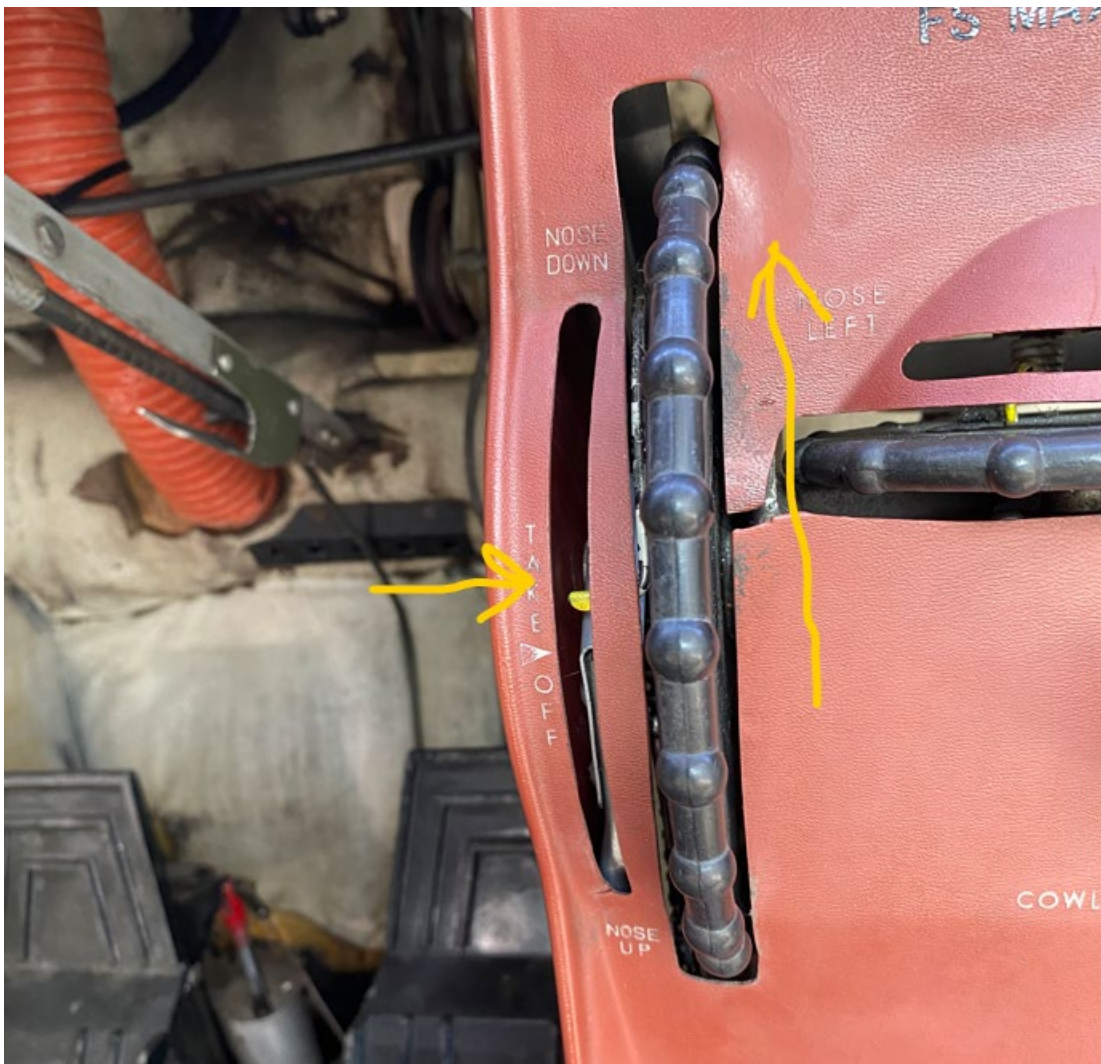
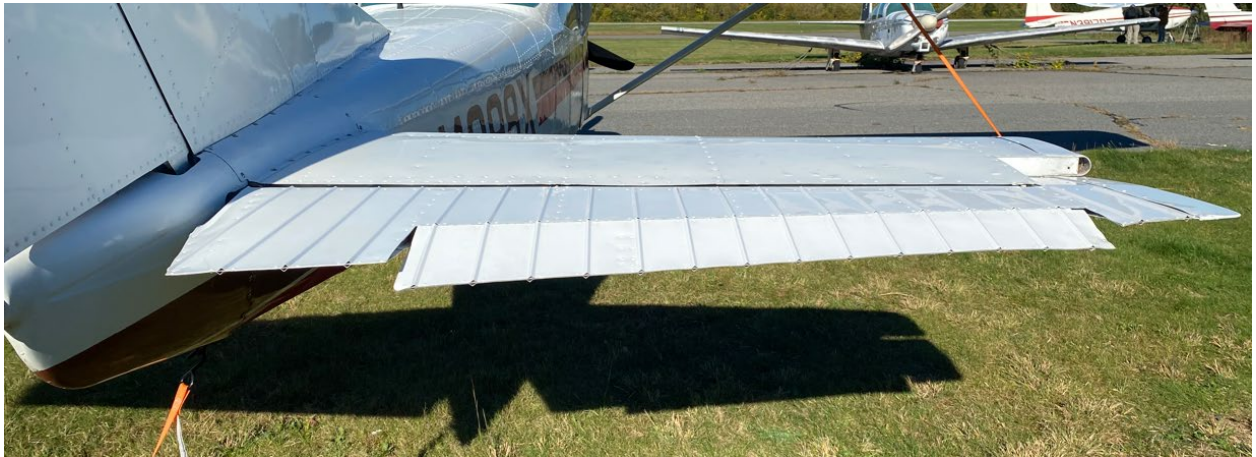
Trim tab with the control wheel in the nose down position.

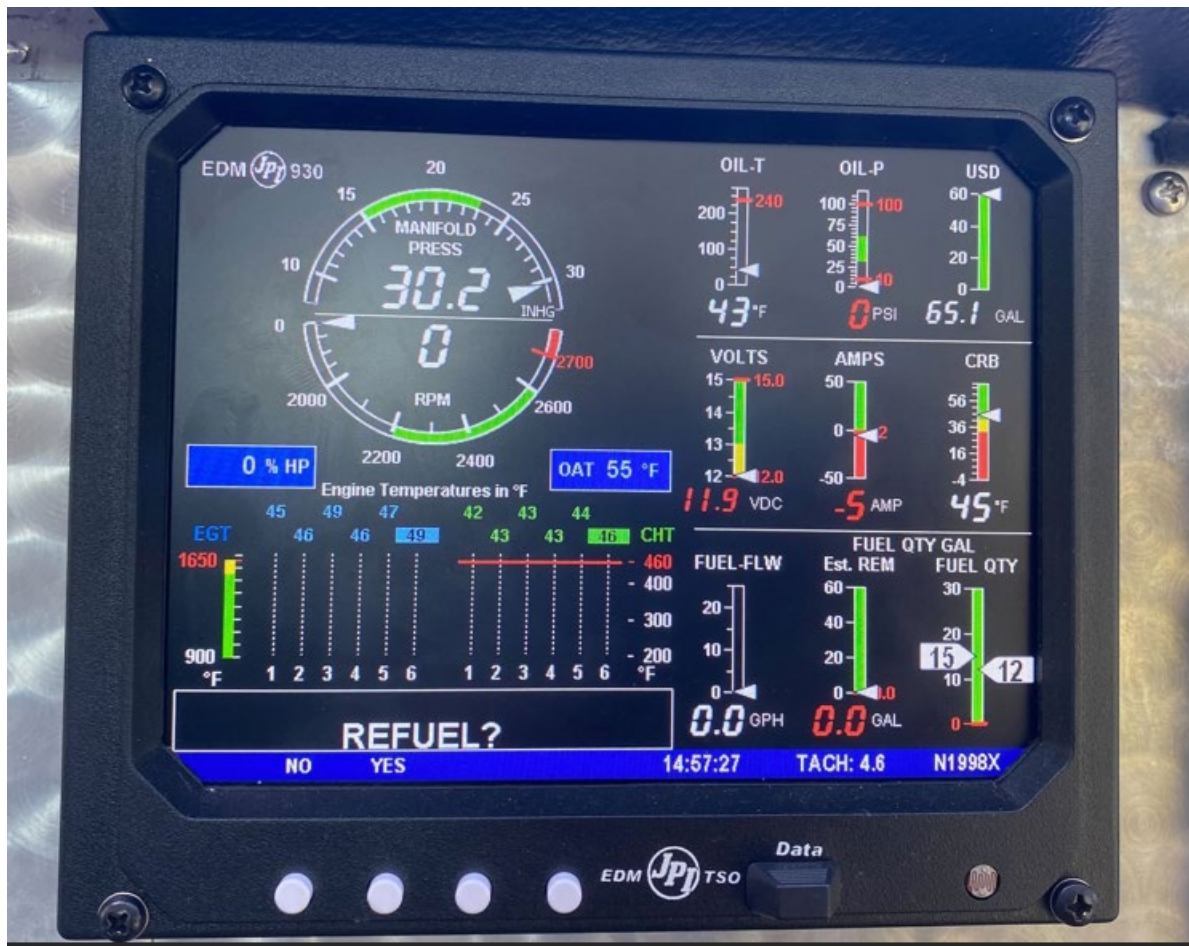
- Instrument markings cannot be verified: Green Yellow and Red Arc Warning for RPM missing and/or unknown for this propeller type installed. A FMS for this propeller type installed could not be located in the aircraft or records. The oil pressure, cylinder head temp and oil temp appear accurate per Approved FMS 09-22-2005.
- Engine Serial Number is indicated on the invoice for this installation as Engine Model O-470-R-50 Serial Number 275712-R/P.PONK 2690. The Propeller, PHC-

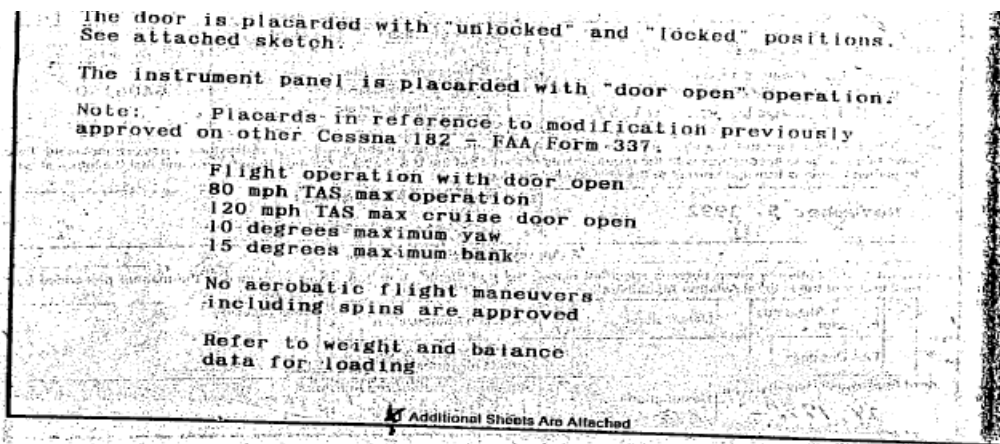
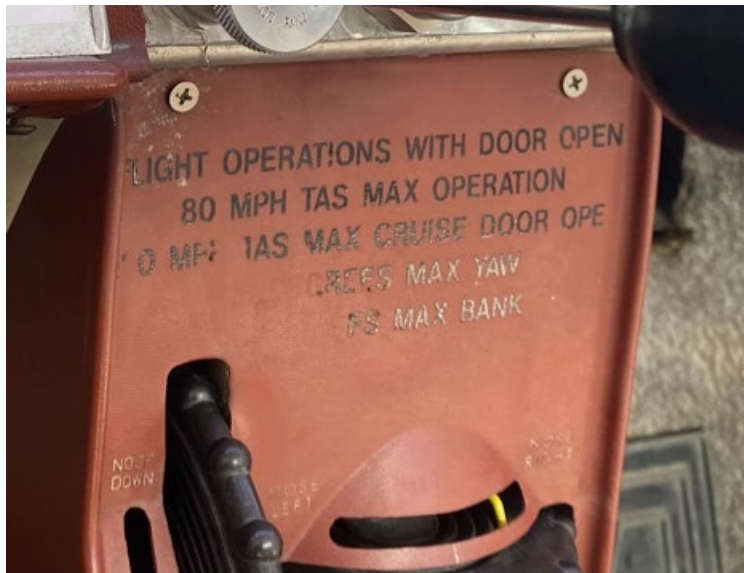
- The placarding for the Jump Operations was not legible. Flight Operations with door open and door locking instructions are missing.

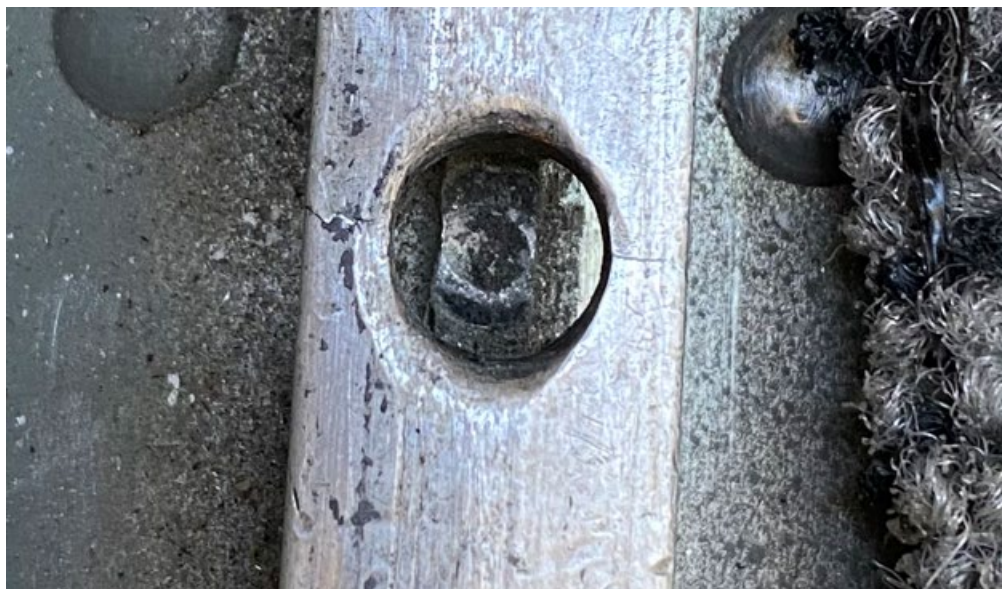
No 4 seat track pin hole.

- A current 14 CFR 91.413 transponder certification entry could not be located.
- Seat track AD 11-10-09 was completed; however, should be reevaluated for cracks in the seat track after the hard landing. It appears that more than the maximum amount of cracks have developed in rail exceeding the total of 4.
