ERA26LA013

## INVESTIGATION PHOTOGRAPHS

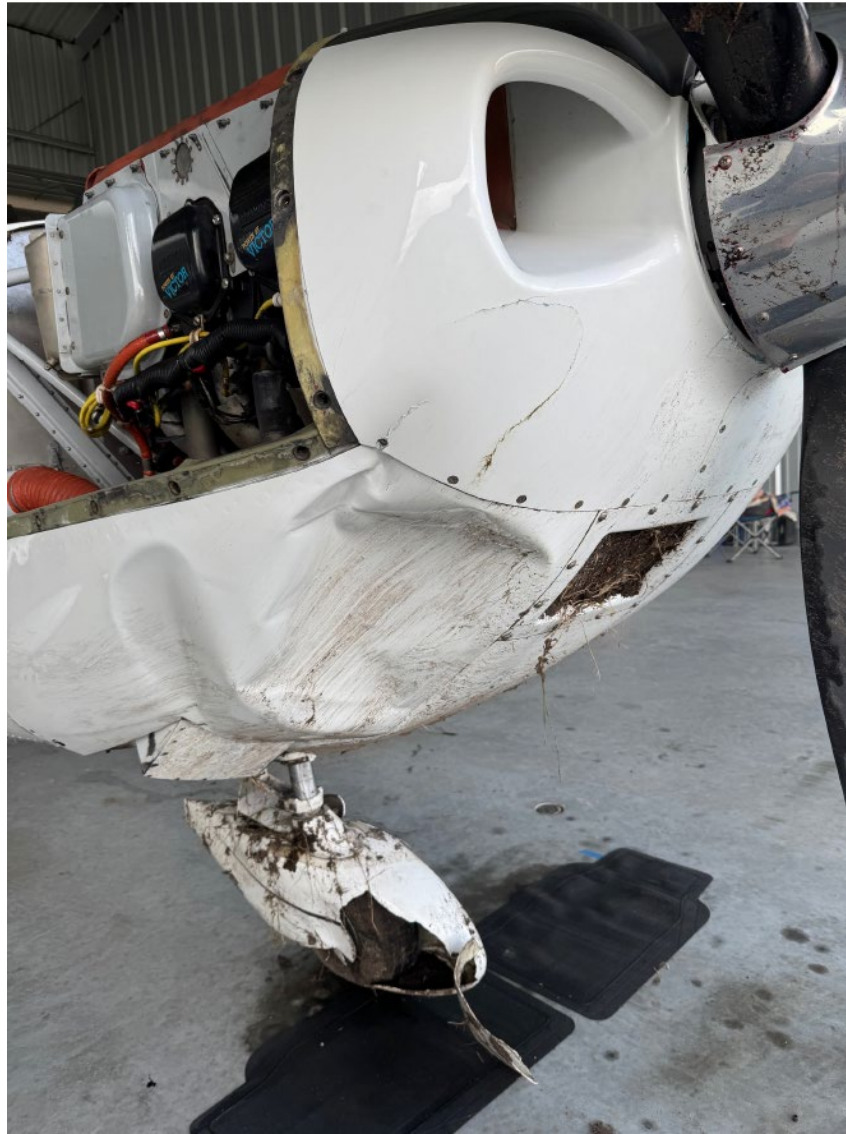
**Photograph 1 - View of right-hand side of aircraft nose showing impact damage (Courtesy of Maintenance Facility)**

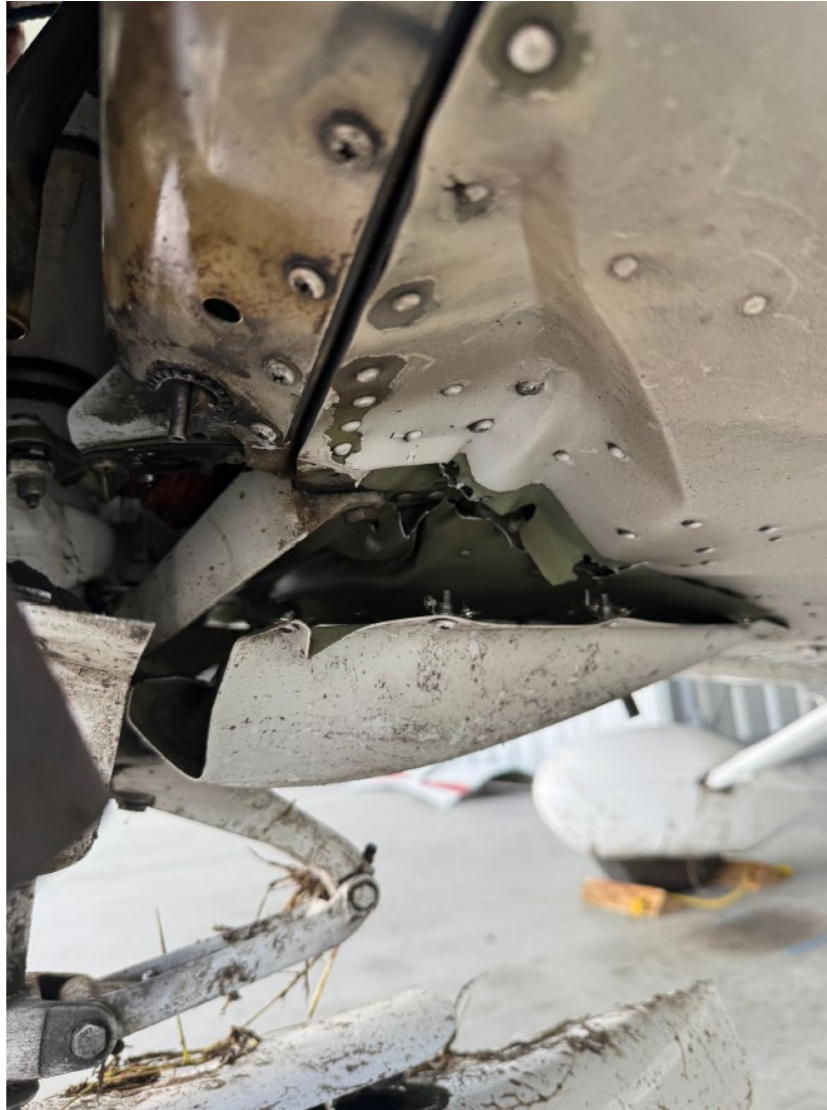
**Photograph 2 - View of underside of fuselage behind firewall showing substantial damage  
(Courtesy of Maintenance Facility)**

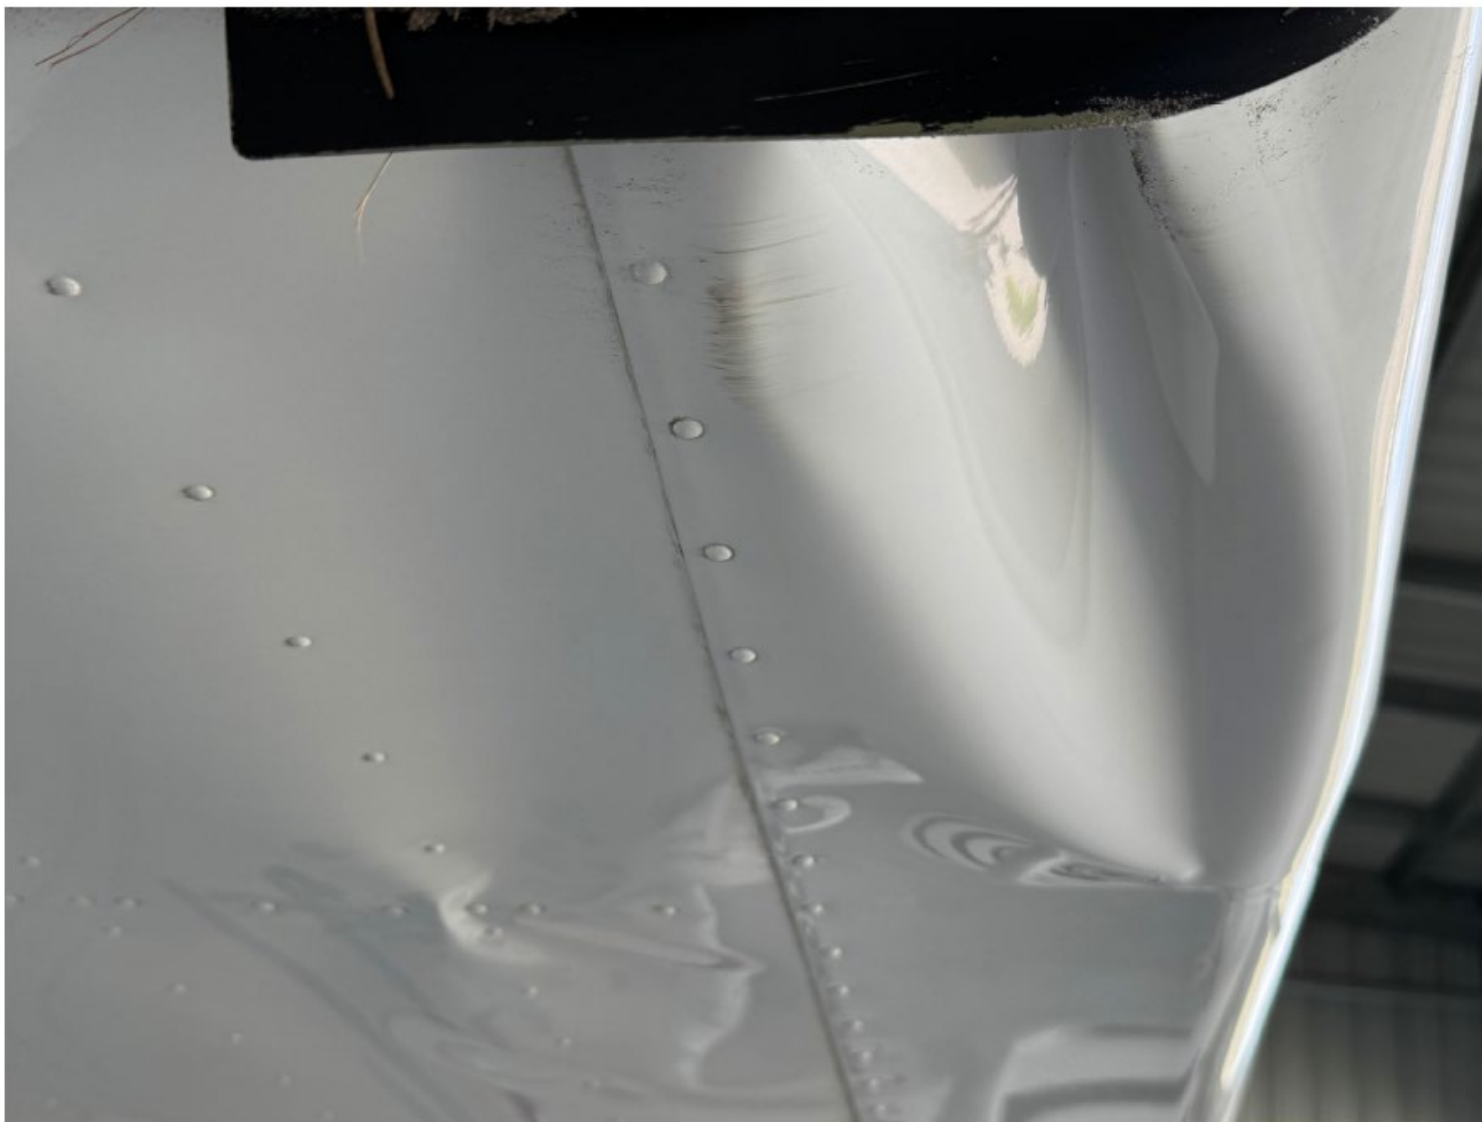
**Photograph 4 - View of right-hand wing showing leading edge and spar damage (Courtesy of Maintenance Facility)**

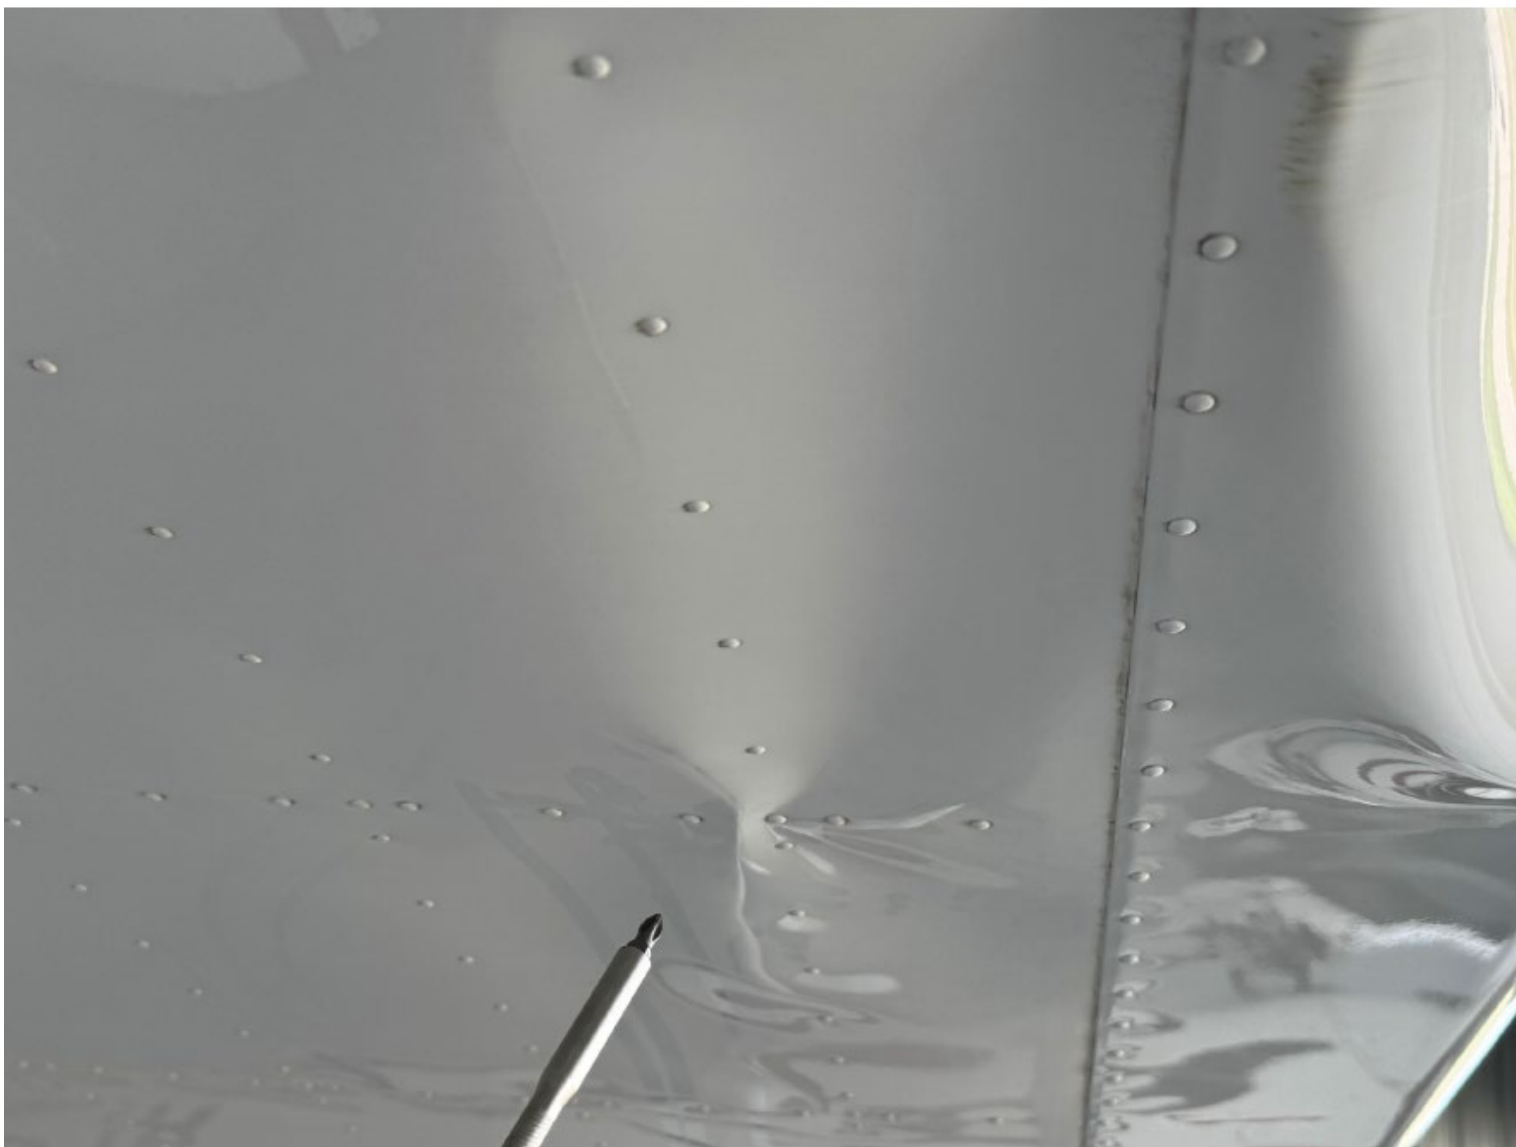
**Photograph 5 - View of underside of right-hand wing showing buckling from spar damage  
(Courtesy of Maintenance Facility)**
