ERA26LA016

## INVESTIGATION PHOTOGRAPHS

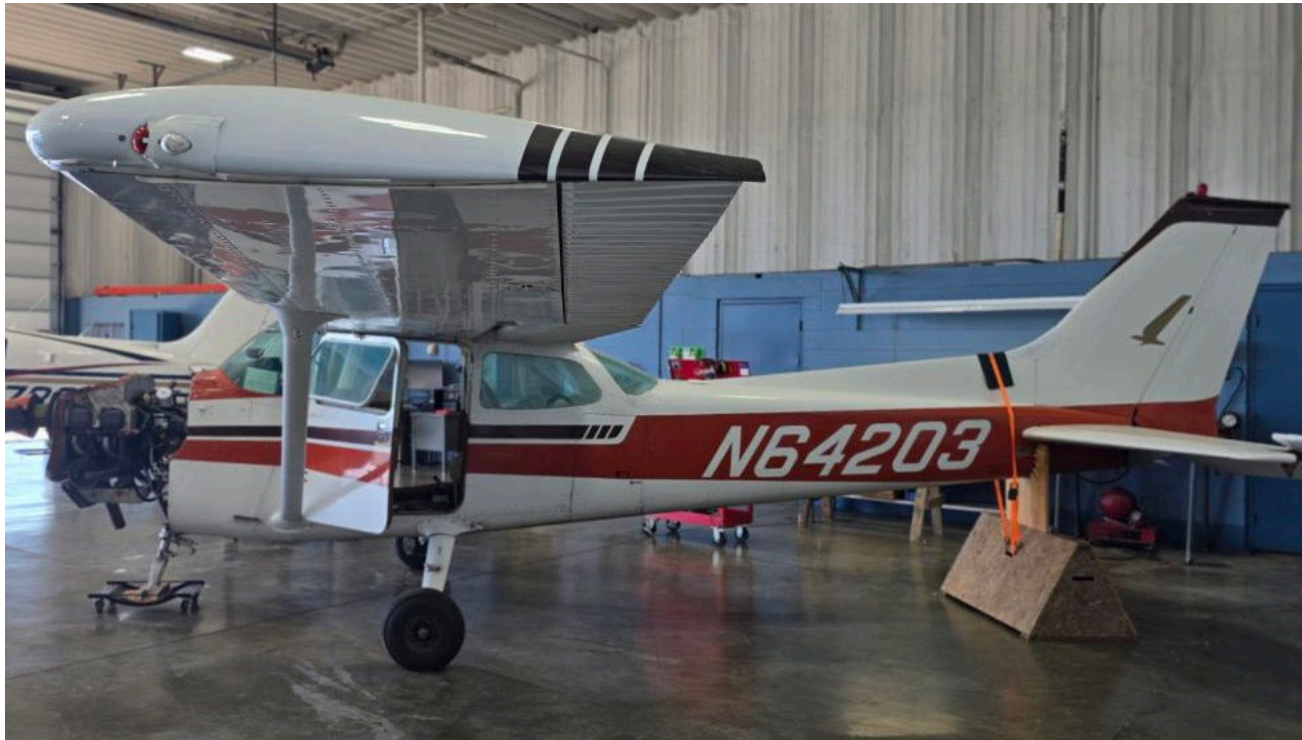
**Photograph 1 - Front End Damage on Accident Aircraft (Courtesy of FAA)**

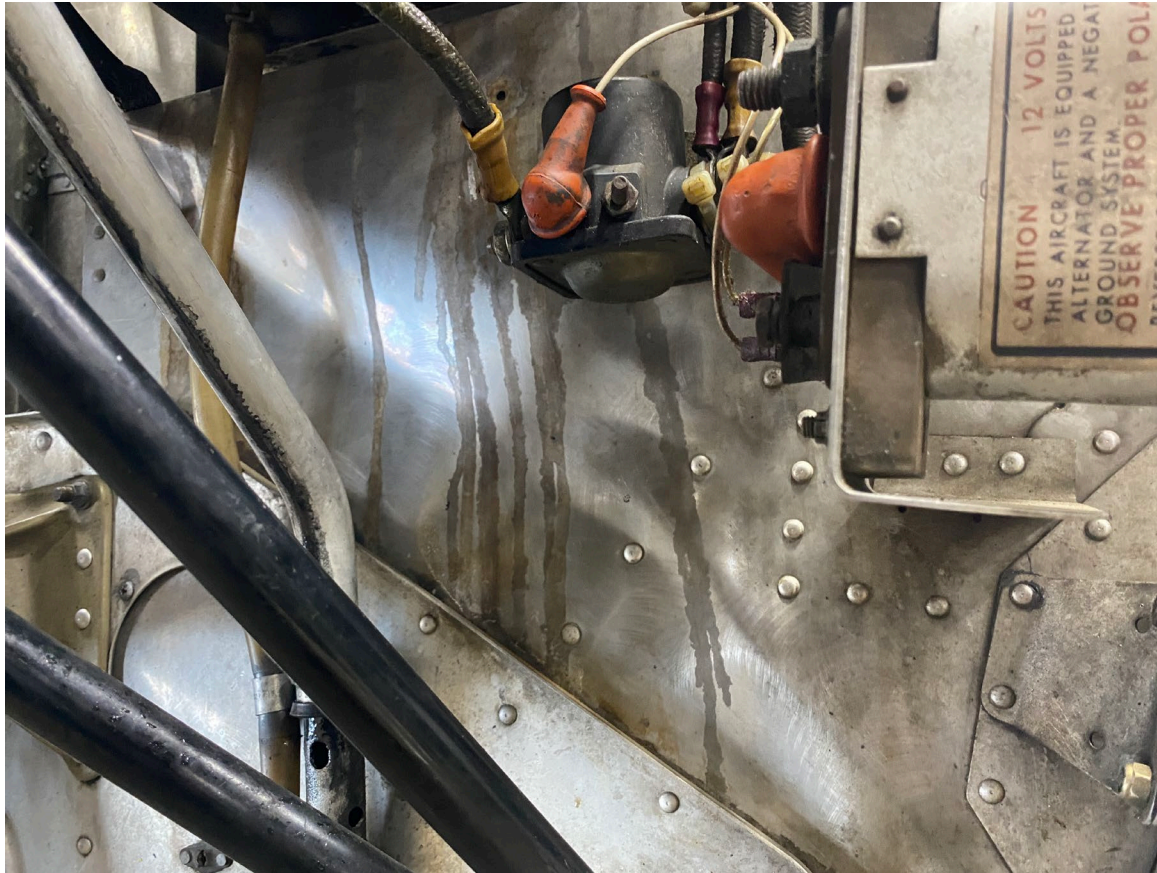
**Photograph 2 - Firewall Wrinkling (Courtesy of FAA)**

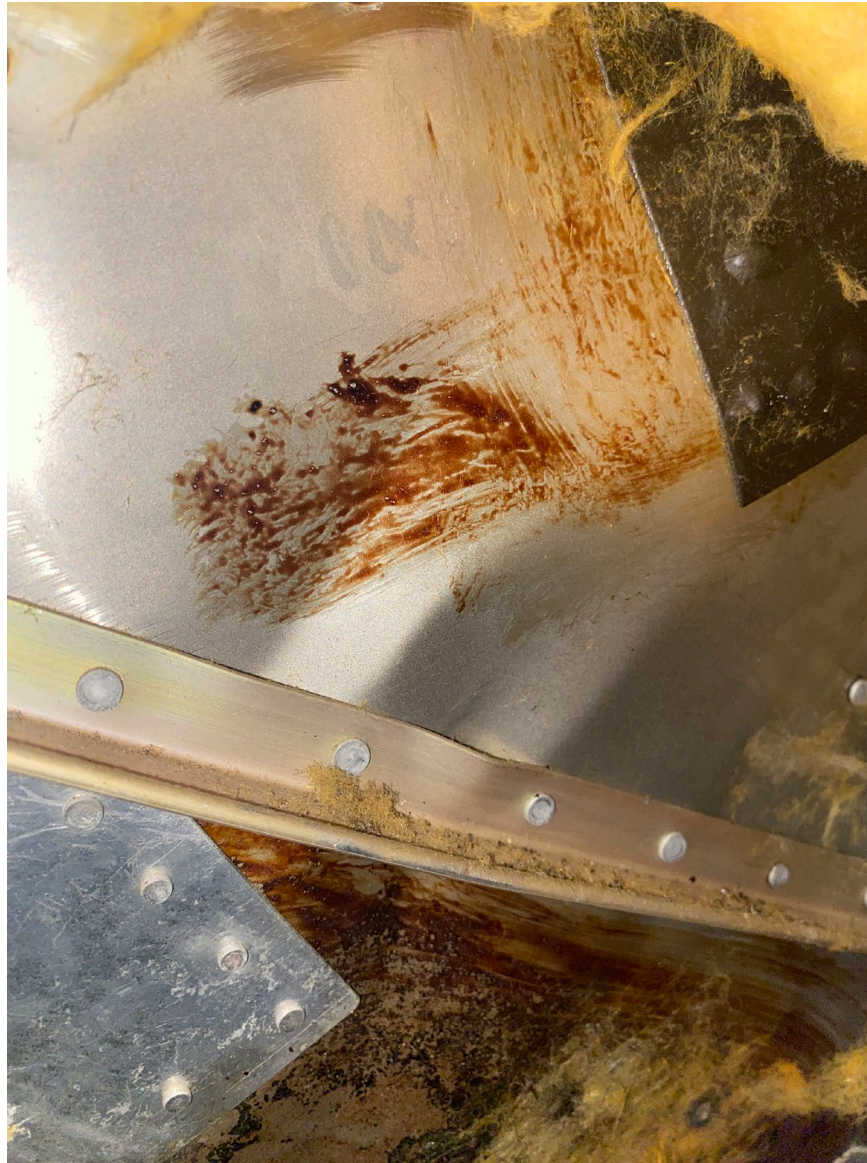
**Photograph 3 - Damaged Cockpit-Side Firewall Stiffener (Courtesy of FAA)**
