ERA26LA026

## INVESTIGATION PHOTOGRAPHS

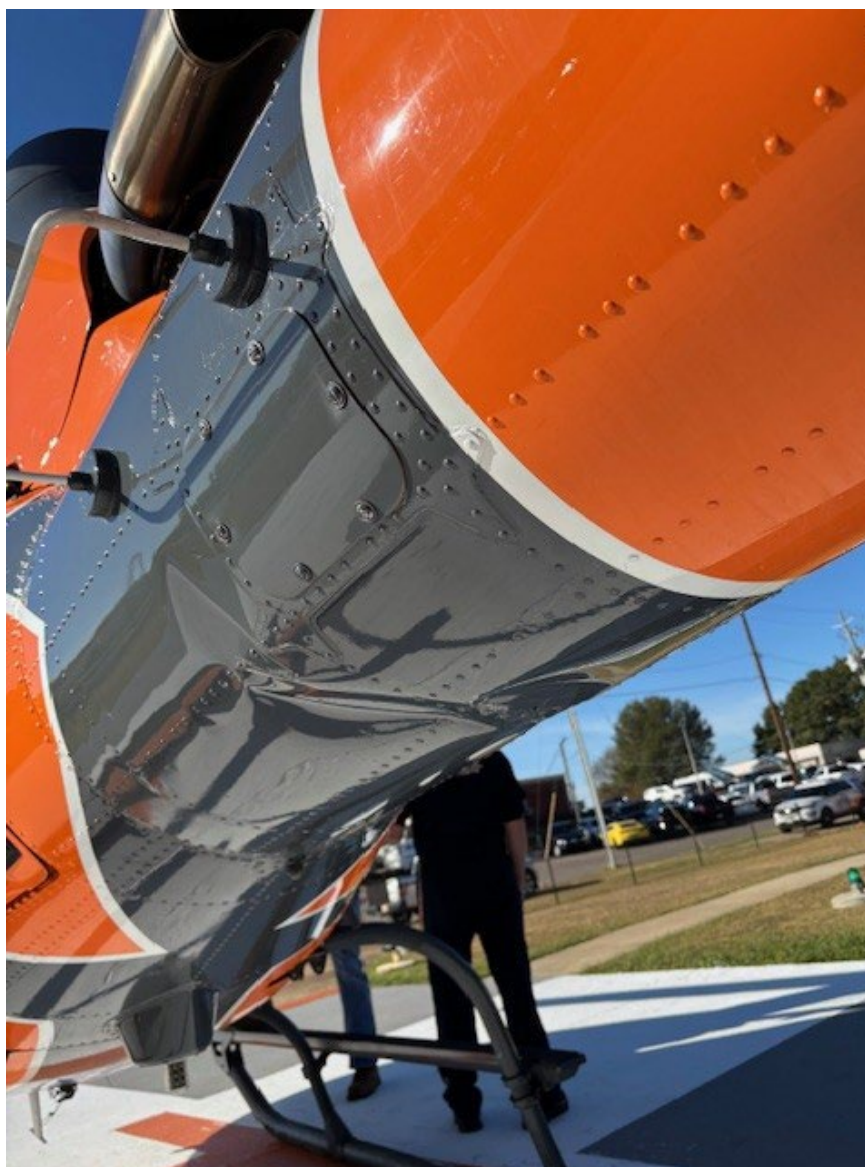
**Photograph 1 - Damage to left side of Tail boom (Courtesy of Operator)**

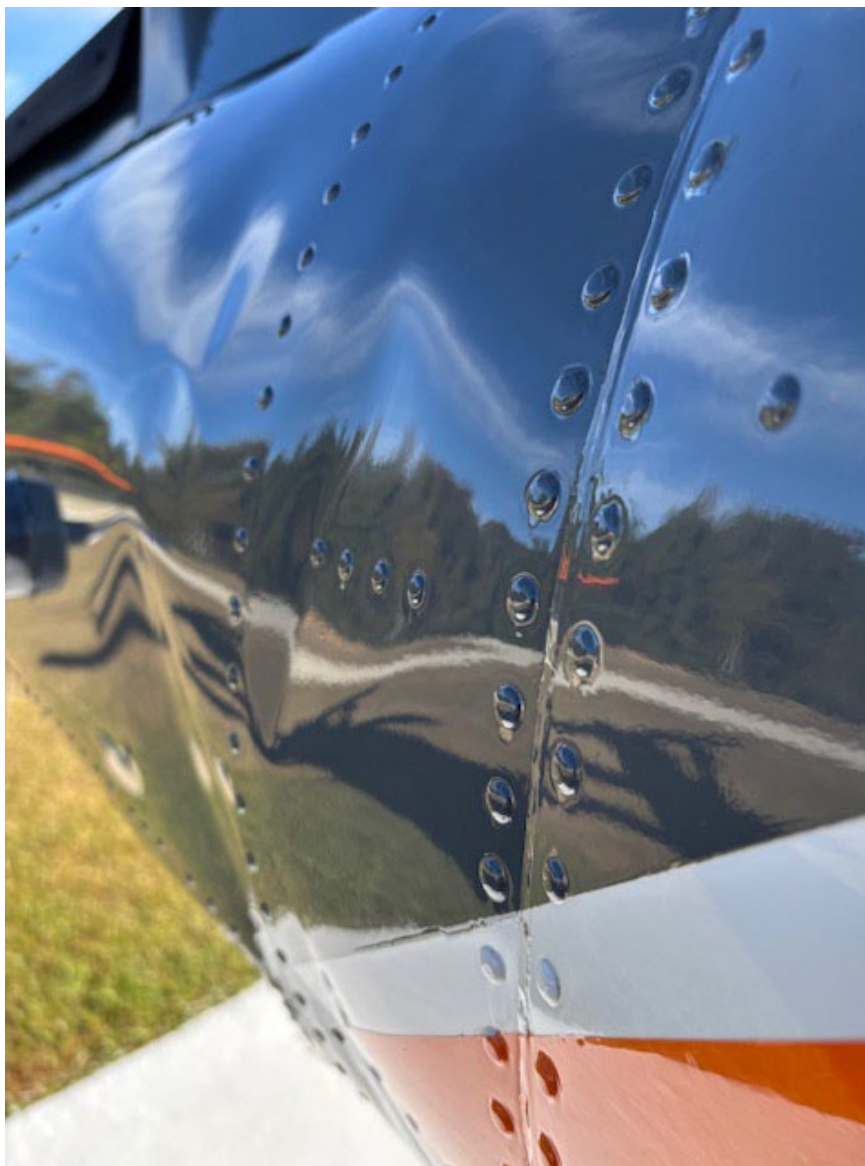
**Photograph 3 - Damage to Right side of Tail boom (Courtesy of Oprerator)**
