ERA26LA028

## INVESTIGATION PHOTOGRAPHS

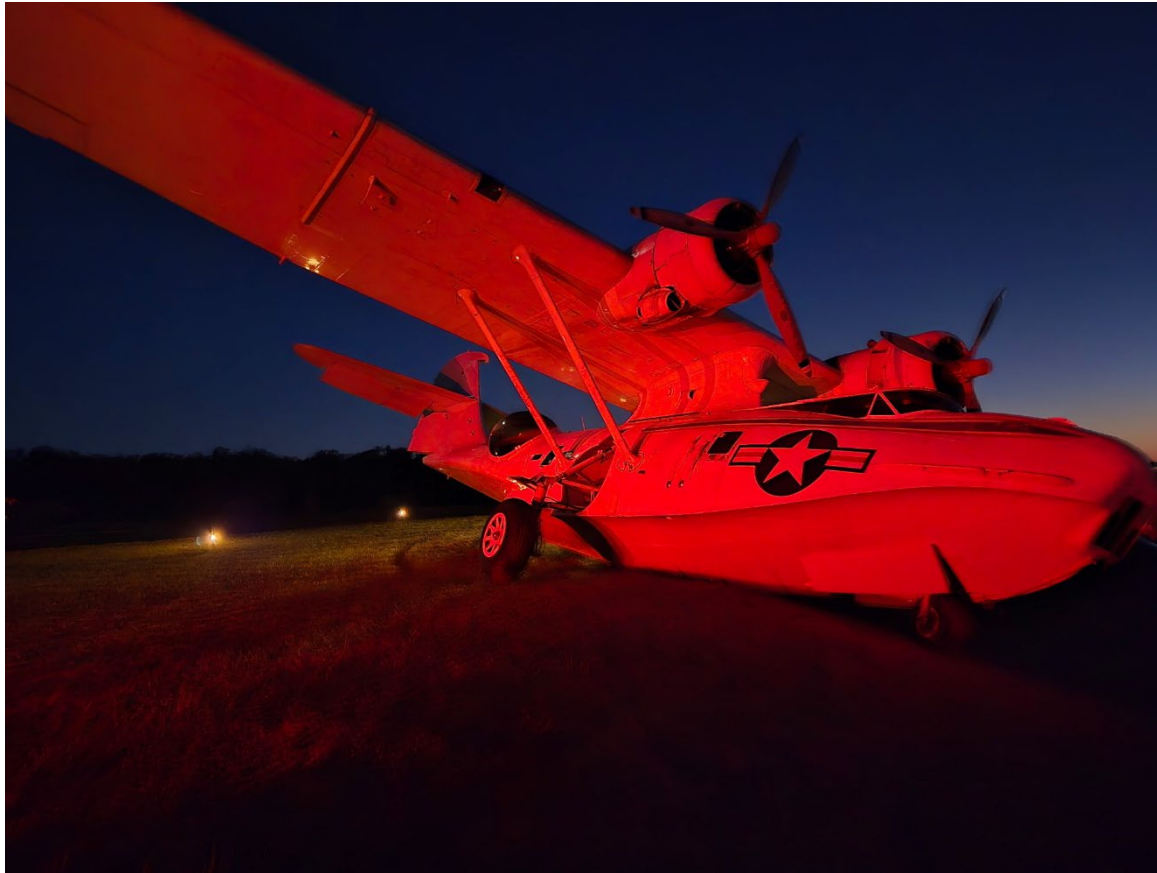
**Photograph 1 - Airplane postaccident (Courtesy of FAA)**

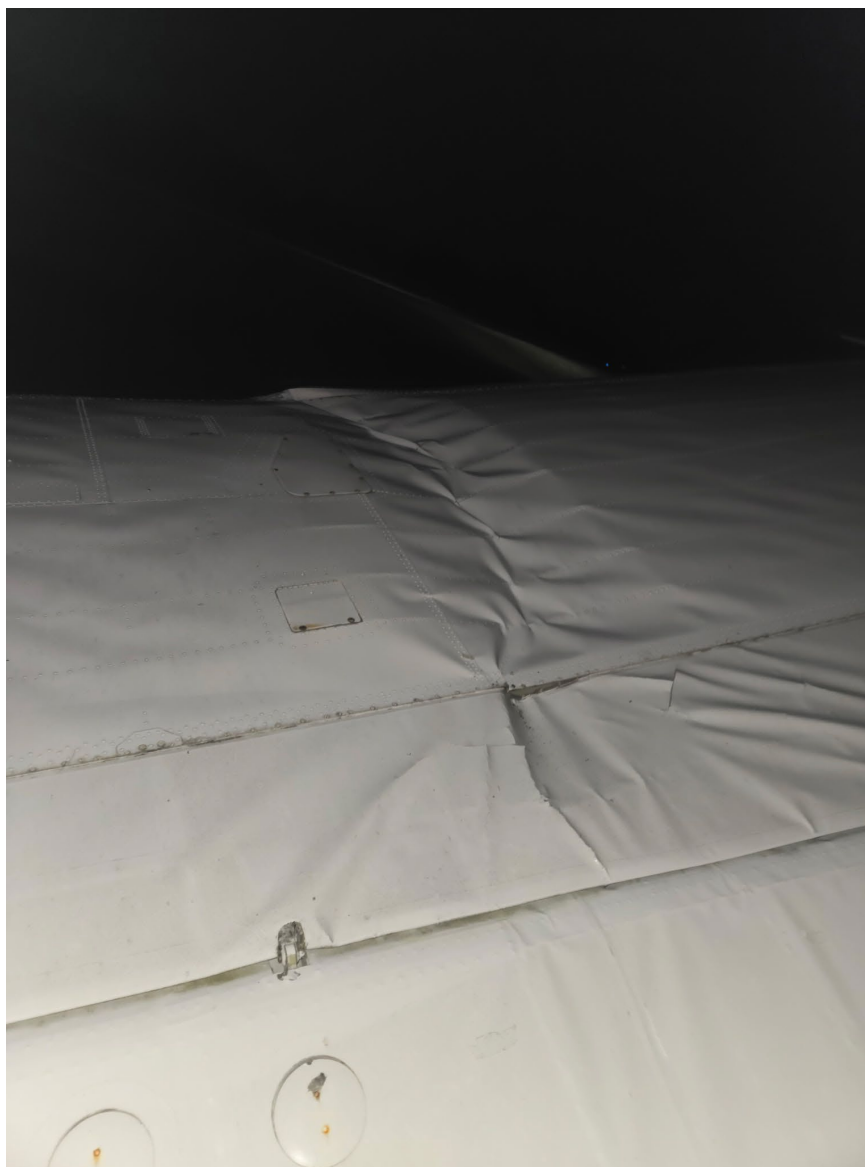
**Photograph 2 - Left wing upper skin damage and spar buckling (Courtesy of FAA)**

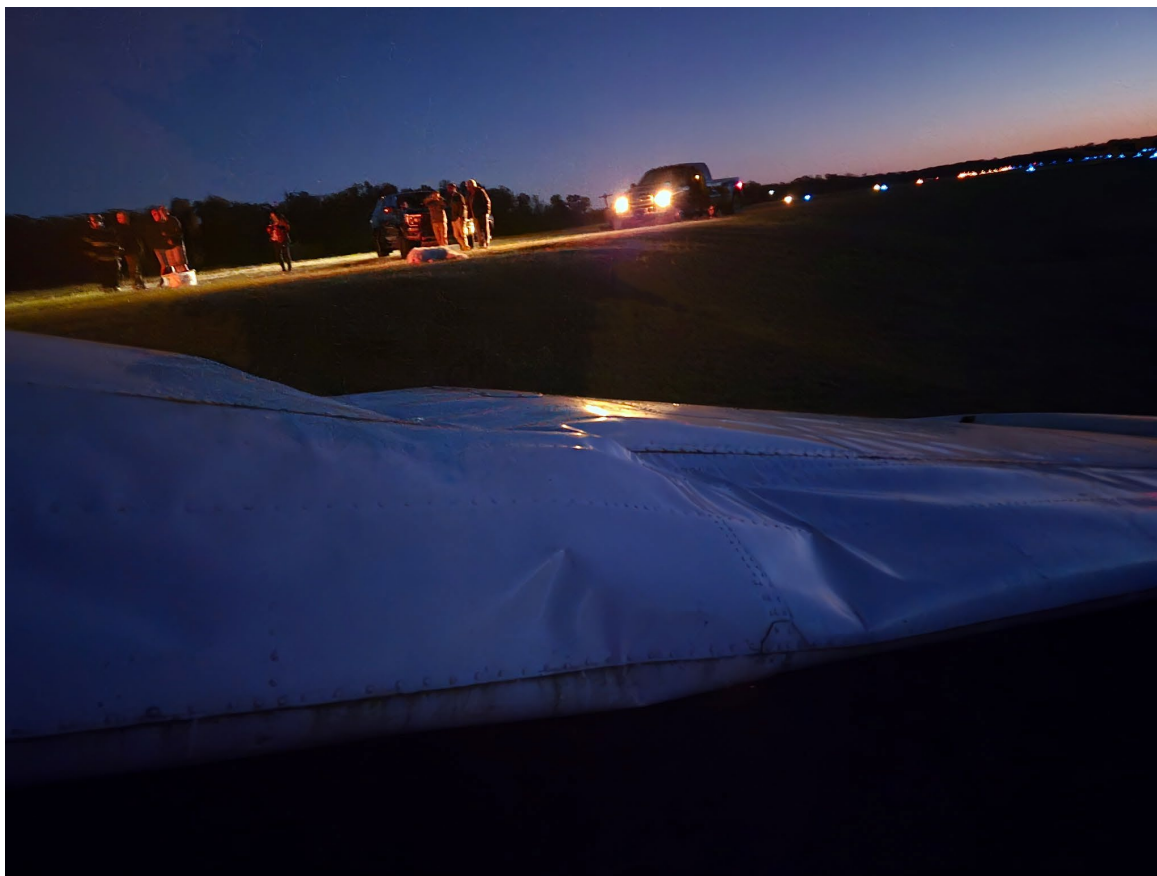
**Photograph 3 - Left wing leading edge damage (Courtesy of FAA)**

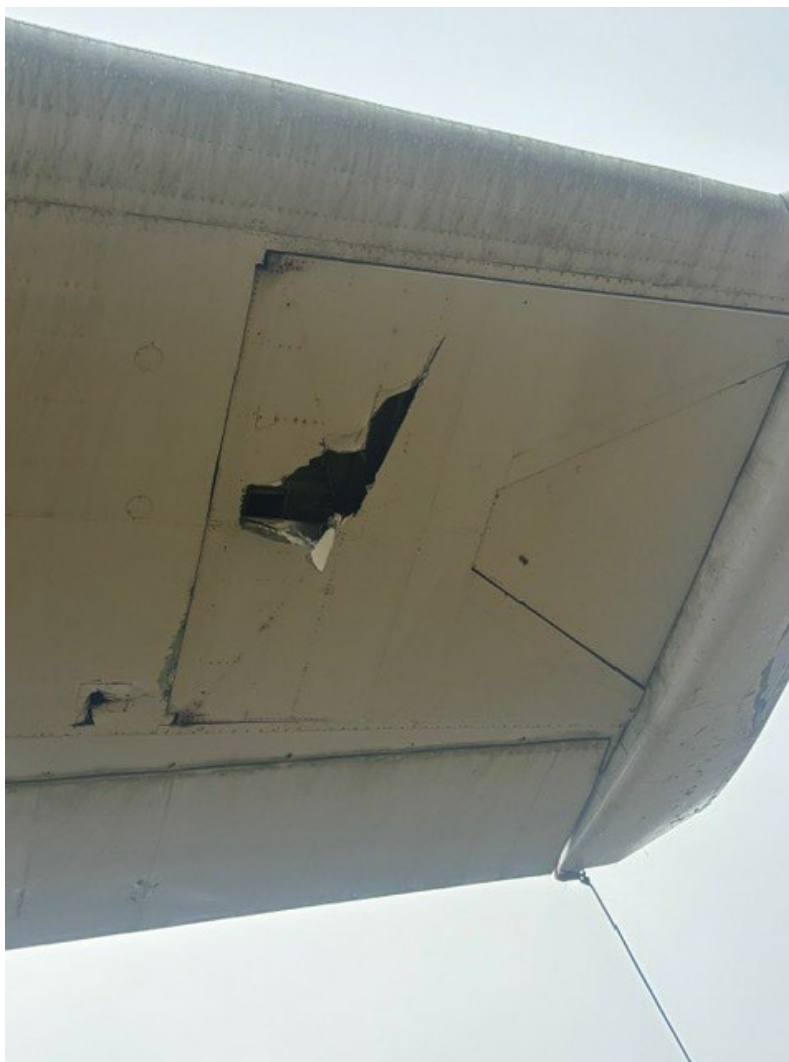
**Photograph 4 - Left wing lower skin damage (Courtesy of Pilot)**

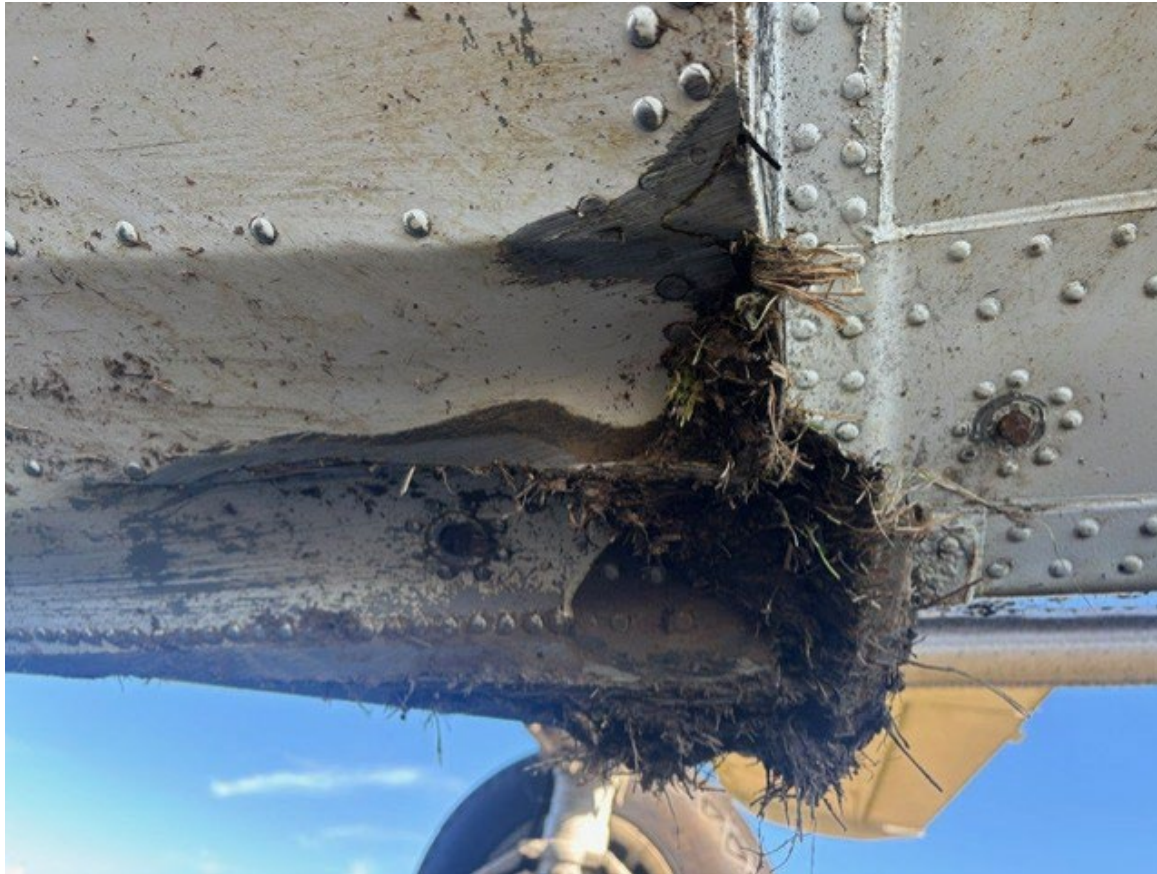
**Photograph 5 - Center hull keel damage (Courtesy of Pilot)**

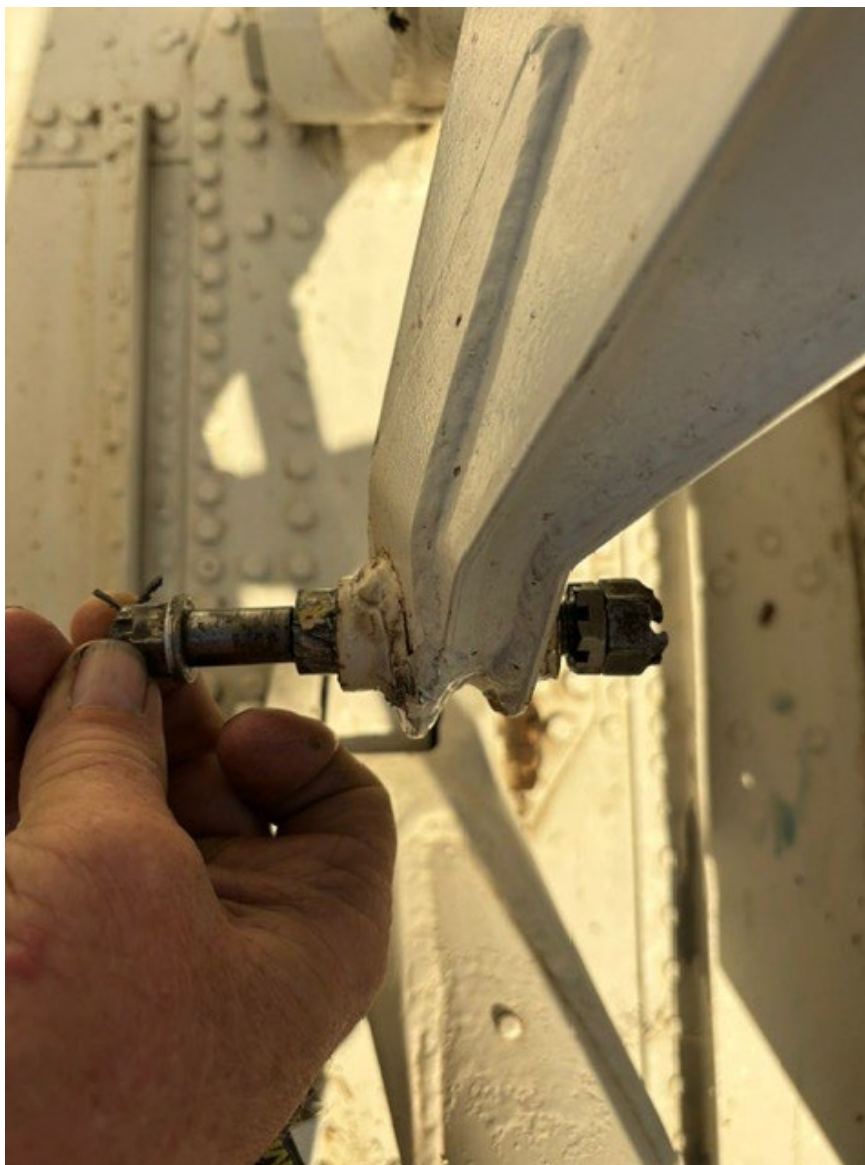
**Photograph 6 - Left Main Landing gear sheared actuator bolt (Courtesy of Pilot)**

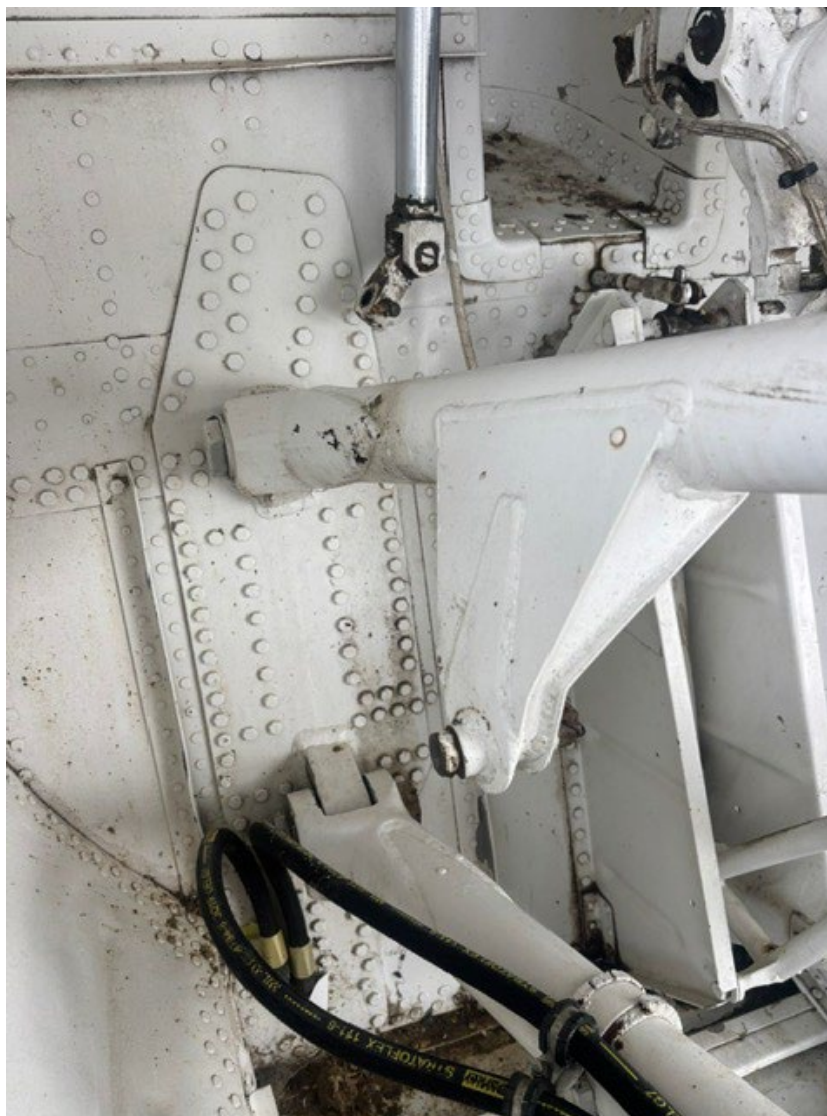
**Photograph 7 - Left main landing gear actuator separated from the landing gear assembly.  
(Courtesy of Pilot)**
