**Date:** April 10, 2025  
**Subject:** ERA26LA028  
**Contact:** Brian Fuchs, Materials Engineer,  
NTSB RE-30

The following is in regards to an accident that happened on October 31, 2025, in Dayton TN. Involving a Consolidated Vultee 28-5ACF, PBV-5A Catalina. Photos of a failed bolt that connects the left main landing gear actuator lower end to the landing gear assembly were shared with Brian Fuchs, Material Engineer in the NTSB Materials Laboratory.

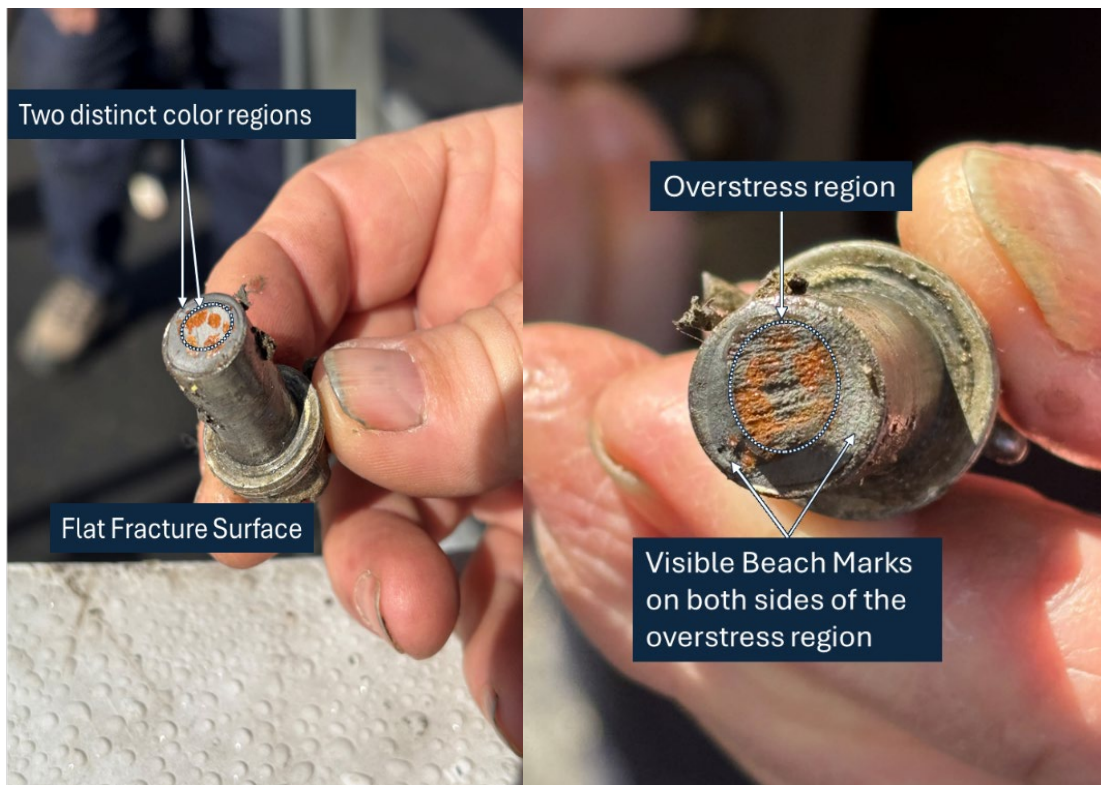
Examination of the failed landing gear bolt revealed reverse bending fatigue resulting from bending loads. The fractured surface exhibited a distinct overstress region with beach marks visible on both sides.
