ERA26LA030

## INVESTIGATION PHOTOGRAPHS

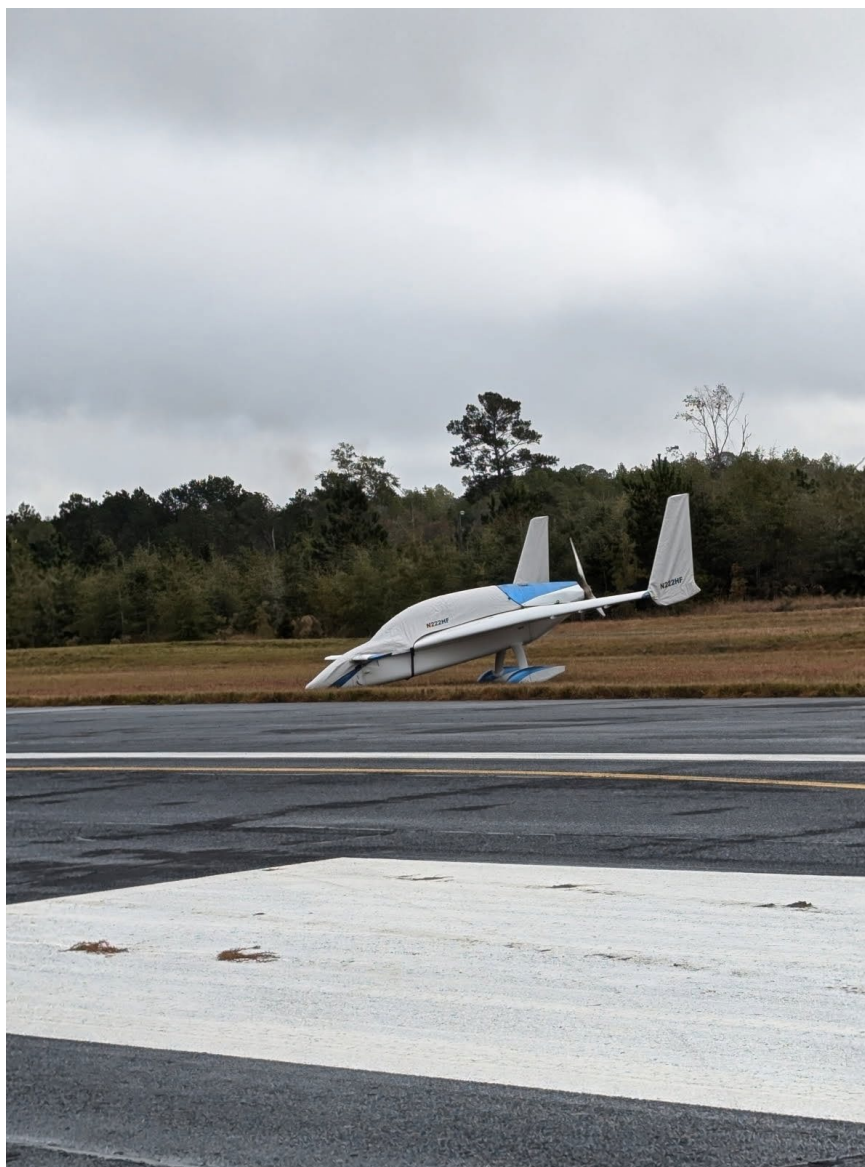
**Photograph 1 - Photo of the aircraft at the scene (Courtesy of owner)**

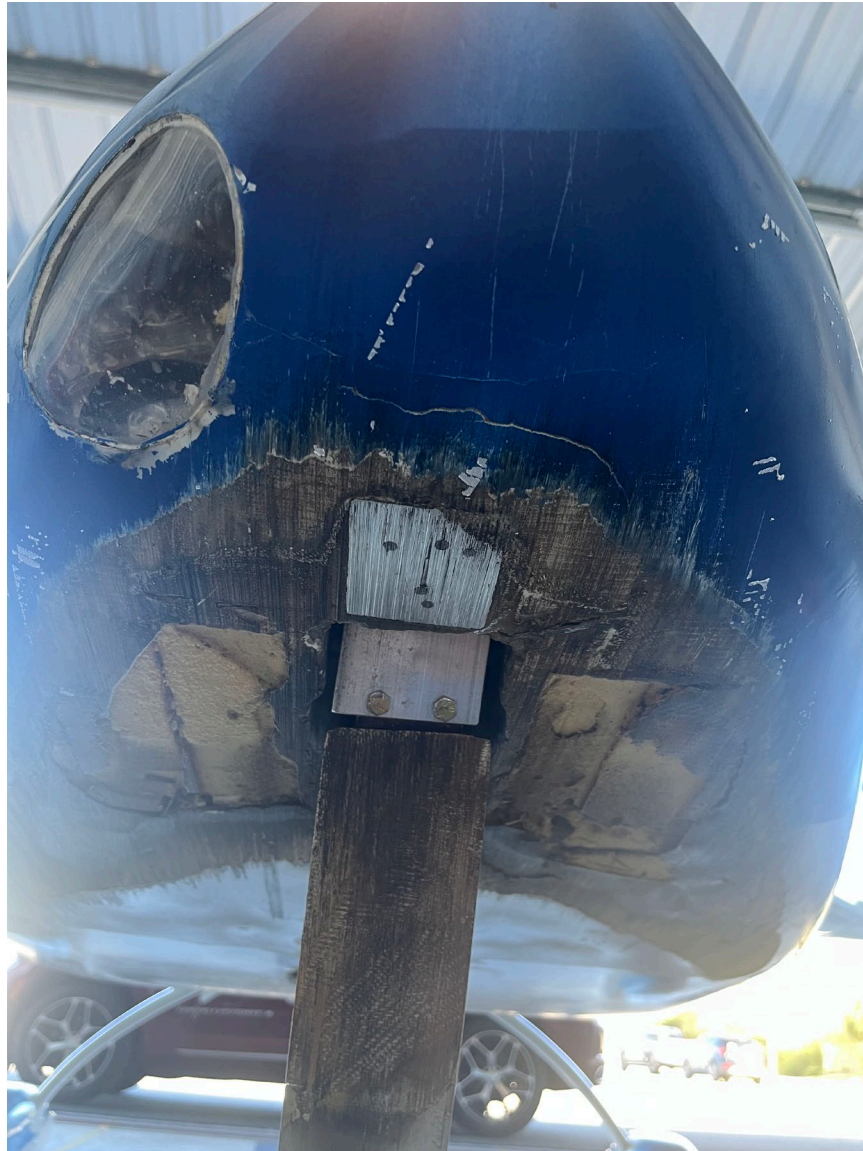
**Photograph 2 - Photo showing substantial damage to the composite structure of the lower nose (Courtesy of owner)**

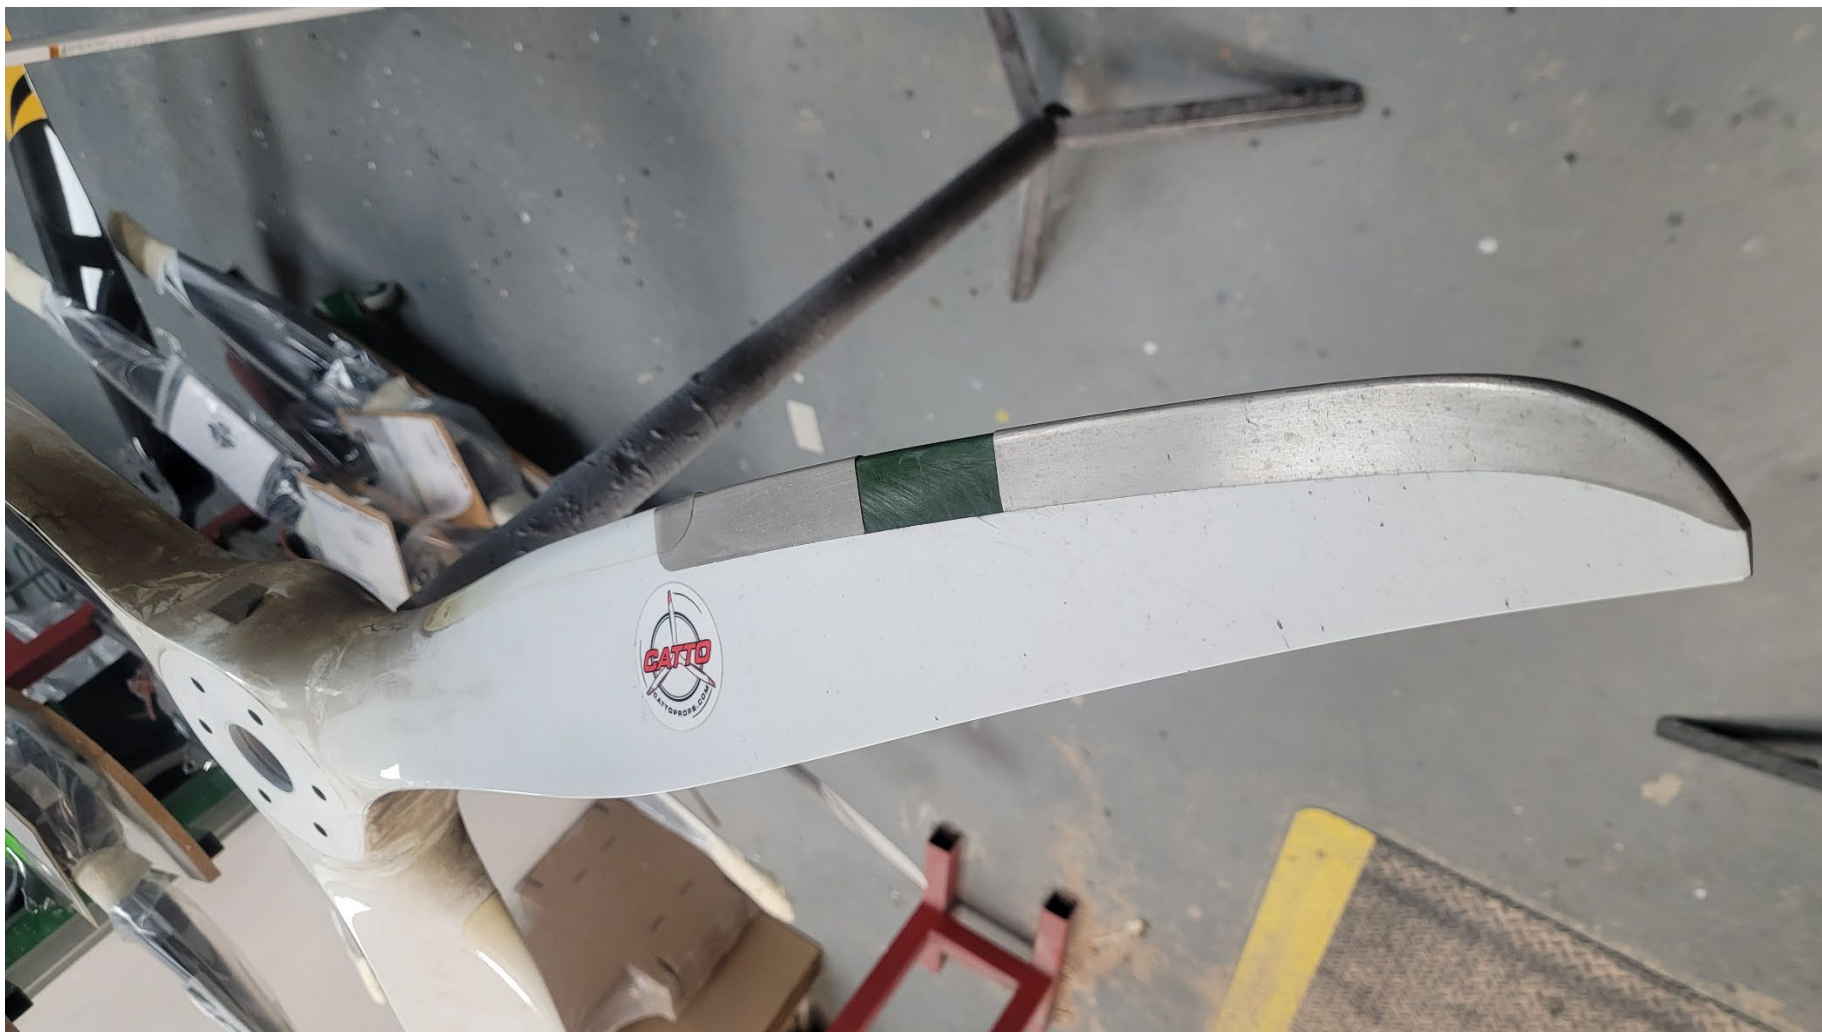
**Photograph 3 - Photo of prop blade after accident with missing nickel leading edge (Courtesy of Catto Propellers)**

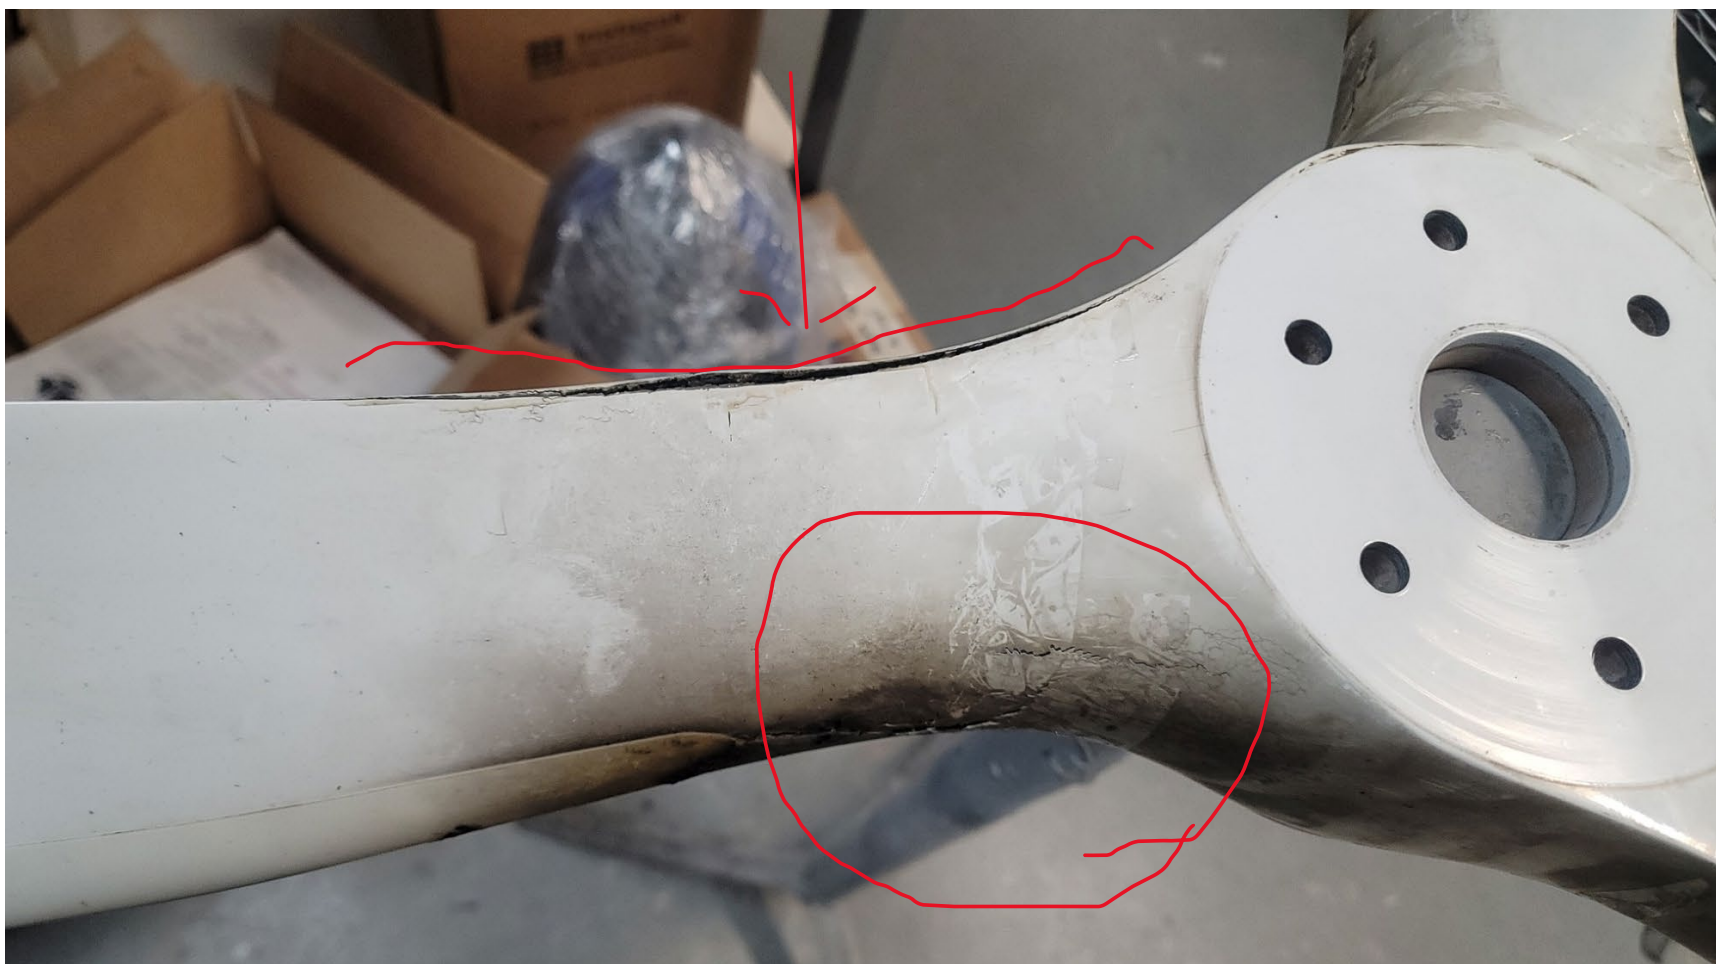
**Photograph 4 - Photo of propeller after the accident showing delamination (Courtesy of Catto Propellers)**

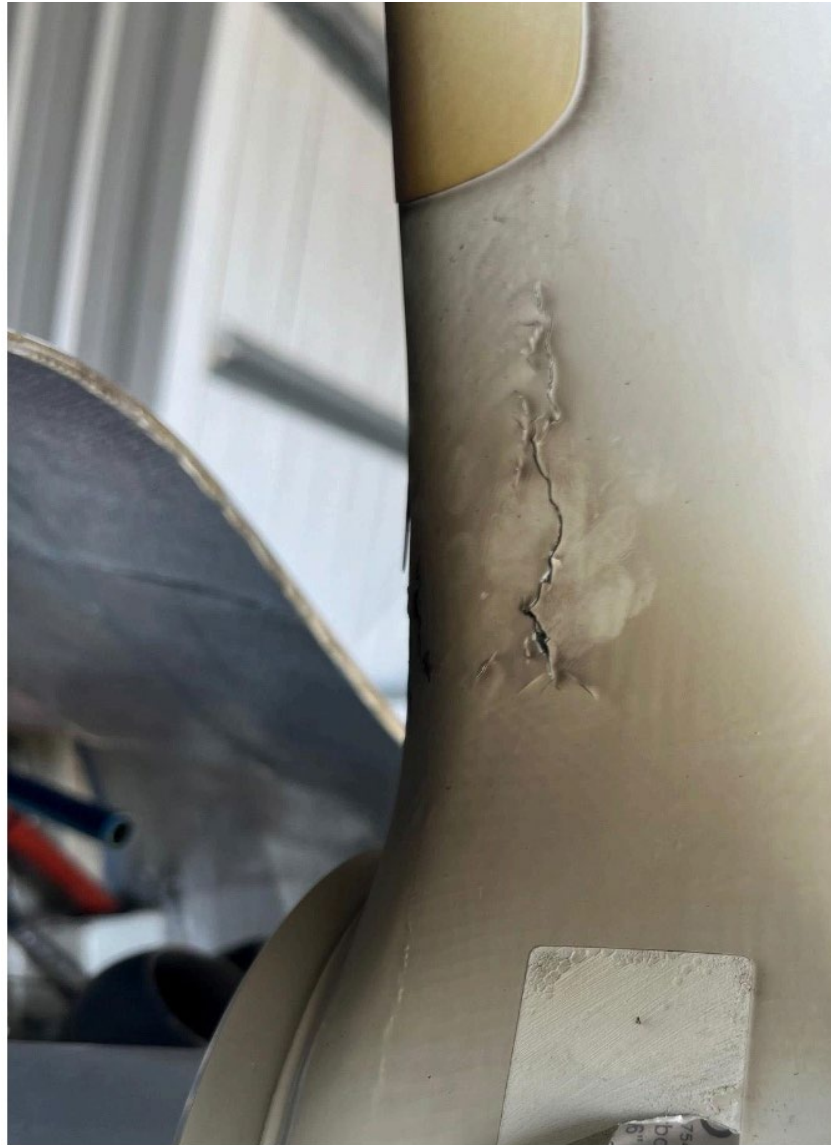
**Photograph 5 - Photo of damage to propeller as reported to manufacturer May, 2025 (Courtesy of Catto Propellers)**
