ERA26LA037

## INVESTIGATION PHOTOGRAPHS

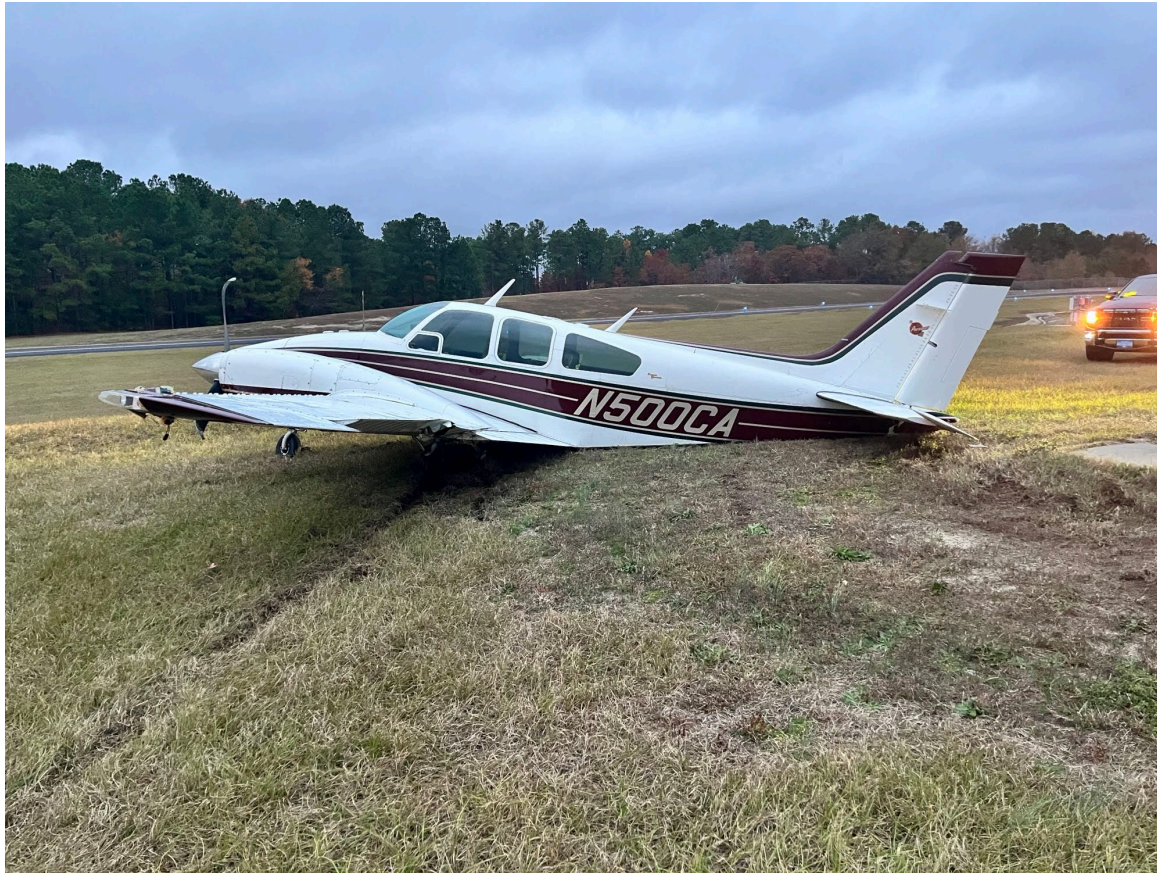
**Photograph 1 - Main Wreckage (Courtesy of Airport Manager)**

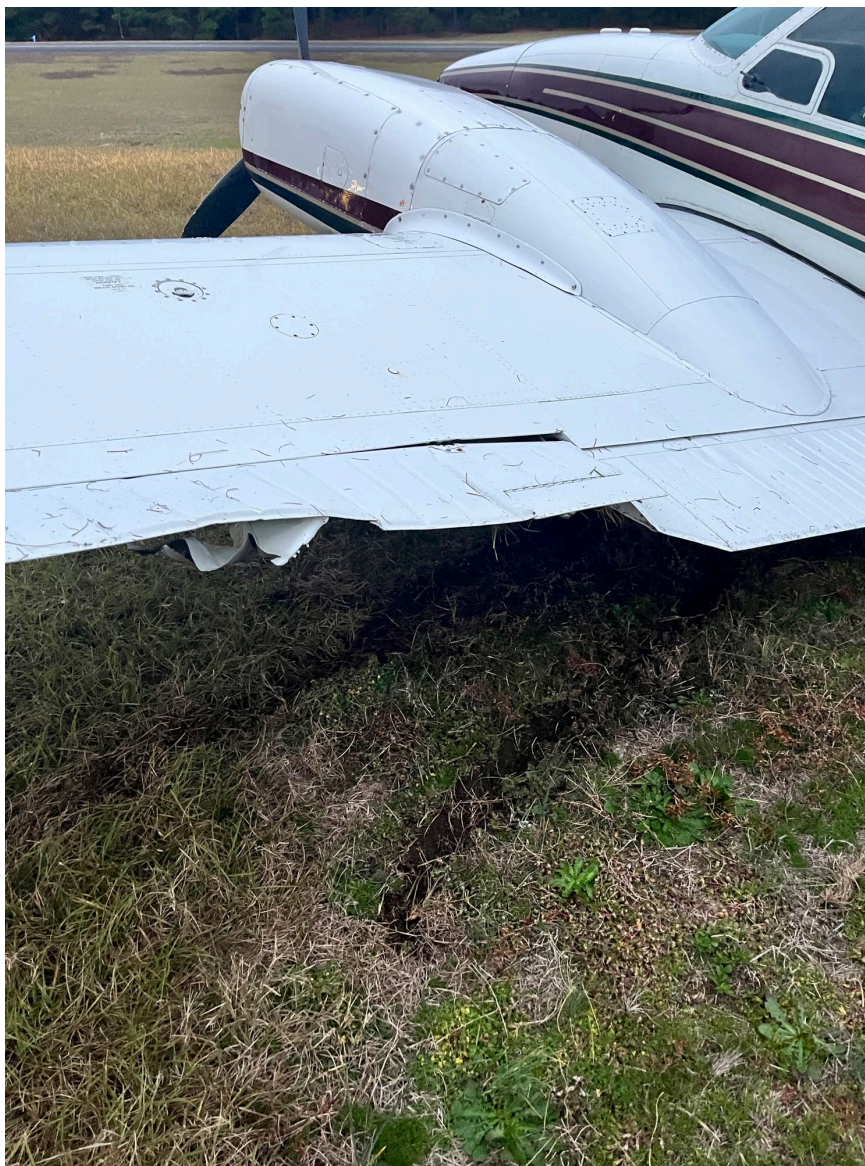
**Photograph 2 - Damage to Left Aileron (Courtesy of Airport Manager)**
