Justin Coe  
Air Safety Investigator  
AS-ERA

**Date:** 1/26/2026

**Subject:** N711FA Landing Gear Inspection

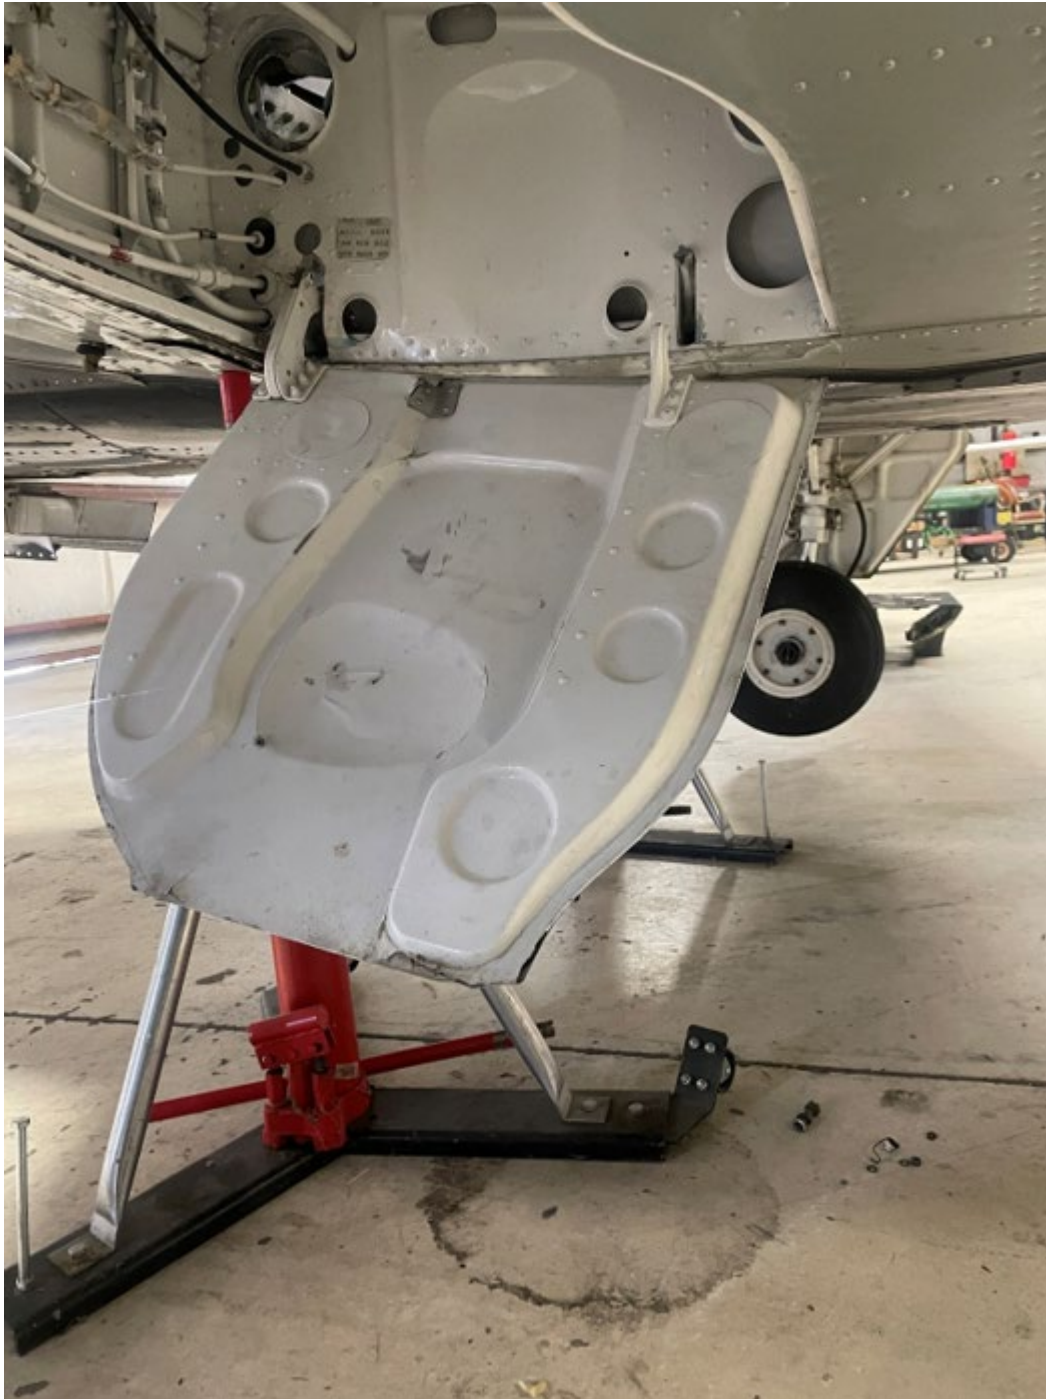
*Figure 1: Left Inboard Main Gear Door*

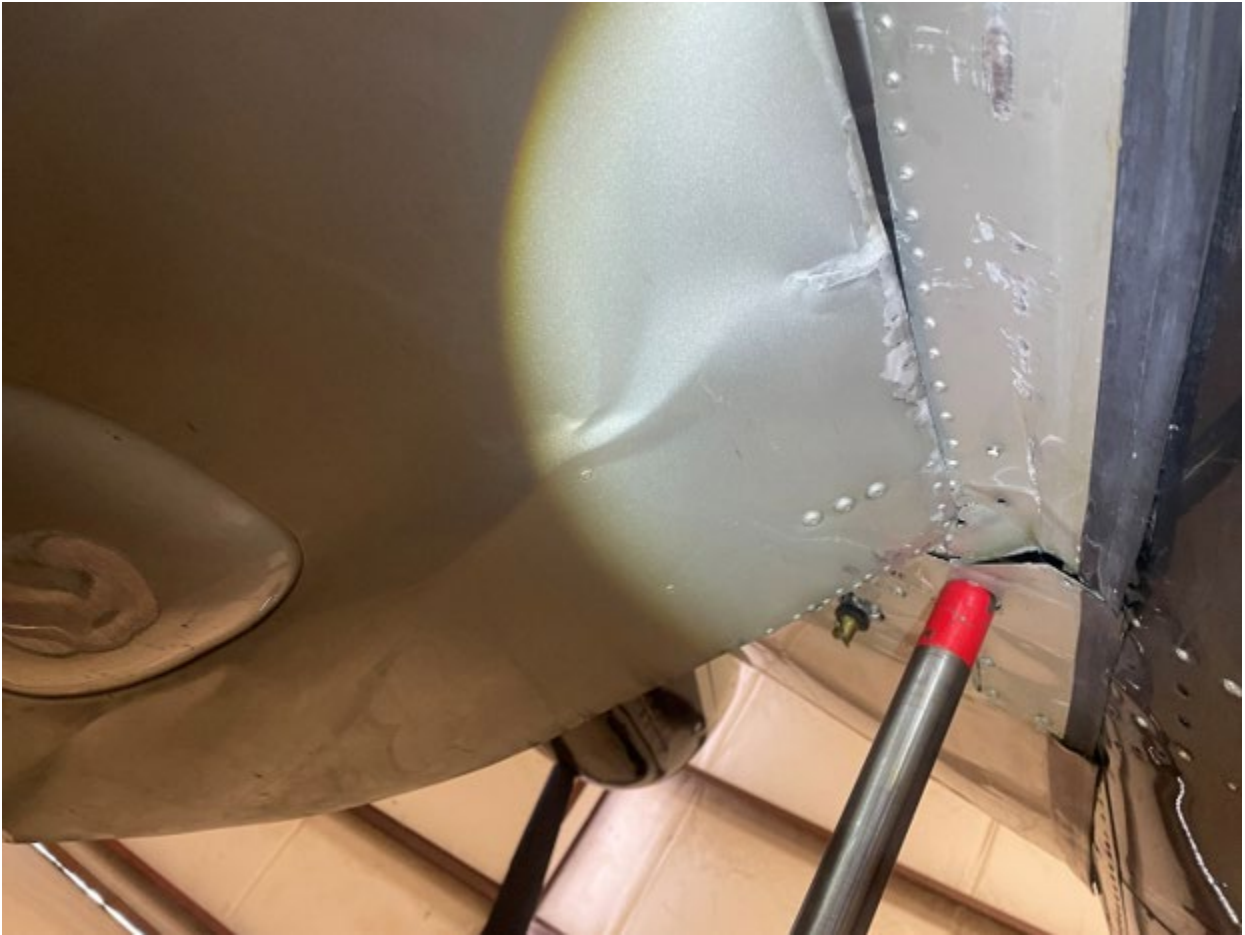
*Figure 2: Underside of Inboard Left Main Gear Door*

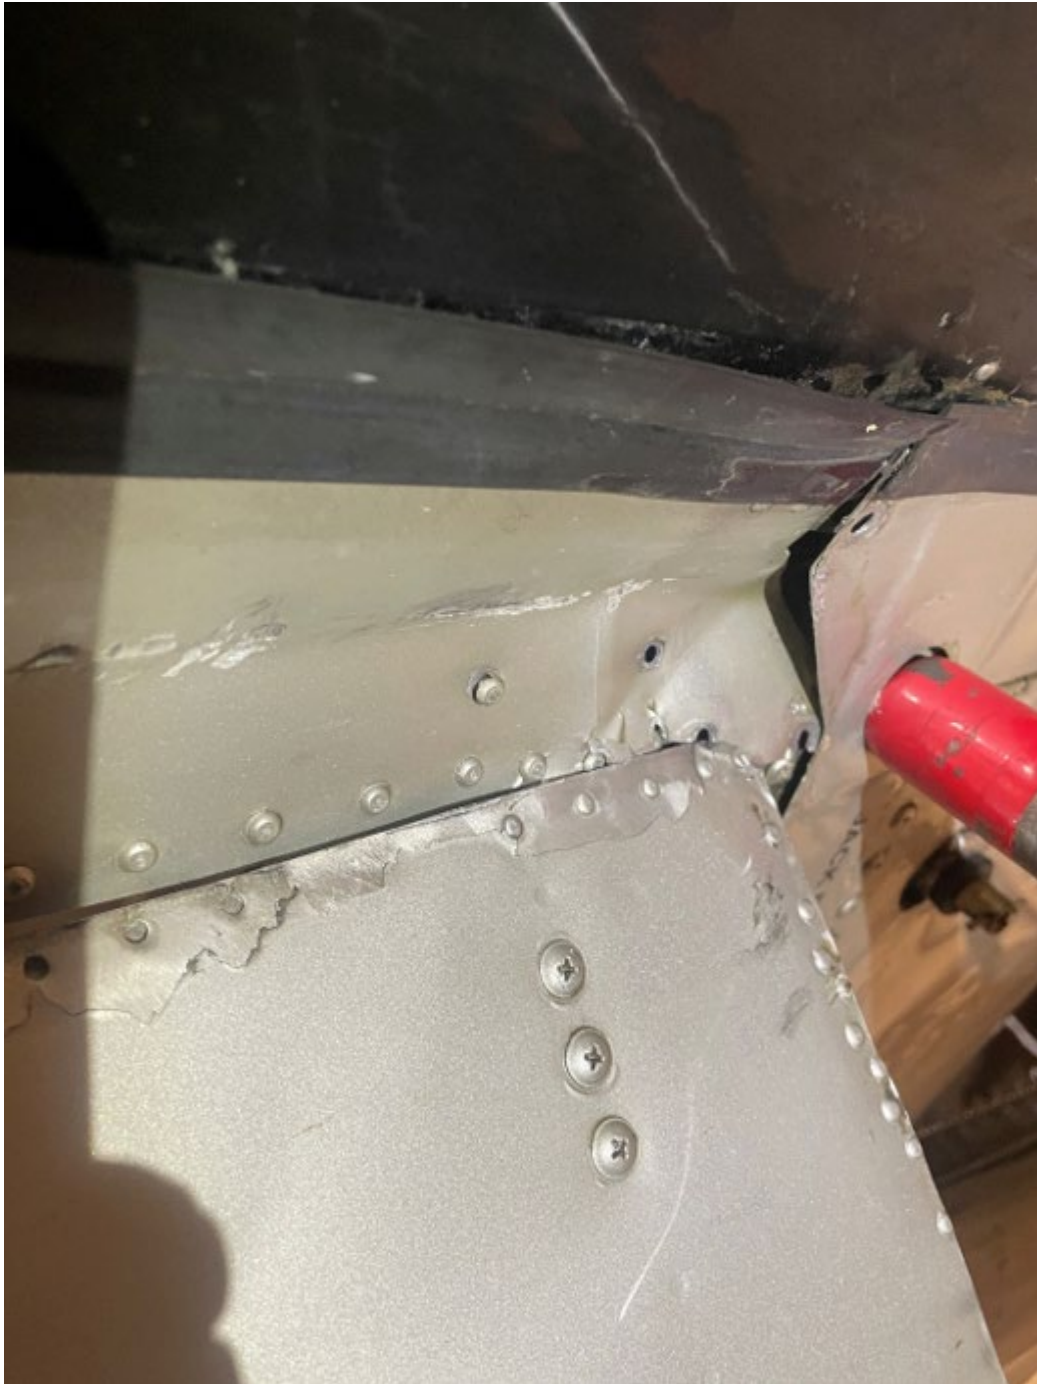
Closer inspection of the left main landing gear revealed the extension rod slip joint retention hardware had been sheared at some point. Closer examination of the main landing gear door hinge points detailed a "clean" break of the aft, inboard gear door hinge. No twisting or other deformation was indicated on the hinge assembly. Distinct discoloring was noticed within the aluminum alloy hinge material. Near the forward hinge point, the gear door exhibited slight curling at the edge, bare metal, and scratches within the metal that were perpendicular to the direction of normal aircraft movement. This appeared to be fresh damage."

*Figure 3: Abrasion Damage on Underside of Inboard Left Main Gear Door*

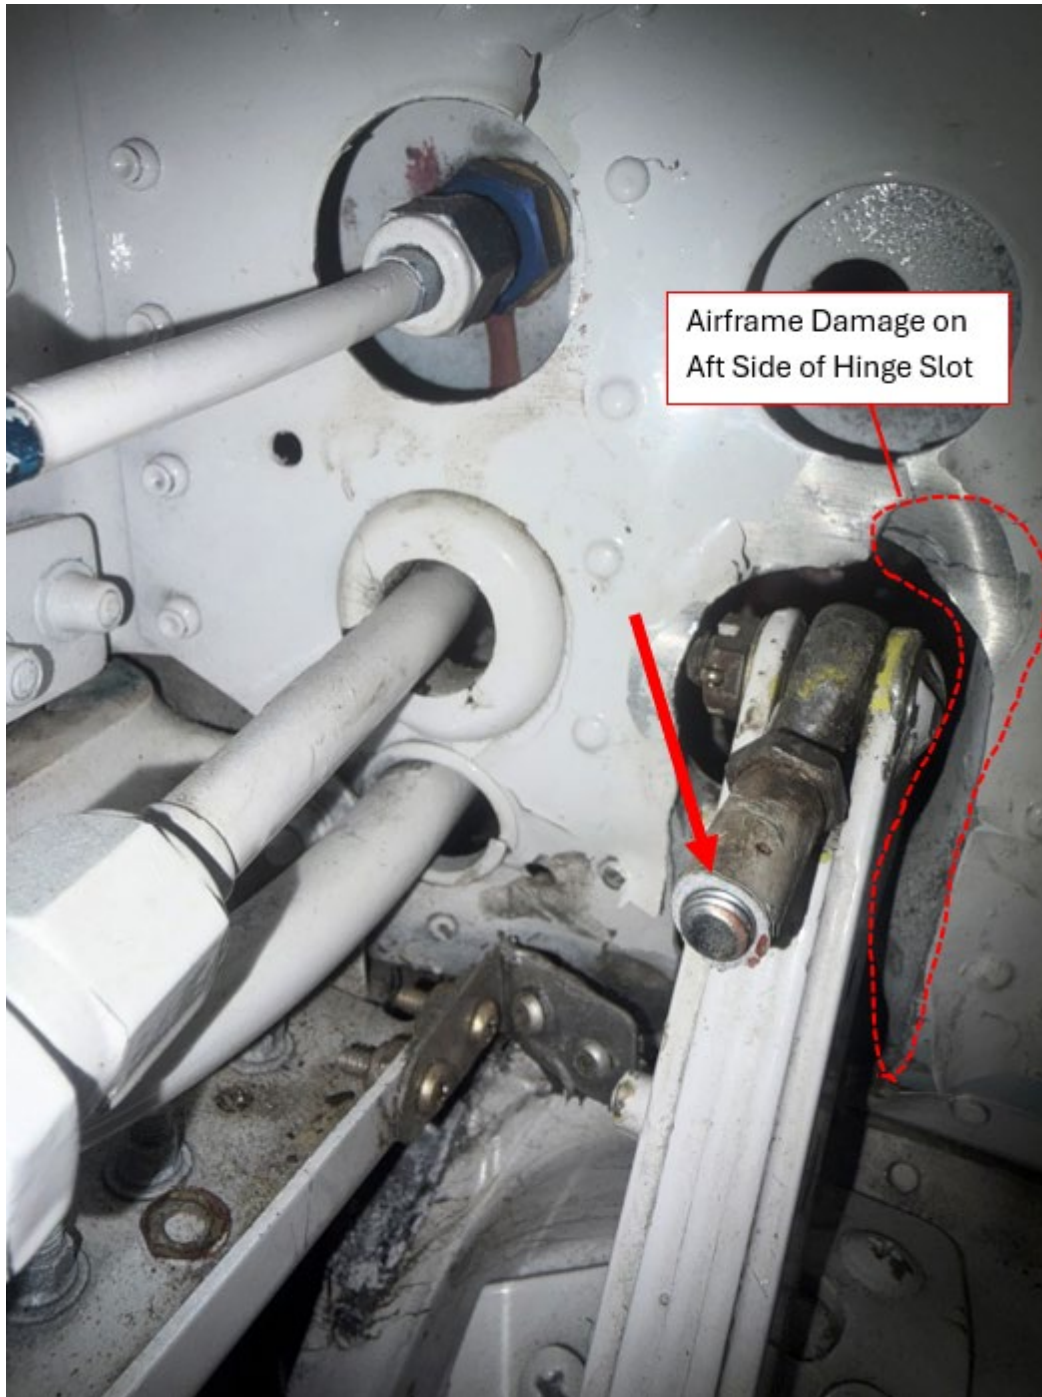
*Figure 4: Failed Left Main Gear Door Link Assembly, Attached to Forward Inboard Hinge*

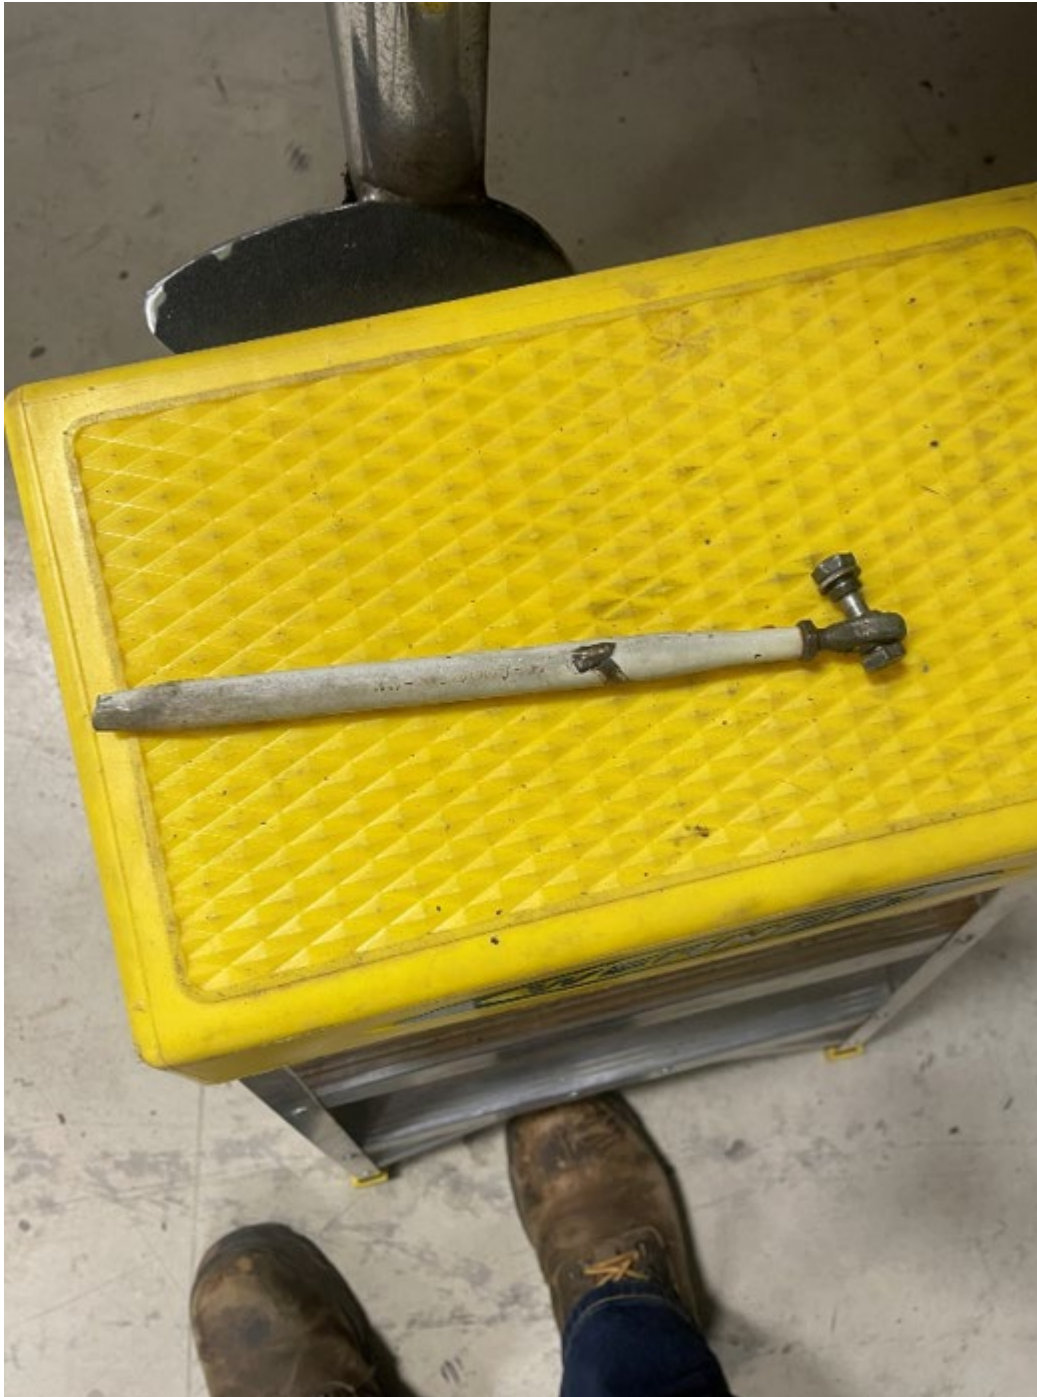
*Figure 5: Rod Portion of Failed Left Main Gear Door Link Assembly*

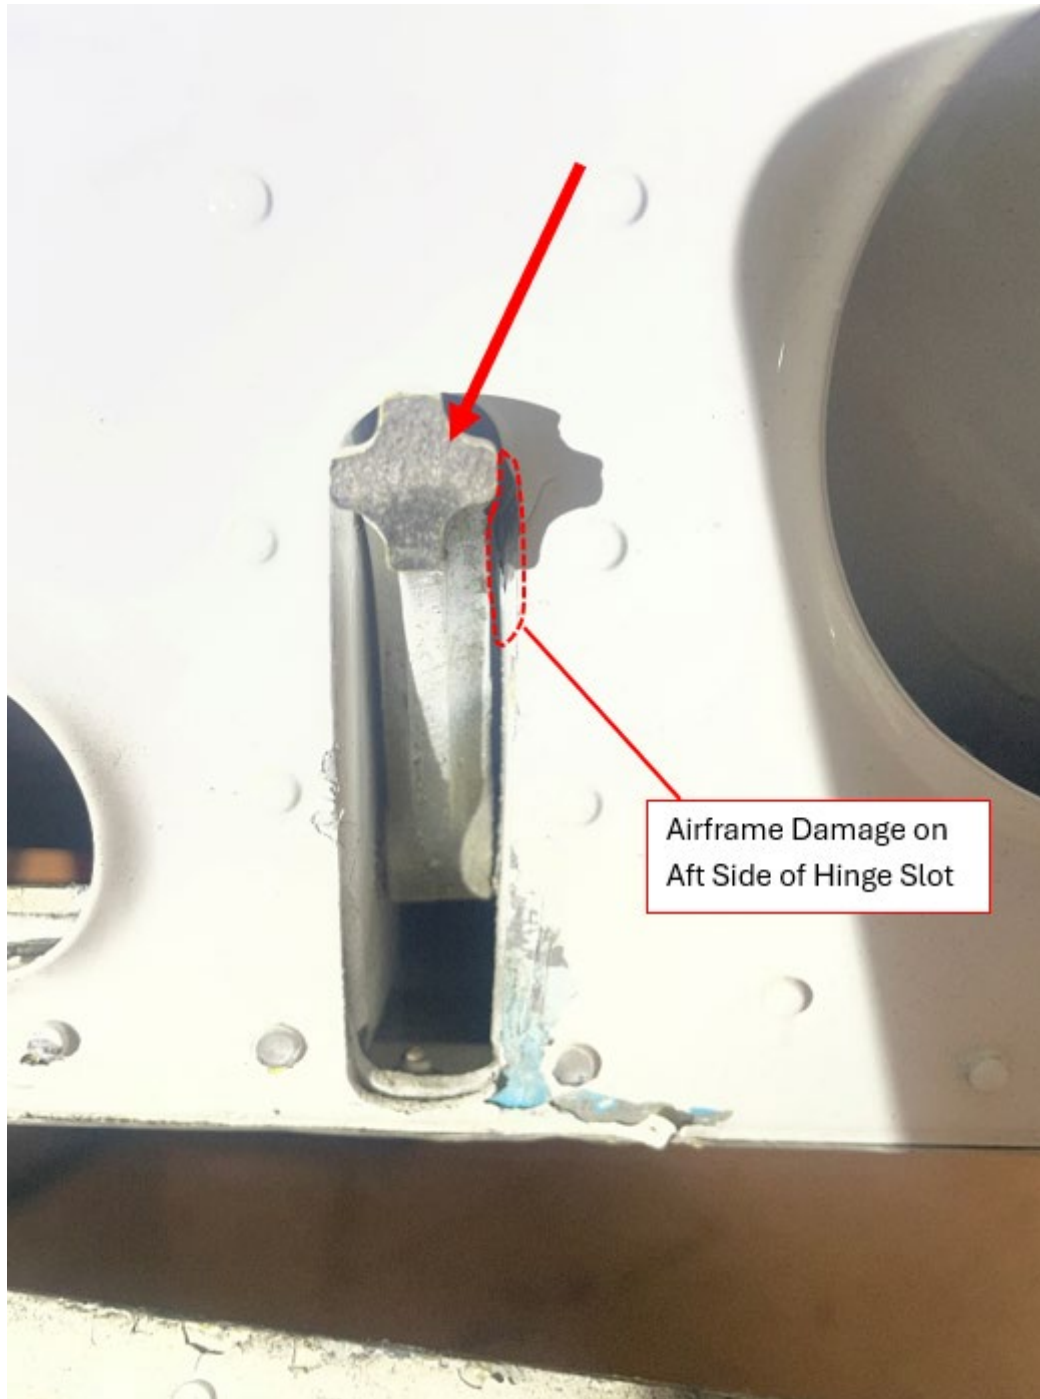
*Figure 6: Failed Left Main Landing Gear Door Aft Inboard Hinge*

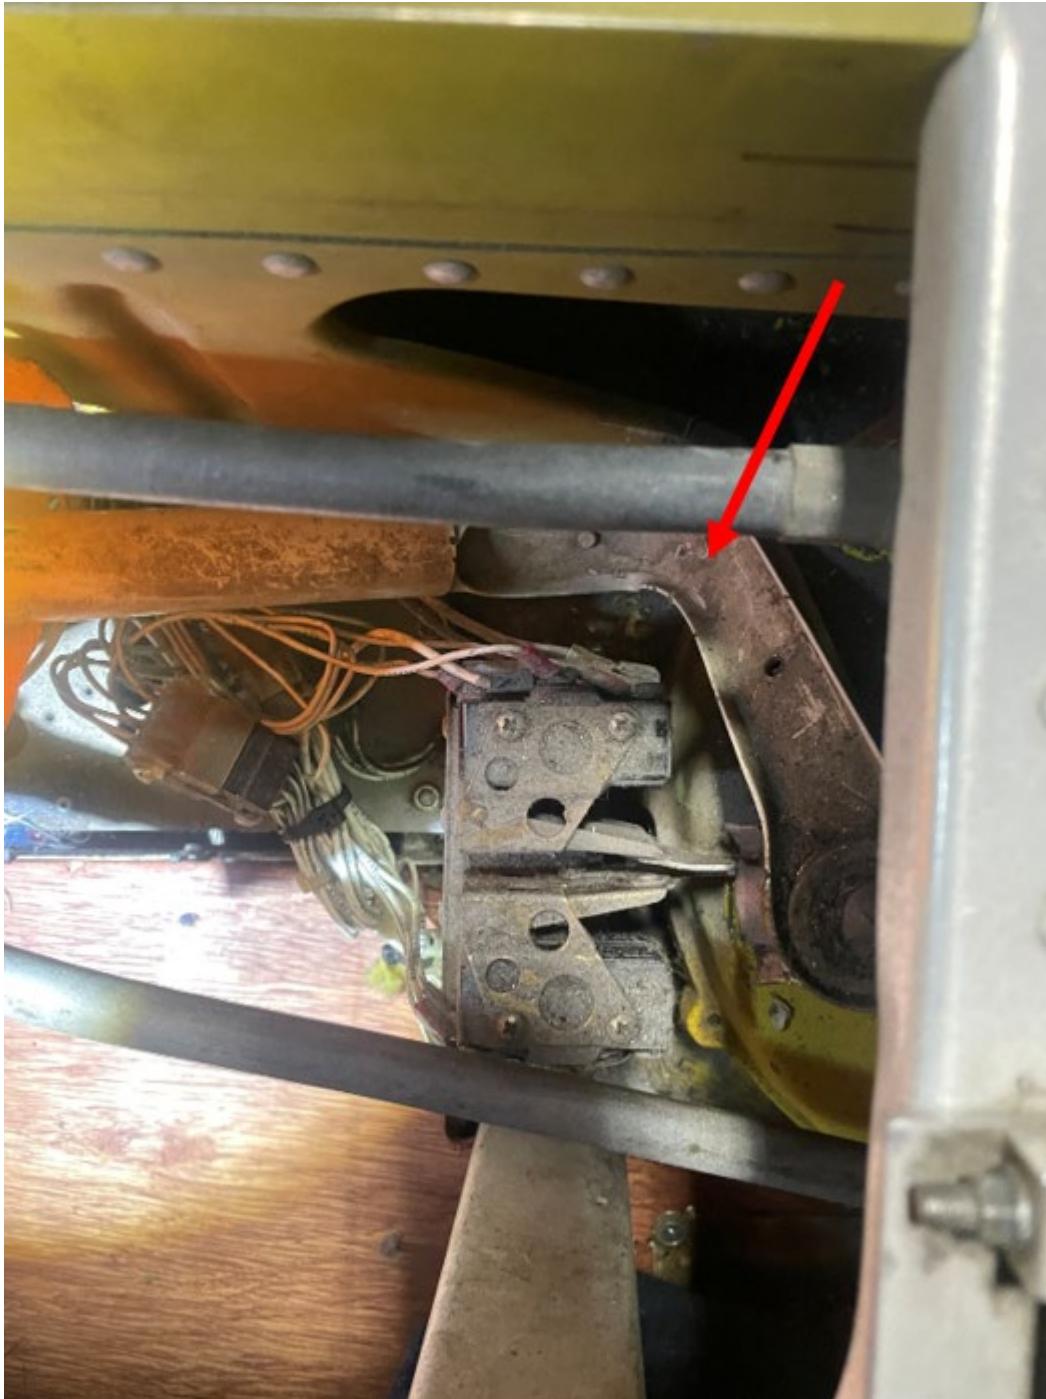
*Figure 7: Bent Left Main Gear Retraction Rod Assembly*

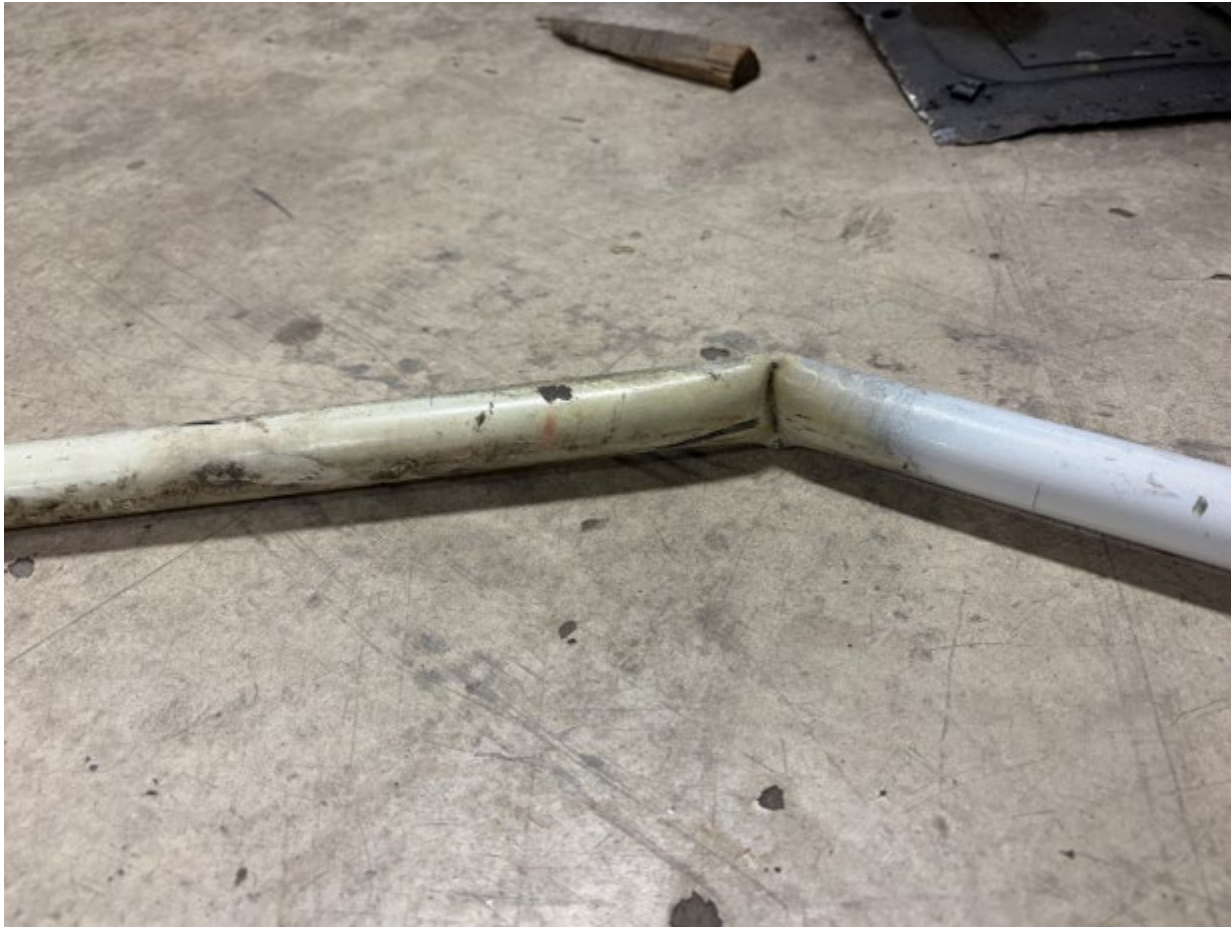
*Figure 8: Buckled Main Gear Retraction Rod Assembly After Removal*

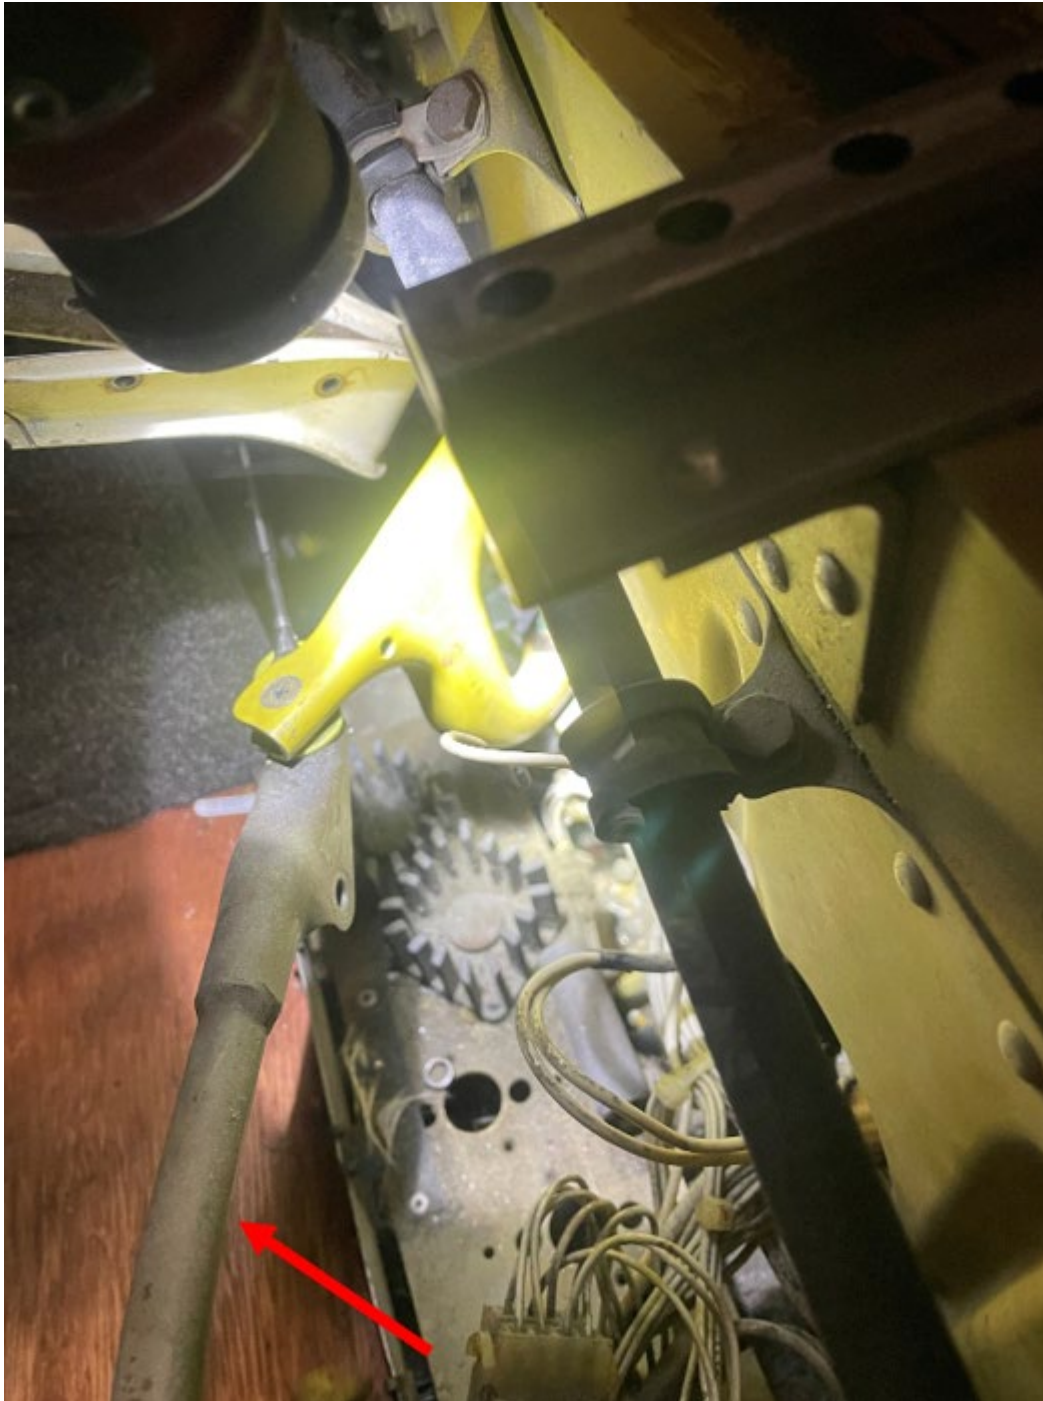
*Figure 9: Bent Left Main Landing Gear Door Actuator Rod Assembly*

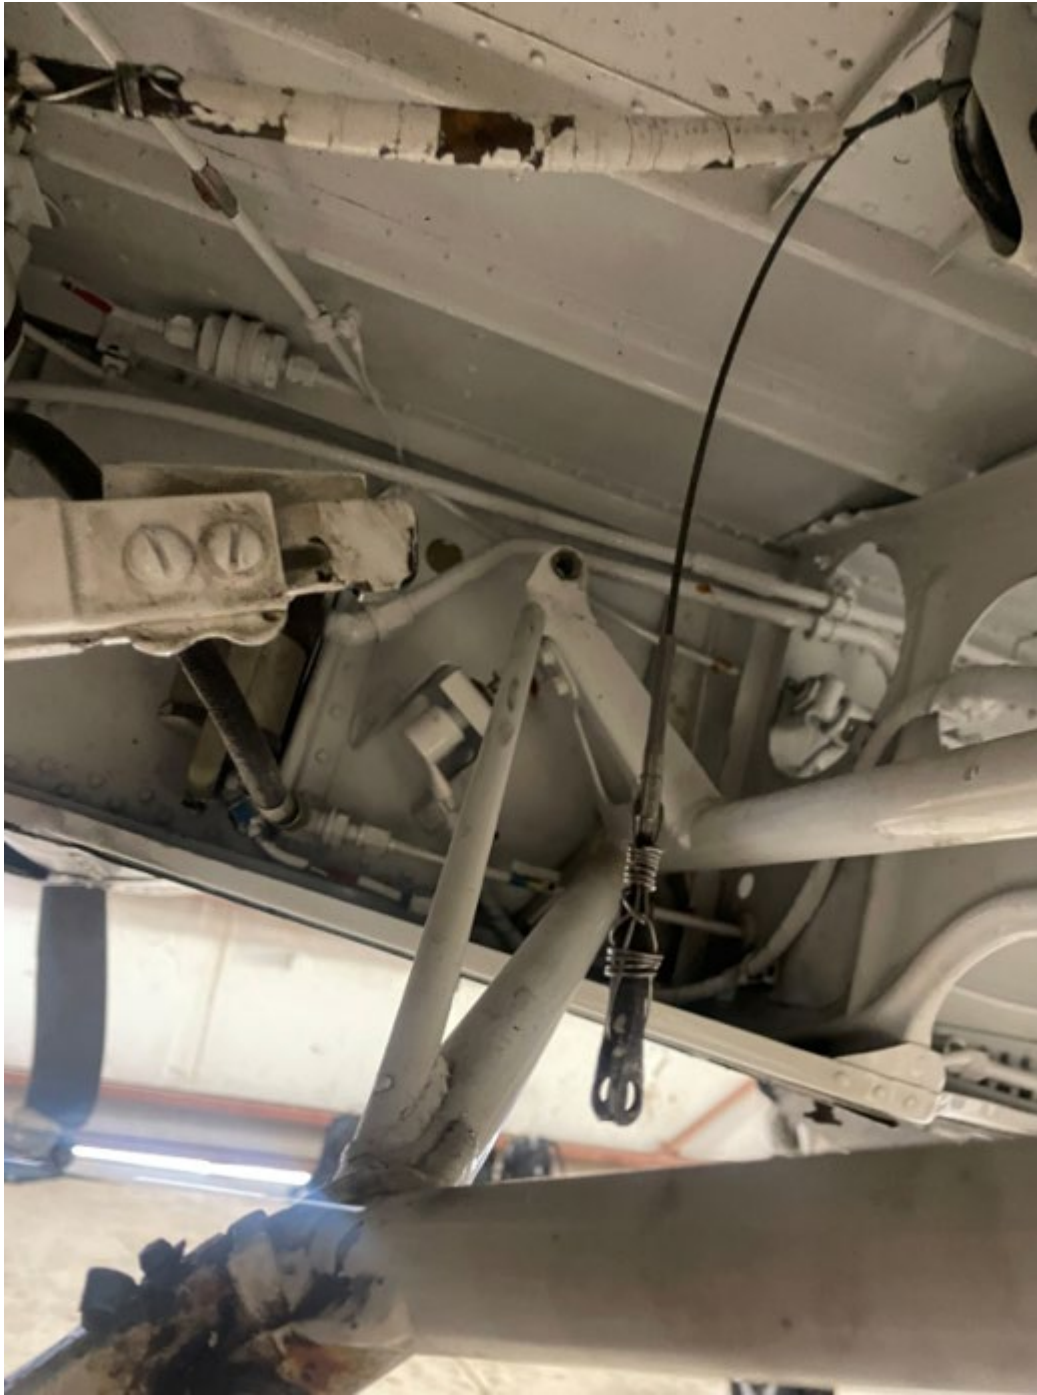
*Figure 11: Left Main Gear Well, After Removal of Main Retraction Rod and Detachment of Downlock Cable*
