ERA26LA043

## INVESTIGATION PHOTOGRAPHS

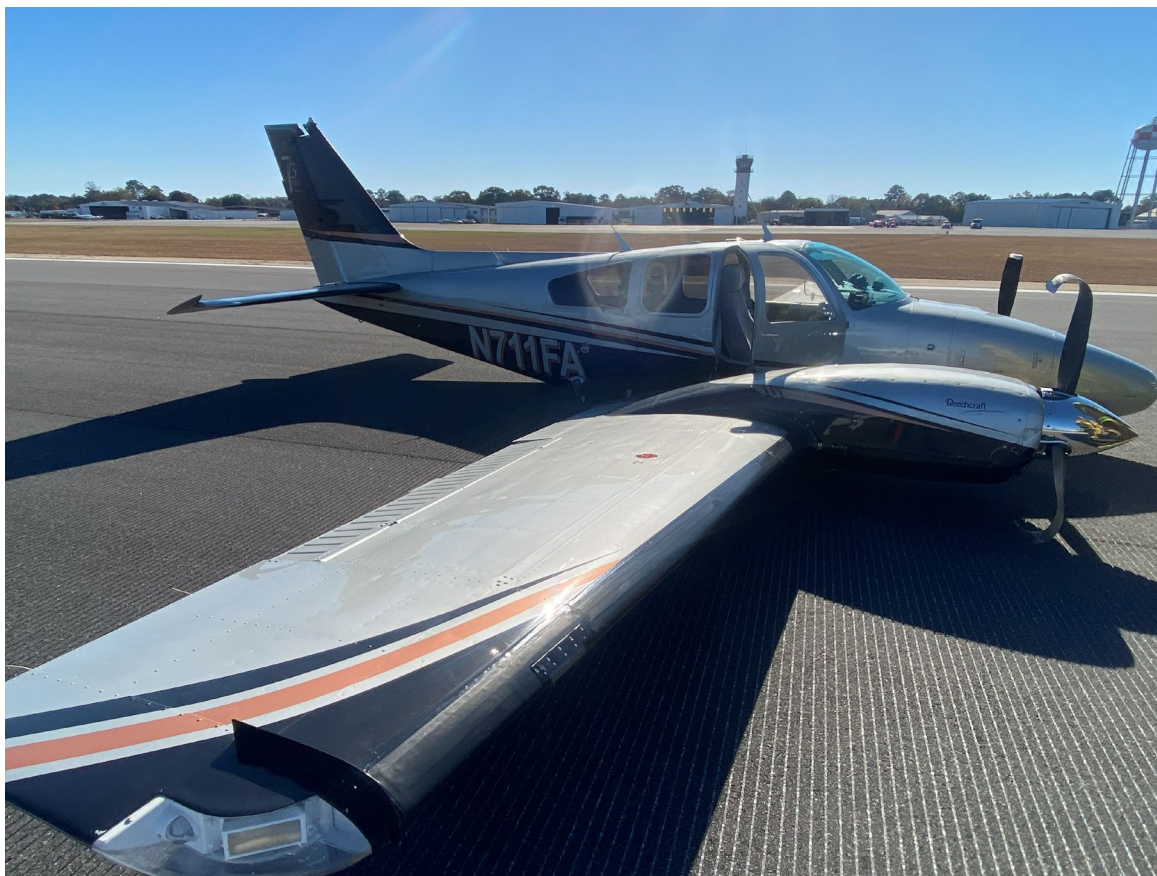
**Photograph 1 - N711FA After Landing with Landing Gear Retracted (Courtesy of Dothan Airport)**

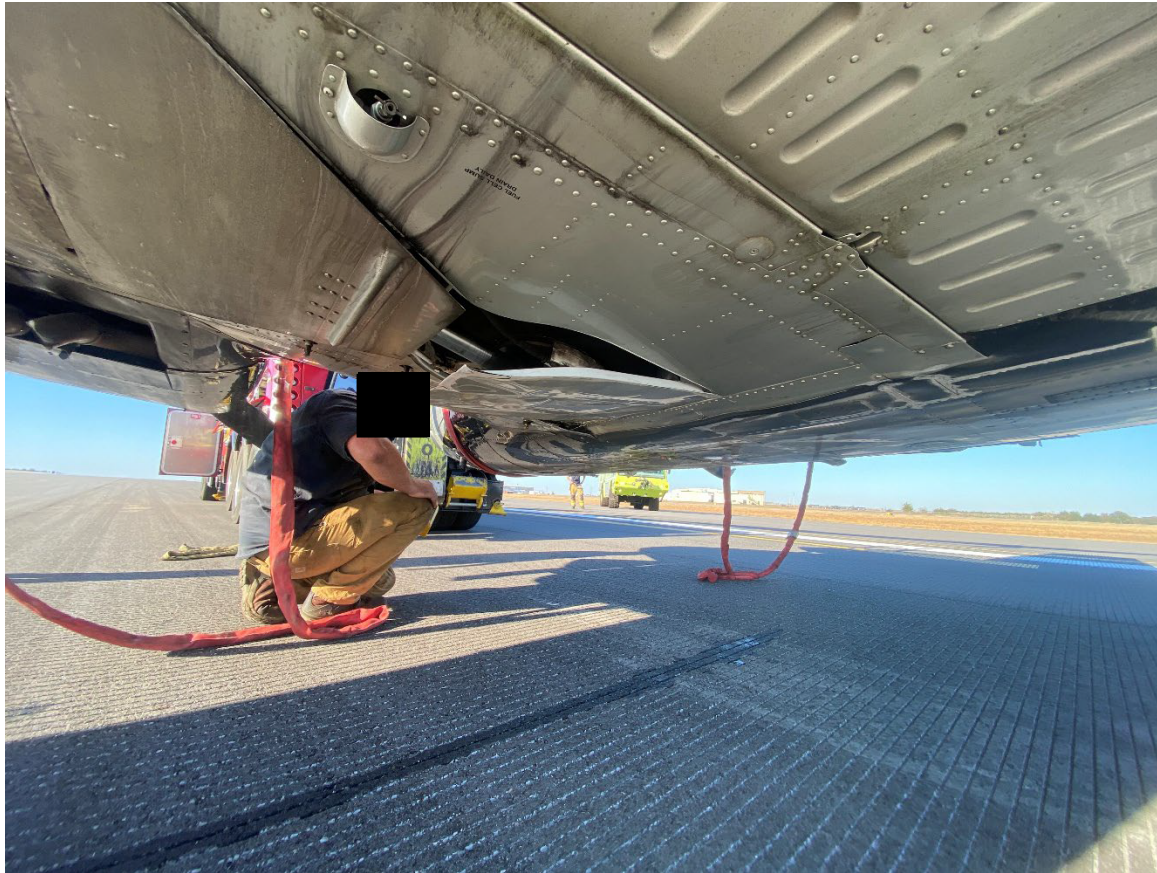
**Photograph 2 - N711FA Prior to Relocation form Runway (Courtesy of Dothan Airport)**

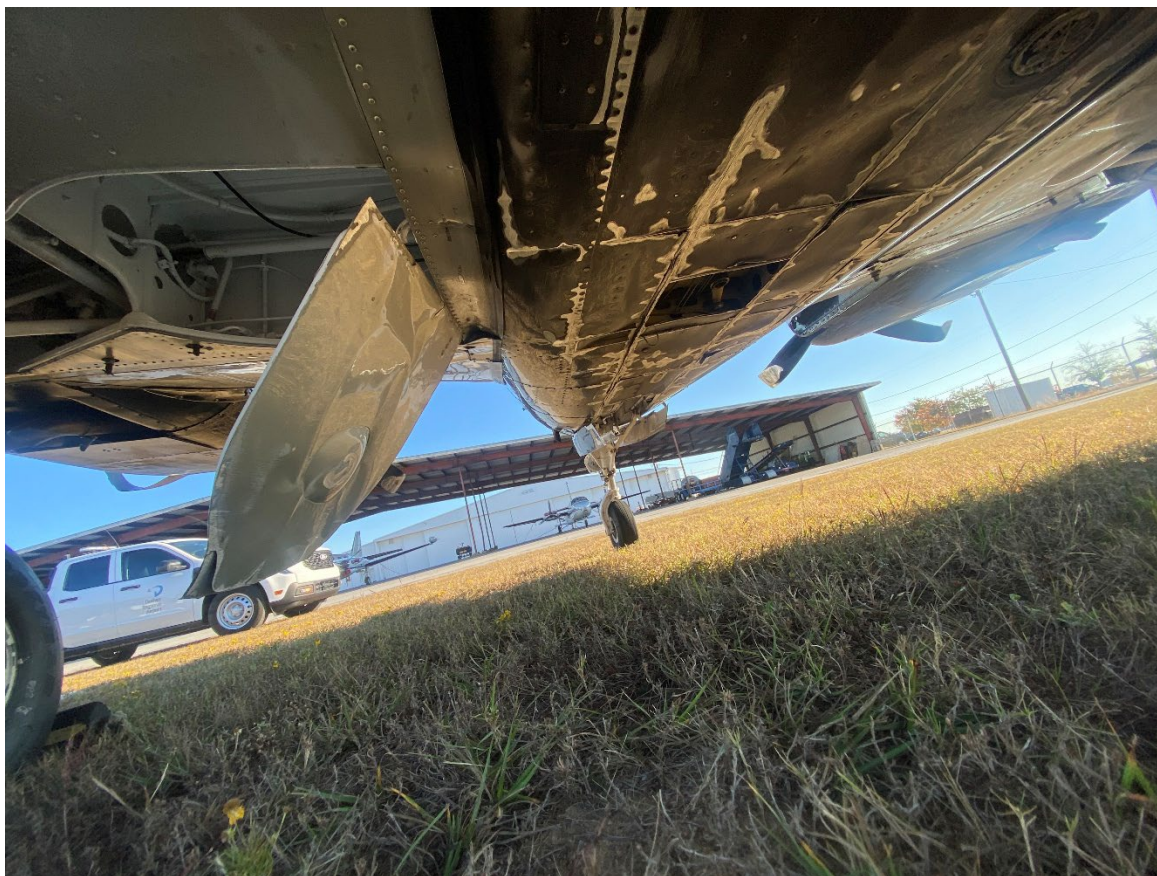
**Photograph 3 - Abrasion Damage to Fuselage(Courtesy of Dothan Airport)**

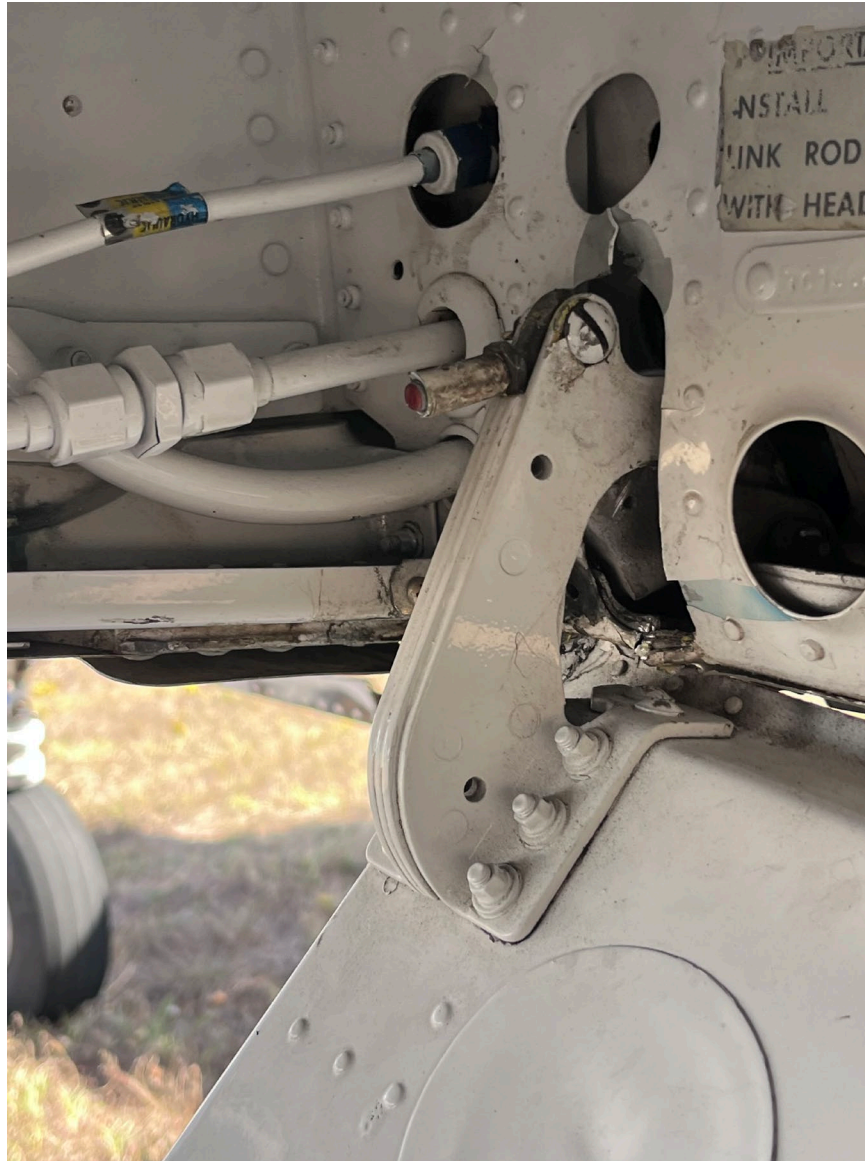
**Photograph 4 - Failed Left Inboard Gear Door Link Assembly (Courtesy of Airplane Owner)**

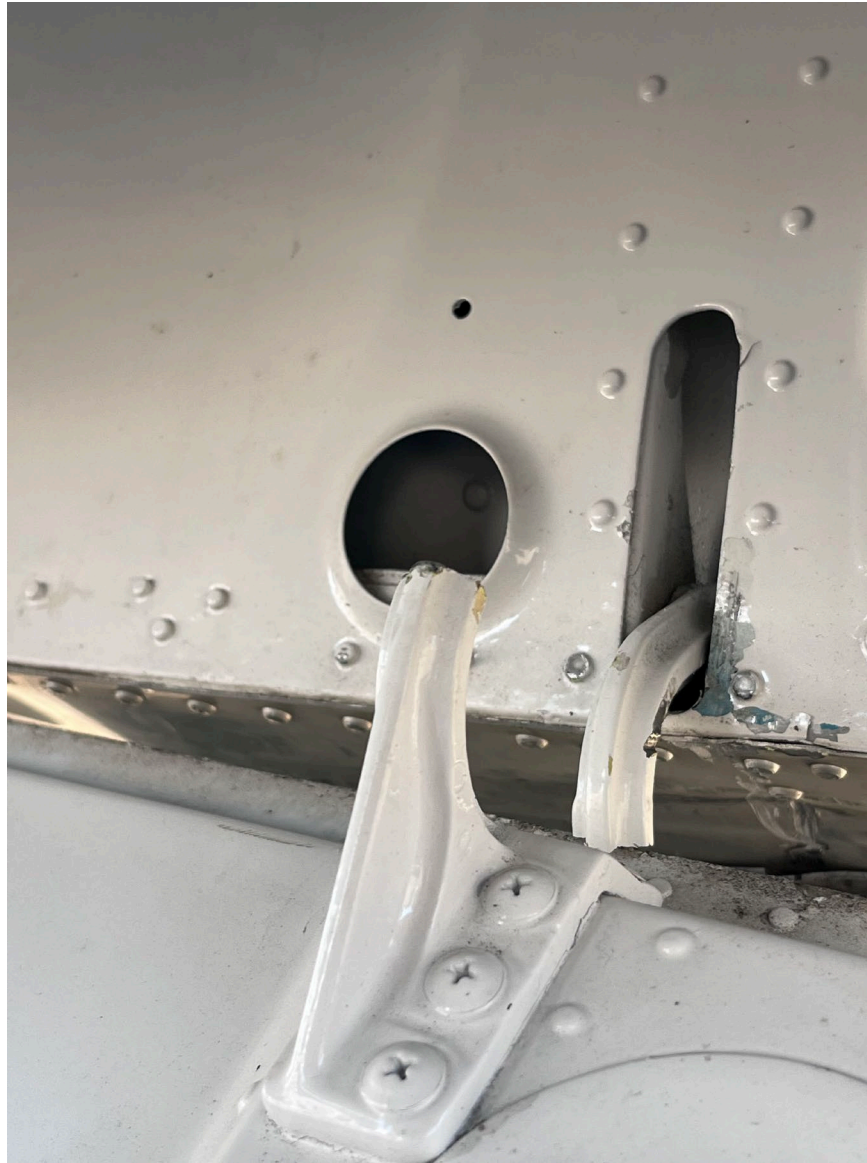
**Photograph 5 - Failed Left Aft Inboard Door Hinge (Courtesy of Airplane Owner)**
