ERA26LA057

## INVESTIGATION PHOTOGRAPHS

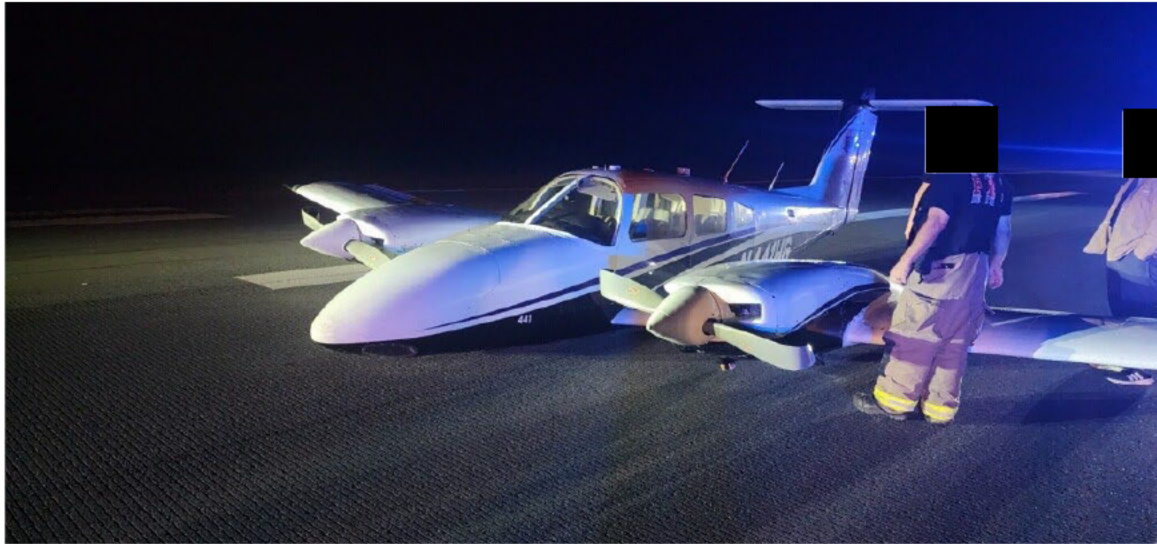
**Photograph 1 - Airplane at Accident Site (Courtesy of FAA)**

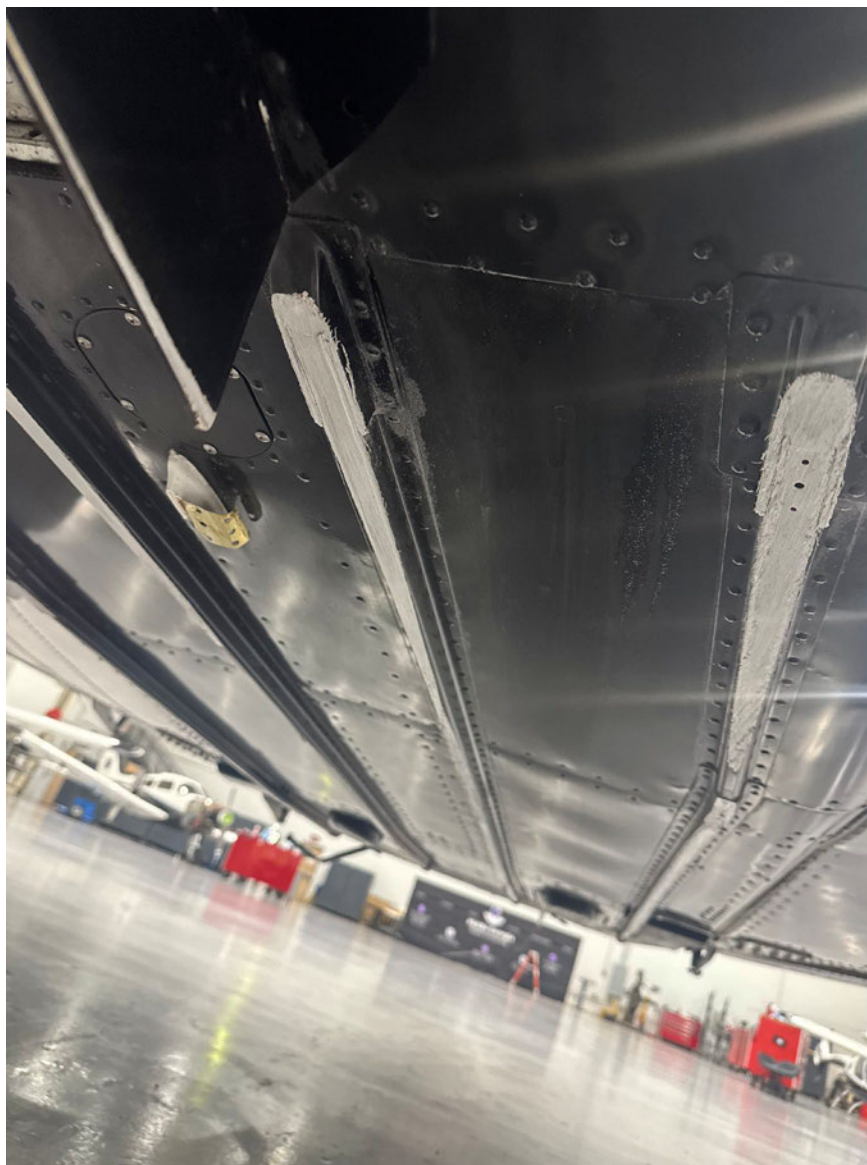
**Photograph 2 - Lower External Longeron Damage (Courtesy of FAA)**
