ERA26LA058

## INVESTIGATION PHOTOGRAPHS

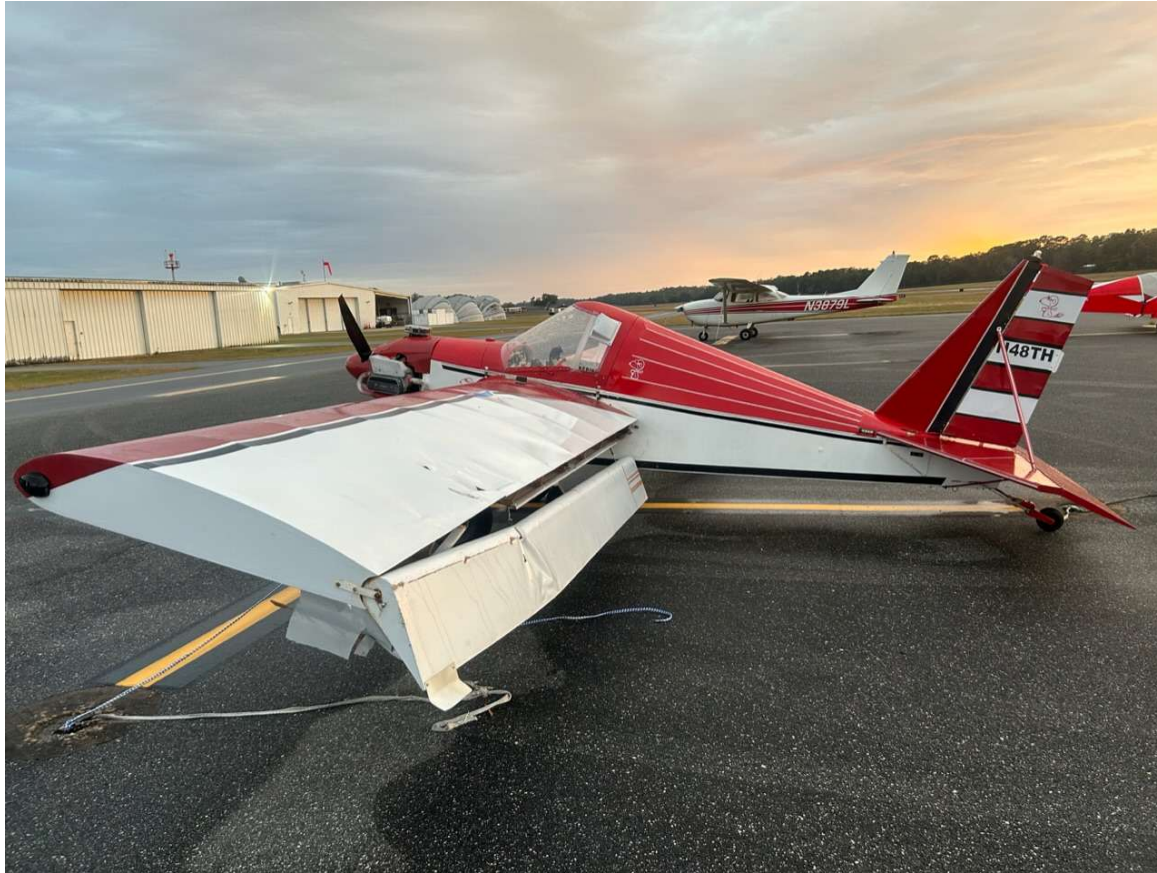
**Photograph 1 - Left Side View showing damage to wing and aileron (Courtesy of FAA)**

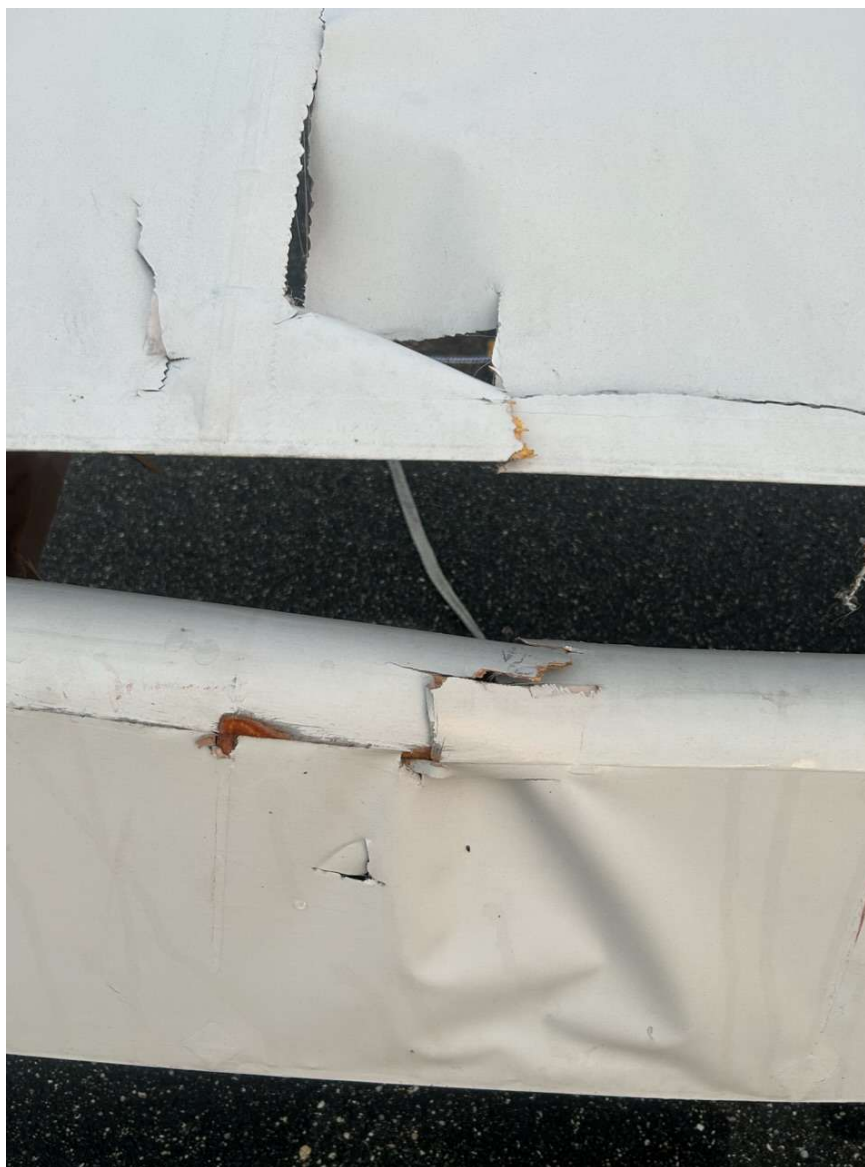
**Photograph 2 - Closeup of damage to left wing and aileron (Courtesy of FAA)**
