ERA26LA060

## INVESTIGATION PHOTOGRAPHS

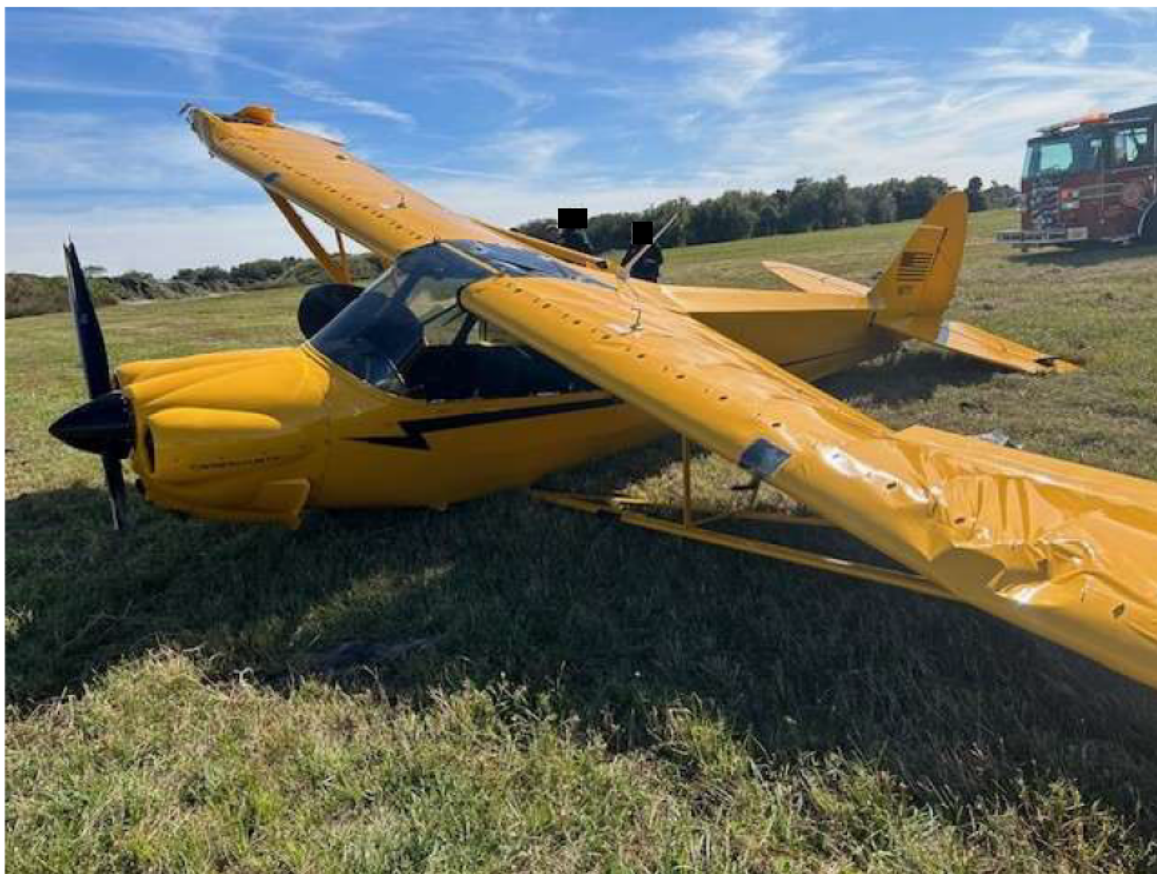
**Photograph 1 - Left-hand front view showing damage to wings (Courtesy of Airport Authority)**

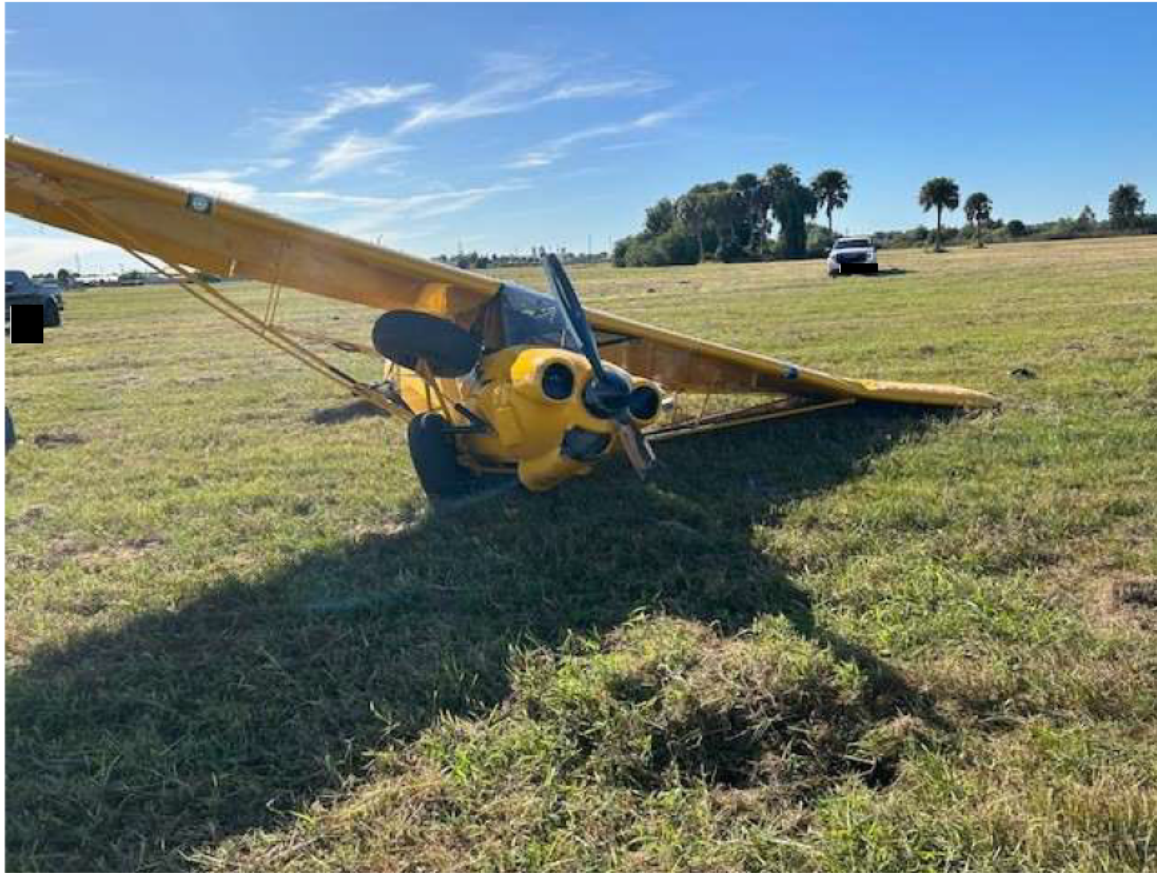
**Photograph 2 - Right-hand front view showing damage to landing gear (Courtesy of Airport Authority)**

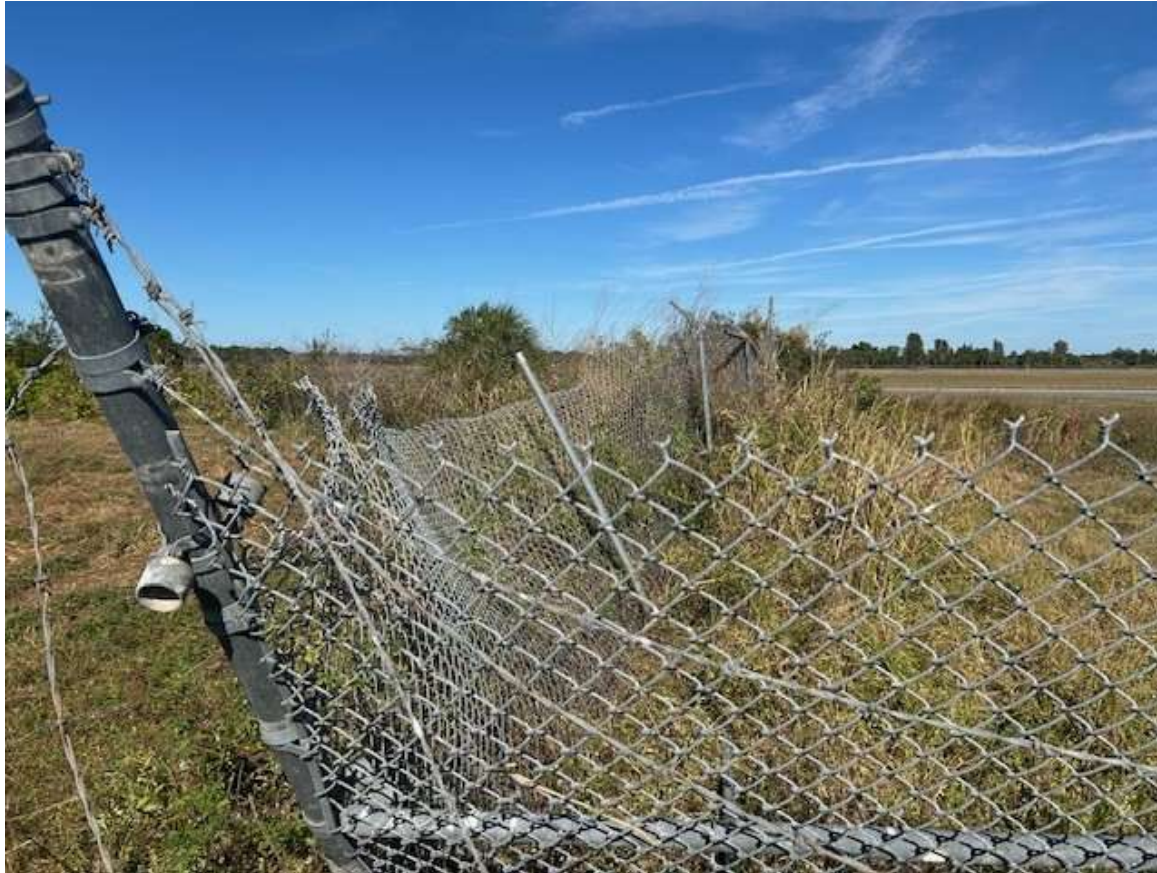
**Photograph 3 - Section of perimeter fence impacted by the aircraft (Courtesy of Airport Authority)**

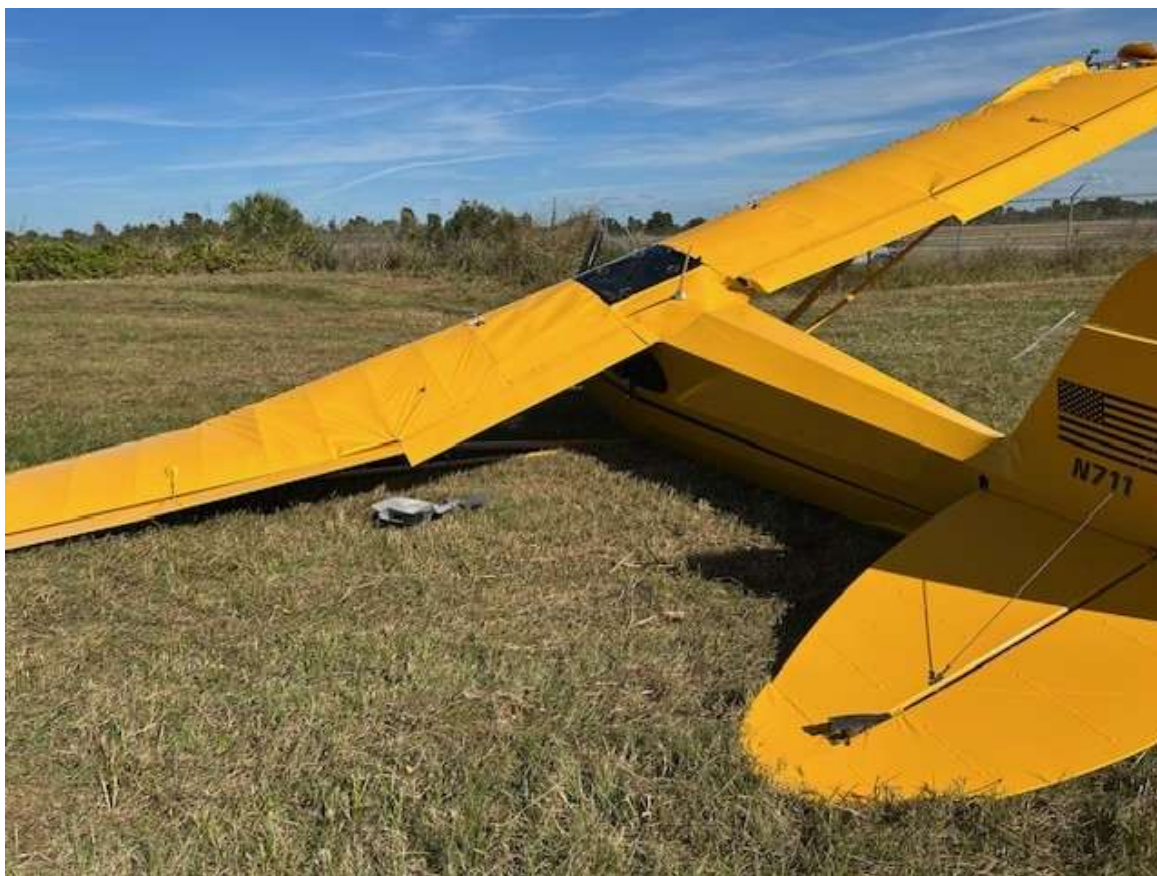
**Photograph 4 - Left-hand rear view showing damage to wings (Courtesy of Airport Authority)**

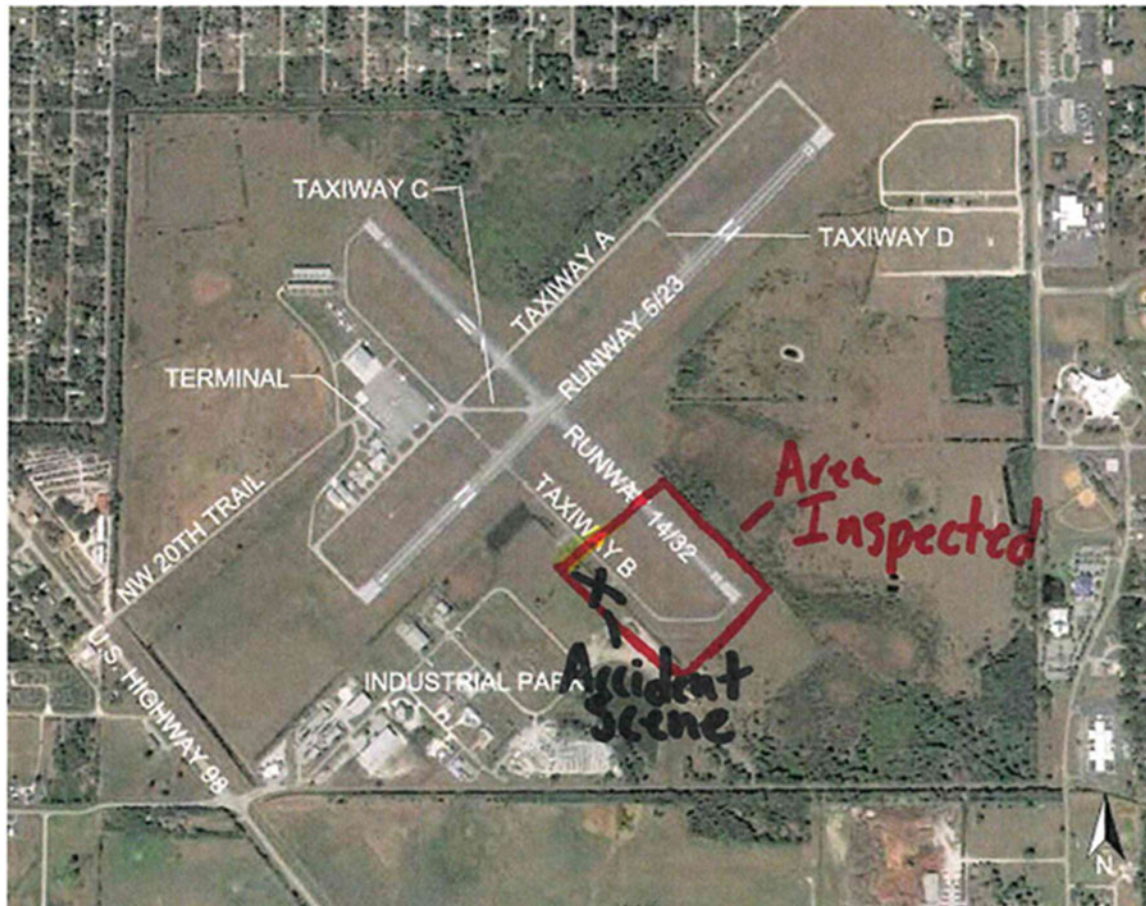
**Photograph 6 - Airport overview of accident location (Courtesy of Airport Authority)**
