# National Transportation Safety Board

ERA26LA062

## **WRECKAGE EXAMINATION**

Location: Pensacola, Florida  
Date: December 07, 2025  
Time: 17:30 CST  
2330 UTC  
Airplane: N6542H; Cessna 172M

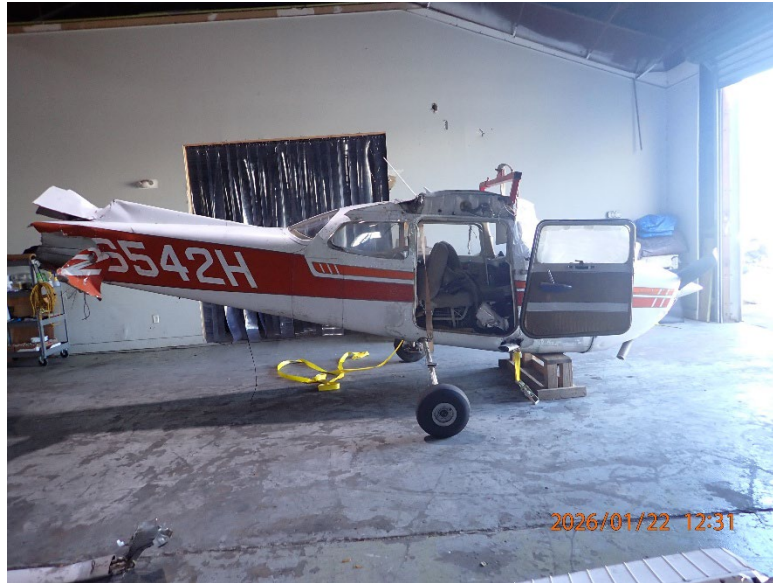
The fuselage remained intact. Impact damage to front left side of the fuselage aft of the firewall rivets, the skin was crushed inward towards the instrument panel. The windscreen was destroyed during the impact sequence. The roof was wrinkled and dented. The left-wing impact resulted in an inward dent above the aft left window.

Photo 1: View of the fuselage.

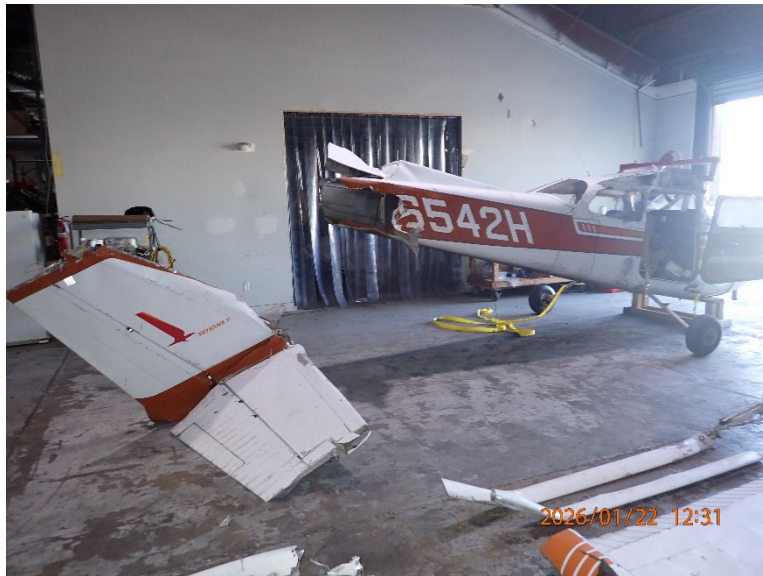
The empennage exhibited tearing on the right side and was impact separated at the rivet line prior to the horizontal stabilizer. The horizontal and vertical stabilizer section remained attached to the empennage via the flight control cables, the flight control cables were cut to facilitate the recovery of the airplane. The vertical stabilizer exhibited impact crushing along the entire leading edge. The top of the rudder had impact damage, and the counterweight was impact separated. The rudder remained attached to the vertical stabilizer at all attachment points and the rudder trim tab remained attached and exhibited impact damage. Flight control continuity was established for the rudder from the flight control surface to the flight controls in the cockpit through a cut made by recovery personnel. The left horizontal stabilizer had aft impact crushing along the entire leading edge. The outboard 16 inches of the leading edge was impact bent down. The left elevator was impact bent up about mid span; the outboard 5 inches of the left elevator were impact bent down. The left elevator counterweight was impact separated. The left elevator remained attached at the two inboard attachment points. The outboard attachment point was impact separated. The right horizontal stabilizer remained attached and was impact damaged along the inboard 21 inches. The counterweight remained intact. The right elevator and elevator trim remained attached at all attachment points and were undamaged. Flight control continuity of the elevator was established from the flight control surface to the controls in the cockpit. Through a cut made by recovery personnel.

Photo 2: View of the right side of the empennage.

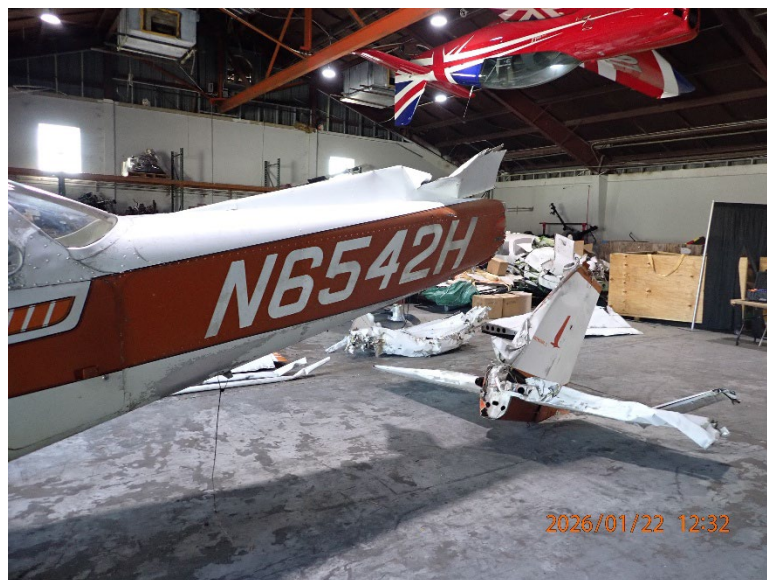
Photo 3: View of the left side of the empennage.

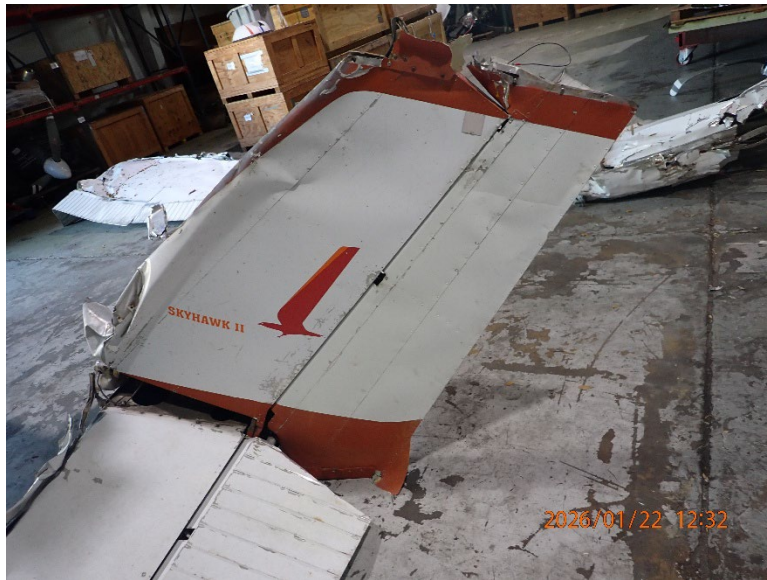
Photo 4: View of the vertical stabilizer and rudder.

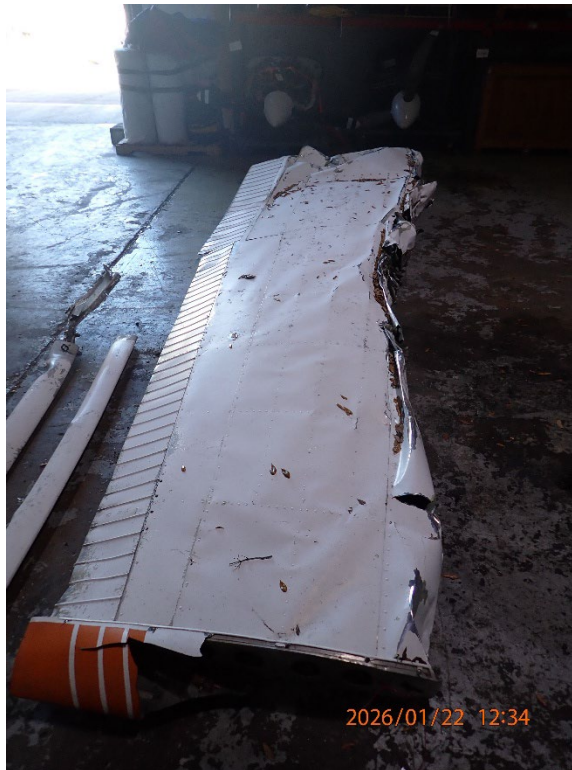
The wings had been removed to facilitate recovery. The right wing had impact crushing aft along the entire leading edge. The inboard 40 inches of the right wing exhibited crumpling from the trailing edge towards the main wing spar. Control continuity was established from the right aileron flight control surface to the flight controls in the cockpit through cuts made during recovery. The right aileron and flap remained attached at all attachment points.

Photo 5: View of the right wing.

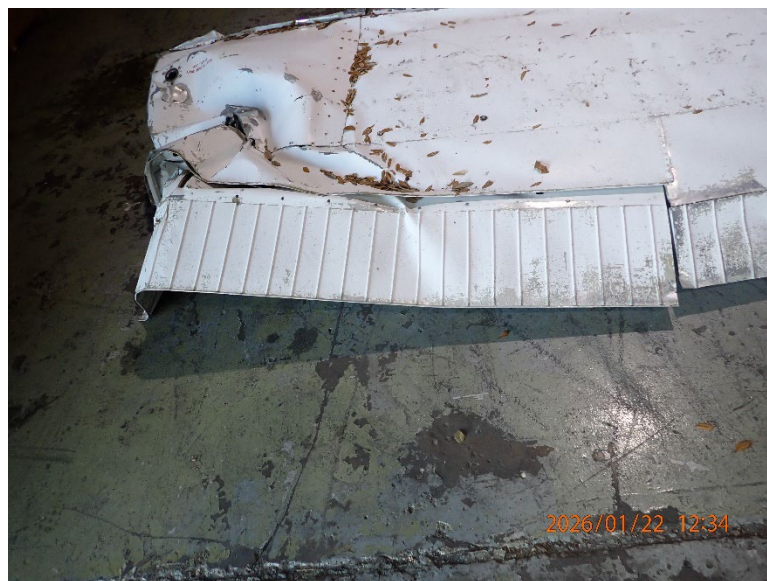
Photo 6: Damage to right wing root

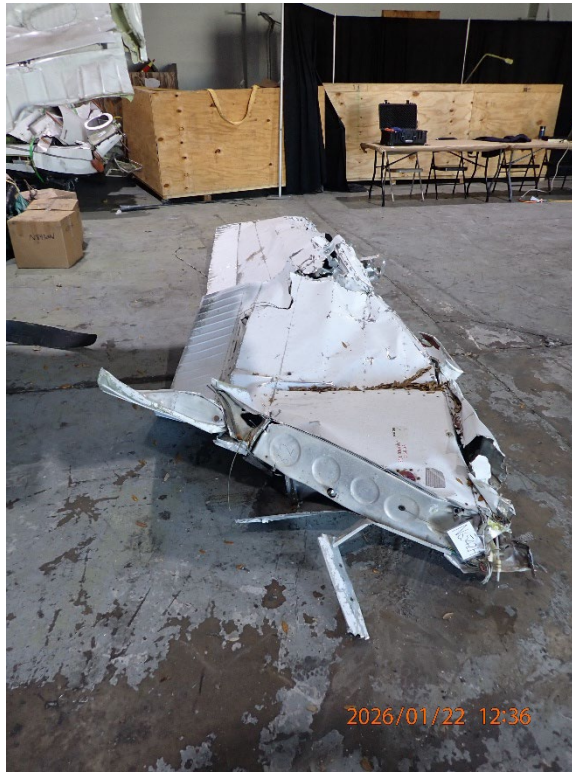
The left wing exhibited aft impact crushing along the entire leading edge. The left wing outboard of the flap was impact separated and remained attached via control cables. Control continuity was established from the left aileron flight control surface to the flight controls in the cockpit through cuts made during recovery. The left aileron and flap remained attached at all attachment points.

Photo 7: View of the left wing.

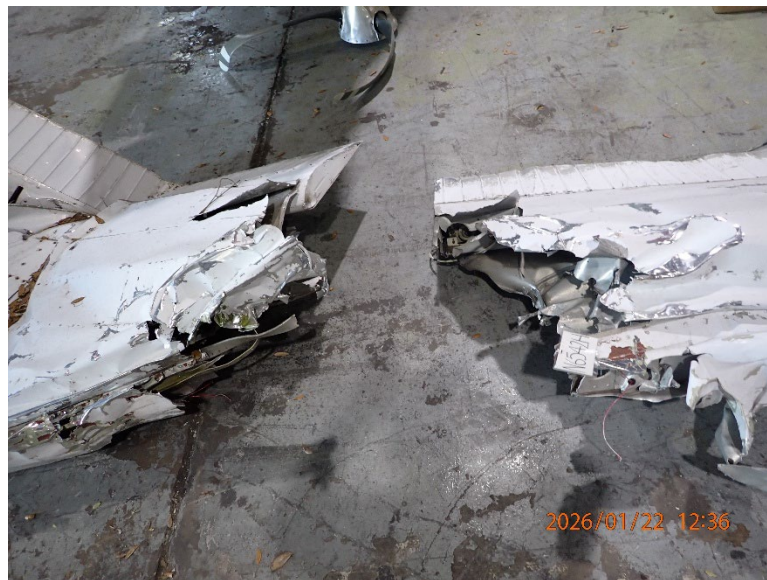
Photo 8: View of the left wing damage.

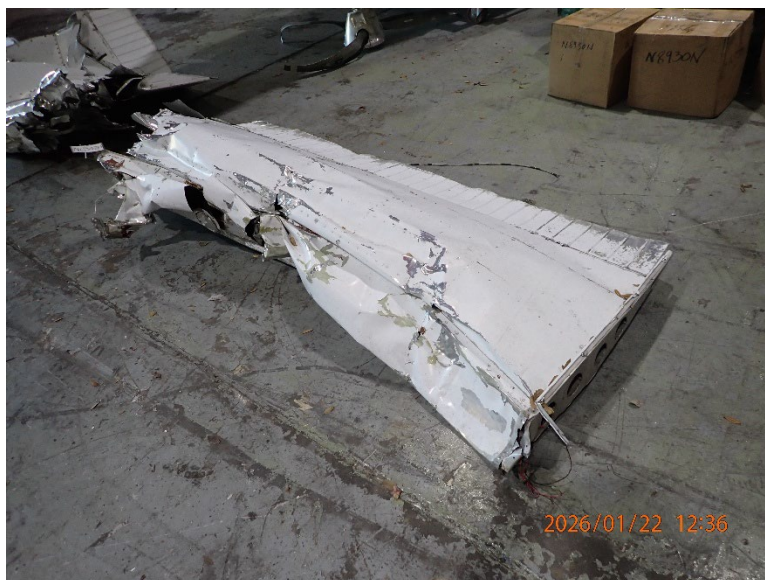
Photo 9: Left outboard wing

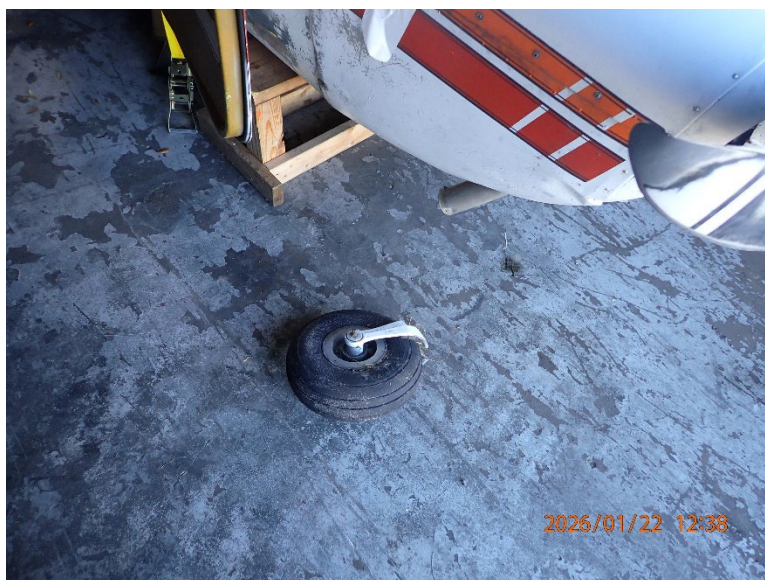
The nose wheel was impact separated. The main gear remained attached to the fuselage.

Photo 10: View of the nose landing gear that was impact separated.

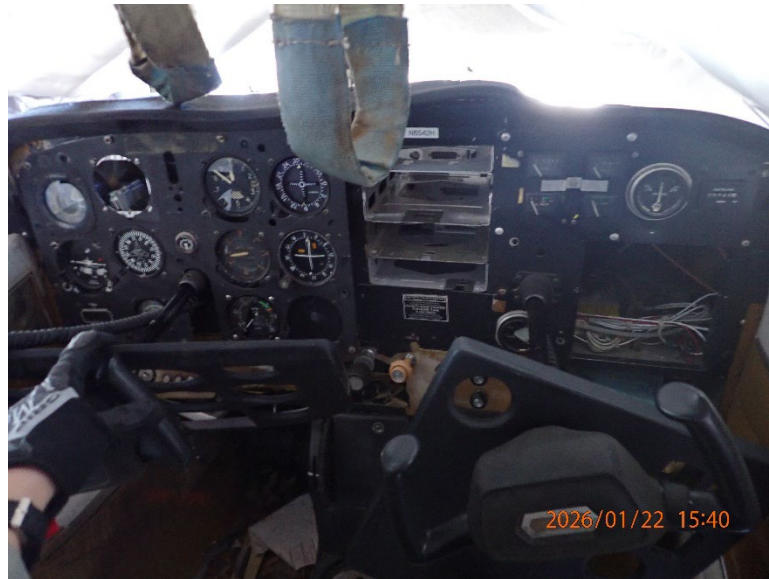
The cockpit remained intact. The instrument panel was impact damaged. The Hobbs meter was found to show 782.8. Circuit breakers were all in. The following switch and lever positions were noted:

Photo 11: View of the instrument panel.

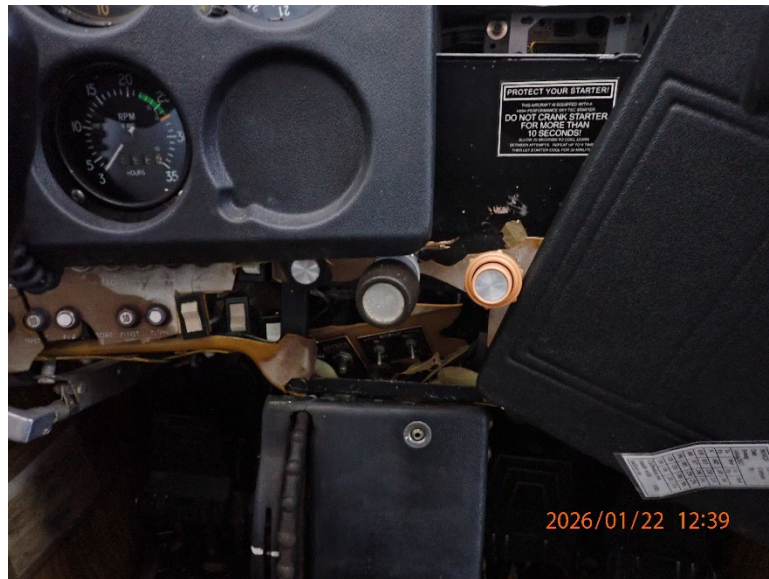
- Throttle: Full forward
- Mixture: Full forward
- Ignition: Both
- Master: OFF

Photo 12: Throttle quadrant

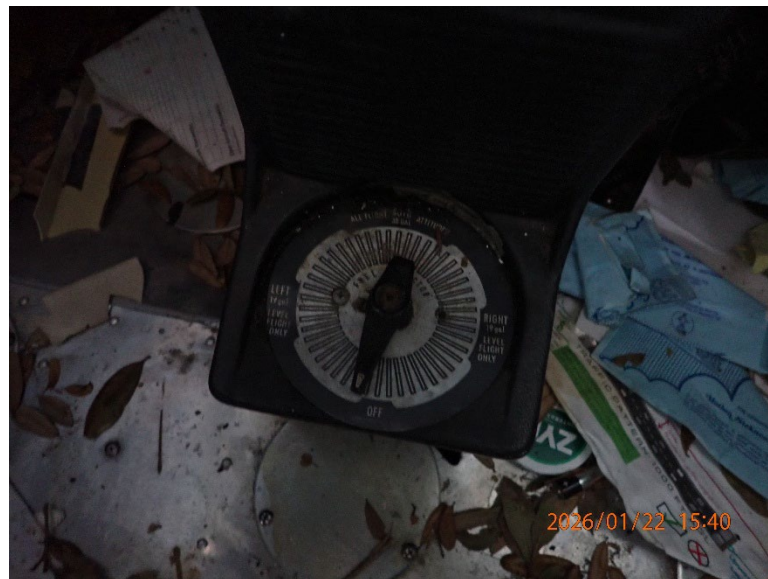
Photo 13: Fuel selector

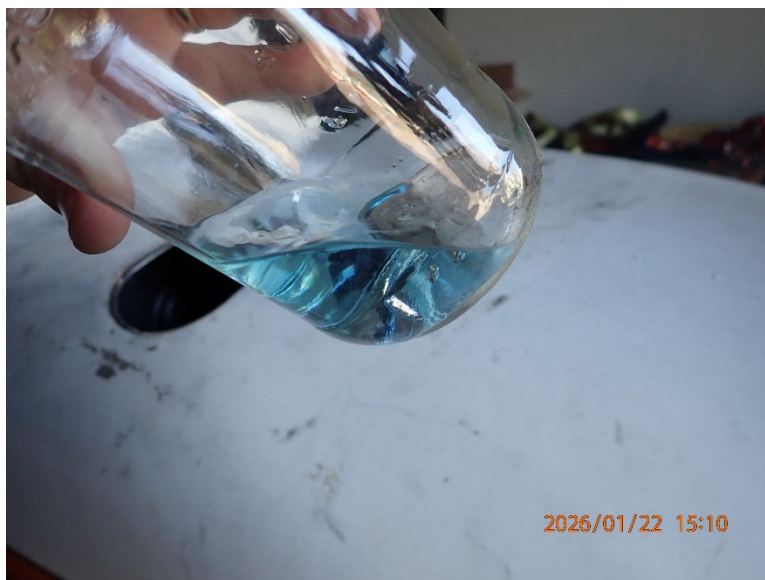
The left fuel cap was secured in the fuel filler opening, and no retention chain was present. The seal was present and pliable. The right fuel cap was secured in the fuel filler opening at the accident site and removed by recovery personnel to drain fuel prior to transport. The left and right fuel tank finger screens were examined and unobstructed. The fuel selector remained installed in the fuselage and was observed in the OFF position. Detents were present in each position of the selector. A fuel sample was taken at the strainer which remained attached to the firewall. The liquid was consistent with 100LL aviation fuel and was clear without sediment. The liquid was tested with water finding paste which found no evidence of water.

Photo 14: Fuel drained from strainer
