ERA26LA074

## INVESTIGATION PHOTOGRAPHS

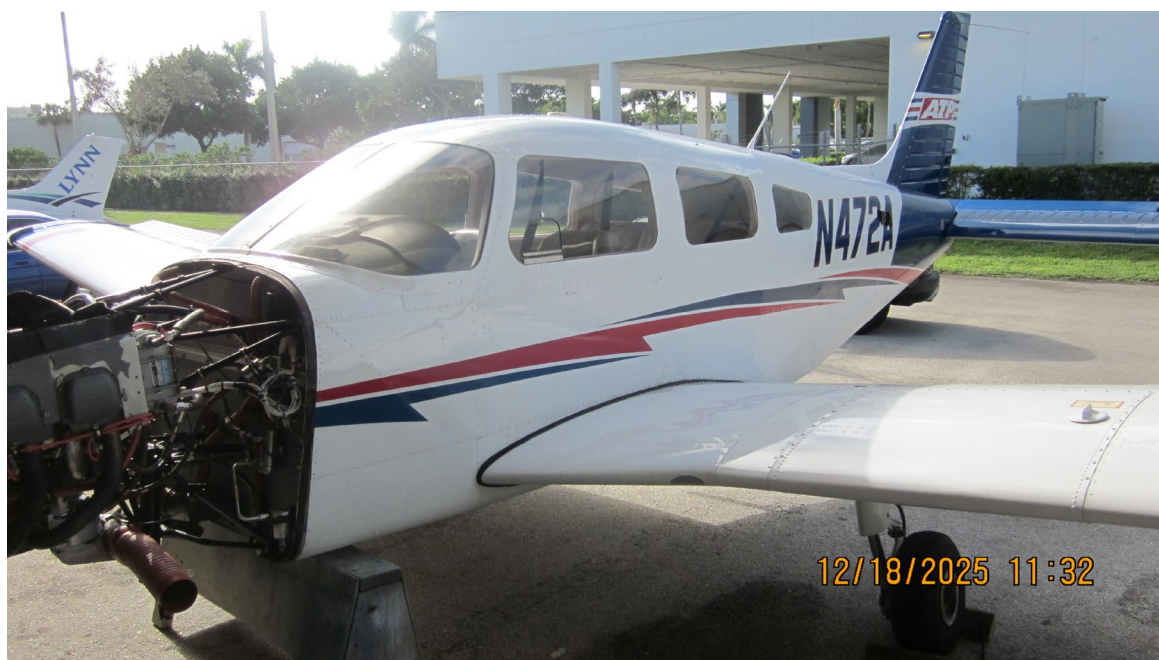
**Photograph 1 - Front Left of Airplane (Courtesy of FAA)**

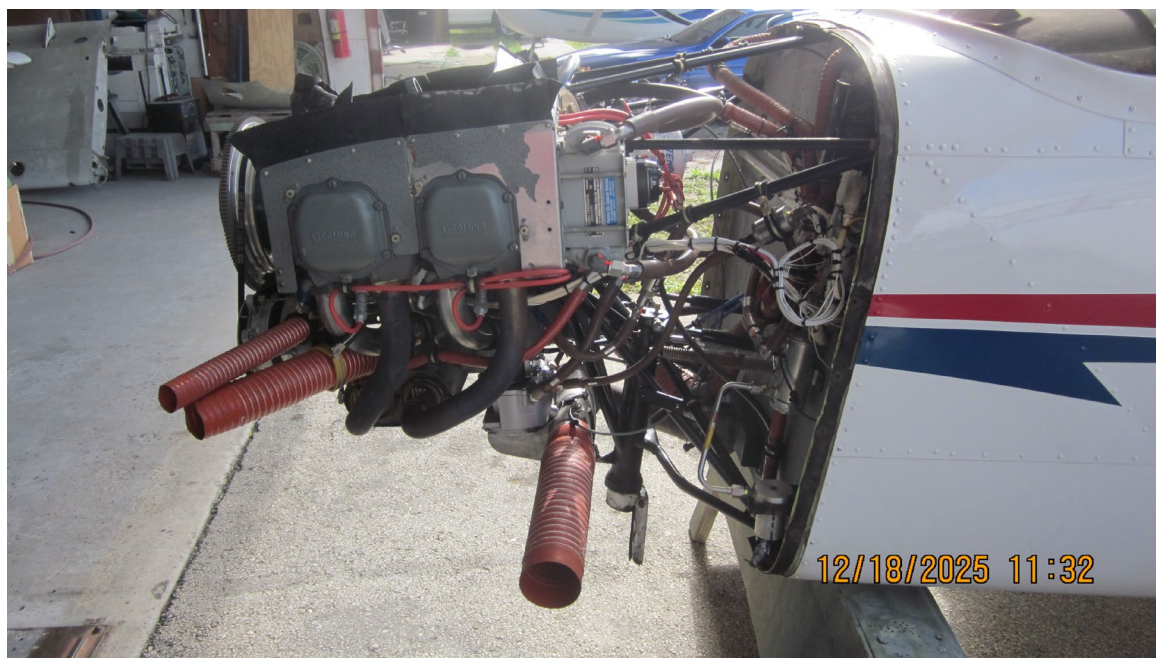
**Photograph 2 - Engine Mount Damage (Courtesy of FAA)**

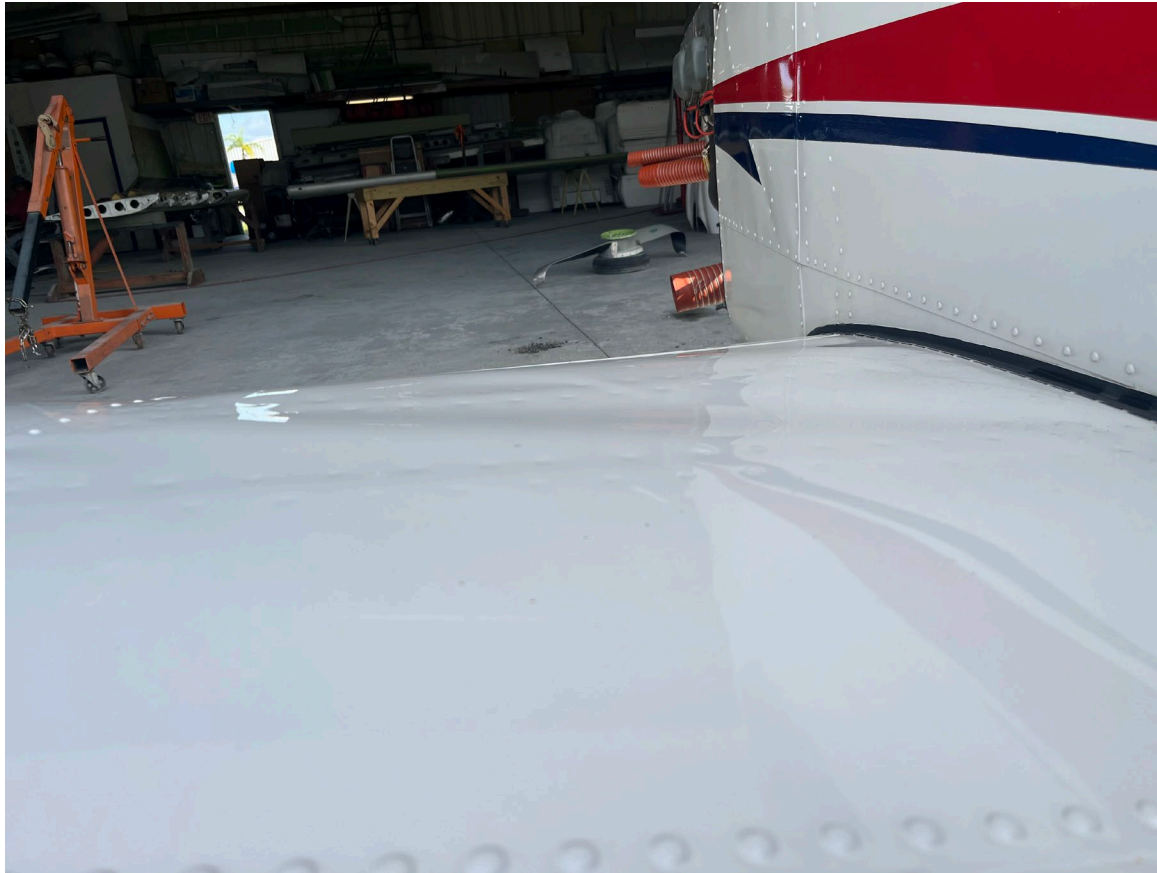
**Photograph 3 - Left Wing Spar Damage (Courtesy of FAA)**

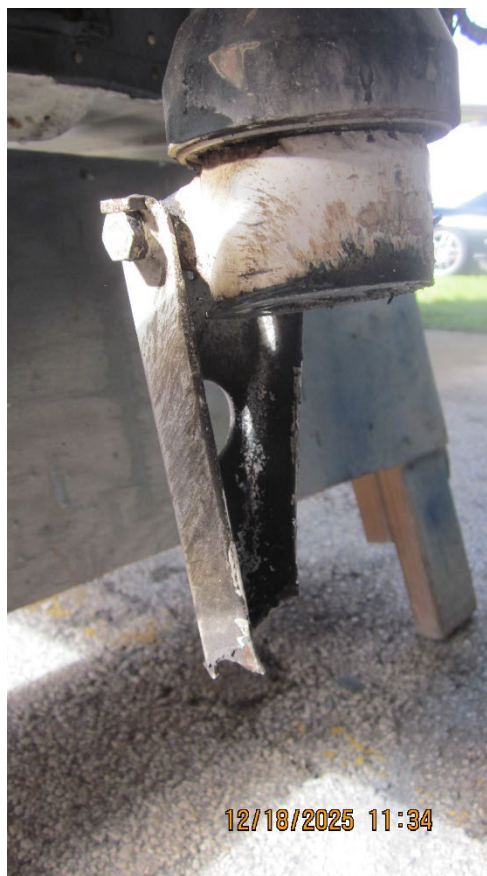
**Photograph 4 - Nose Landing Gear Damage (Courtesy of FAA)**
