ERA26LA075

## INVESTIGATION PHOTOGRAPHS

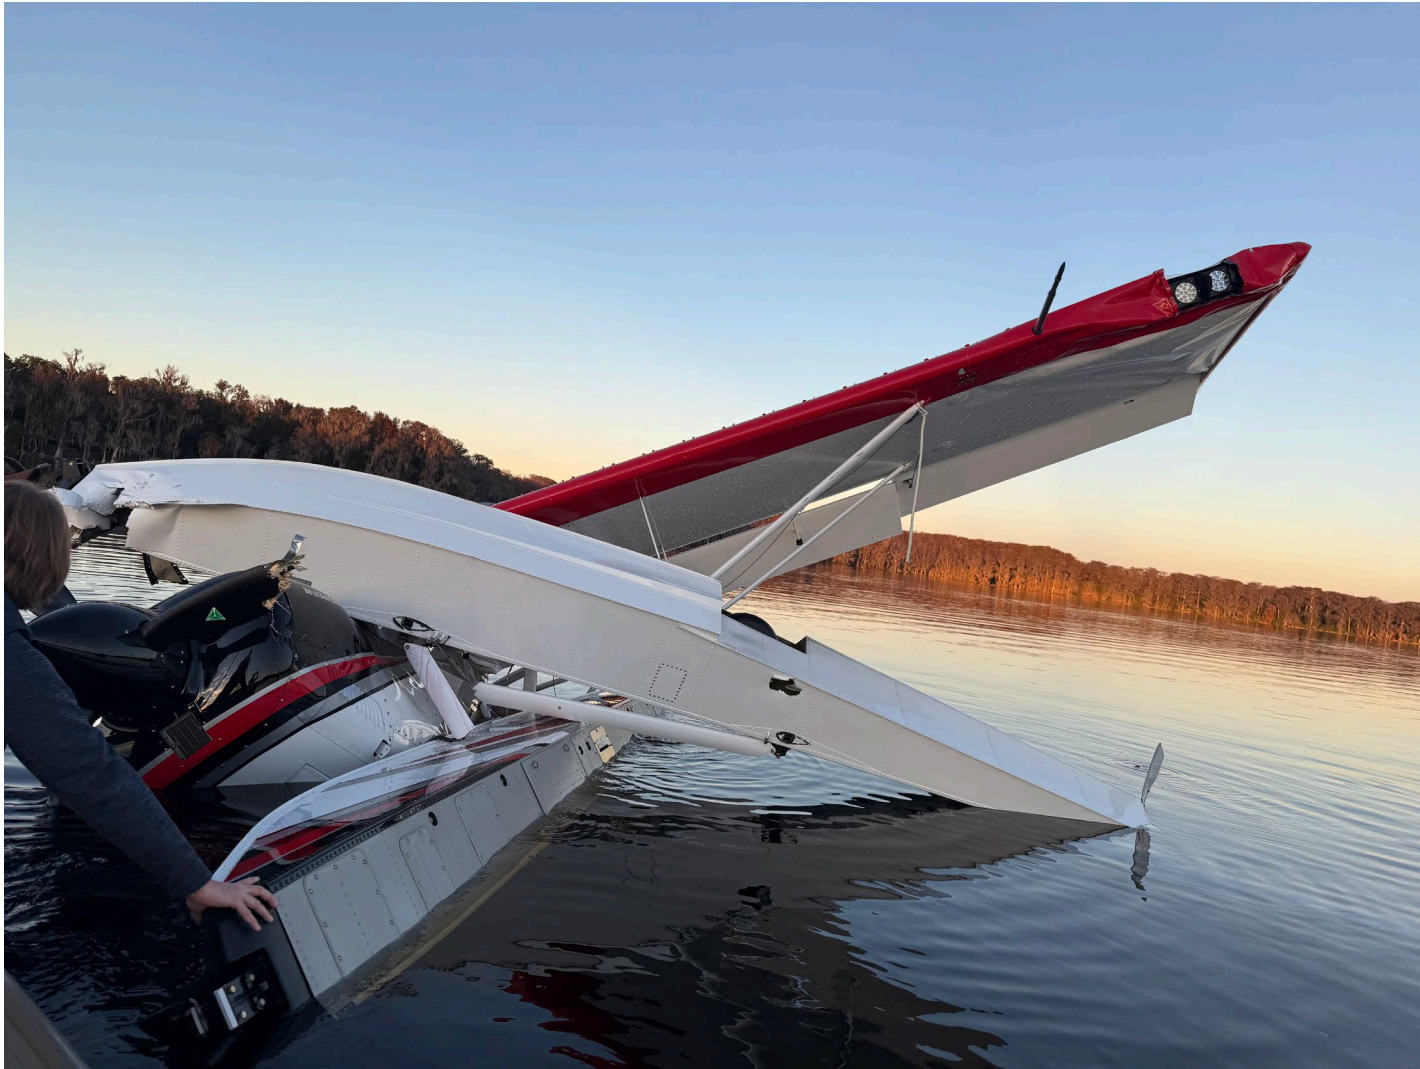
**Photograph 1 - N656B Immediately after Accident in Redwater Lake (Courtesy of Owner)**

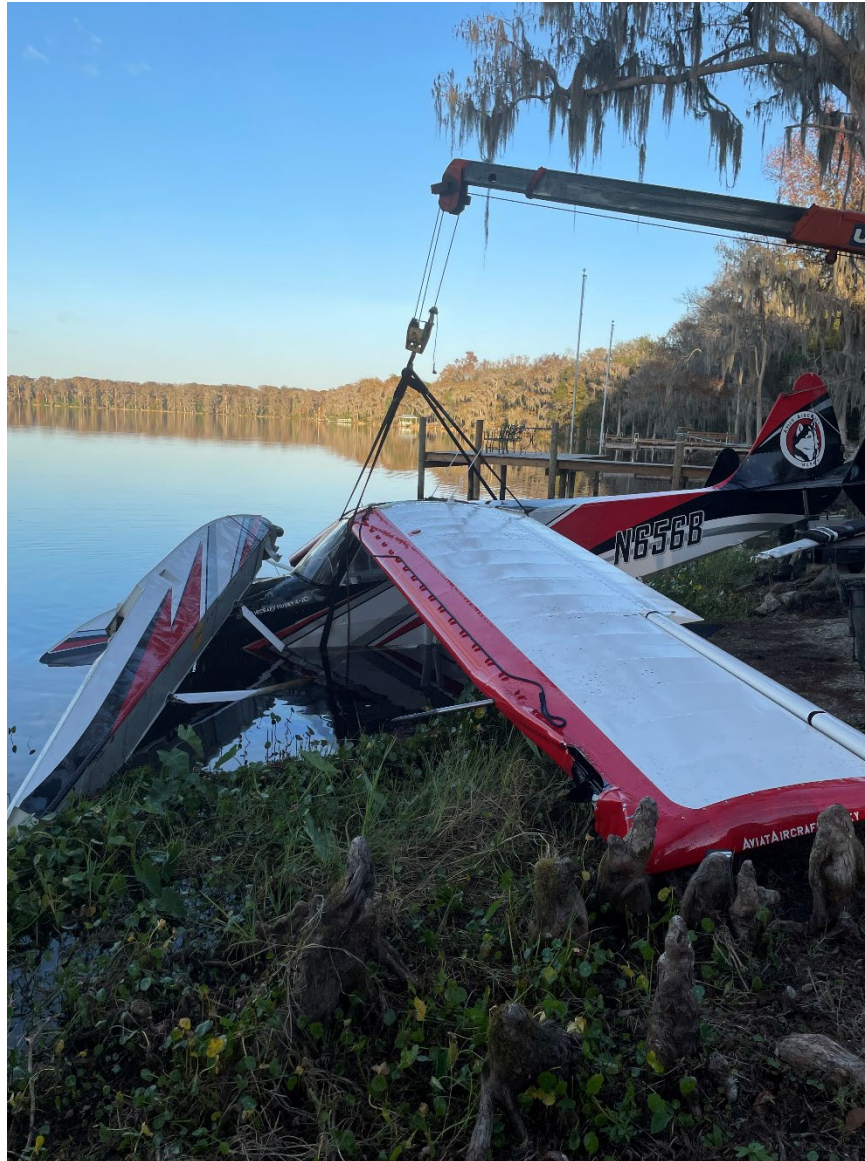
**Photograph 2 - Left-Wing Leading Edge Damage Shown During Recovery (Courtesy of FAA)**

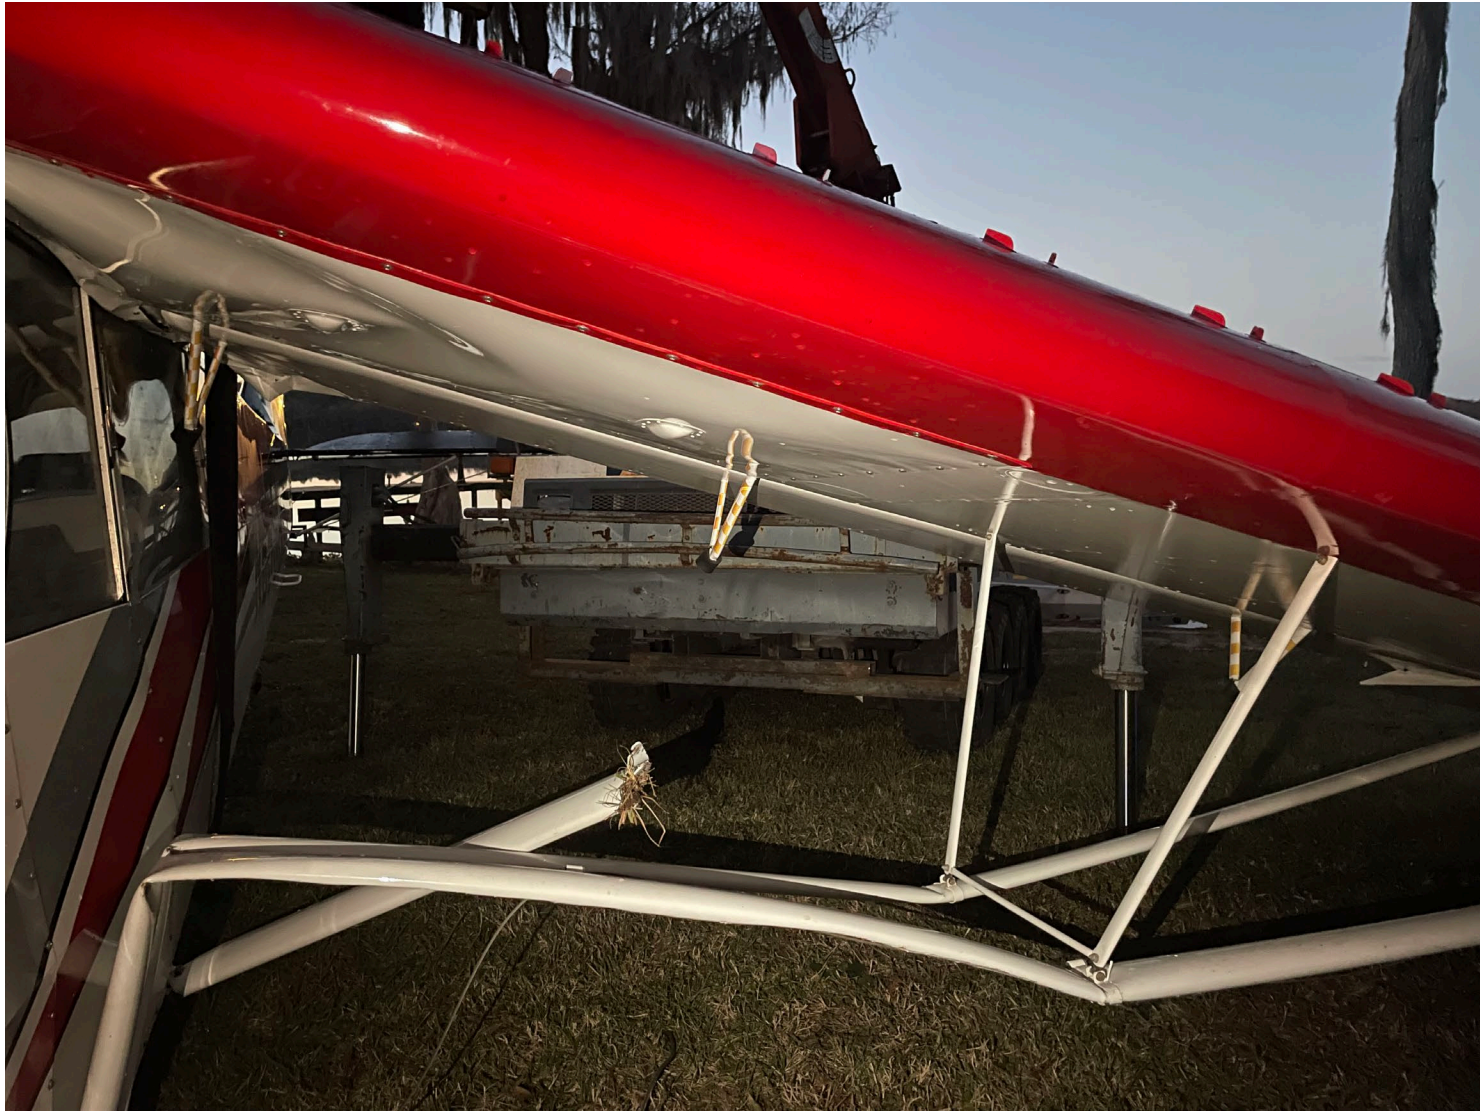
**Photograph 3 - Left Wing Strut Buckled (Courtesy of FAA)**

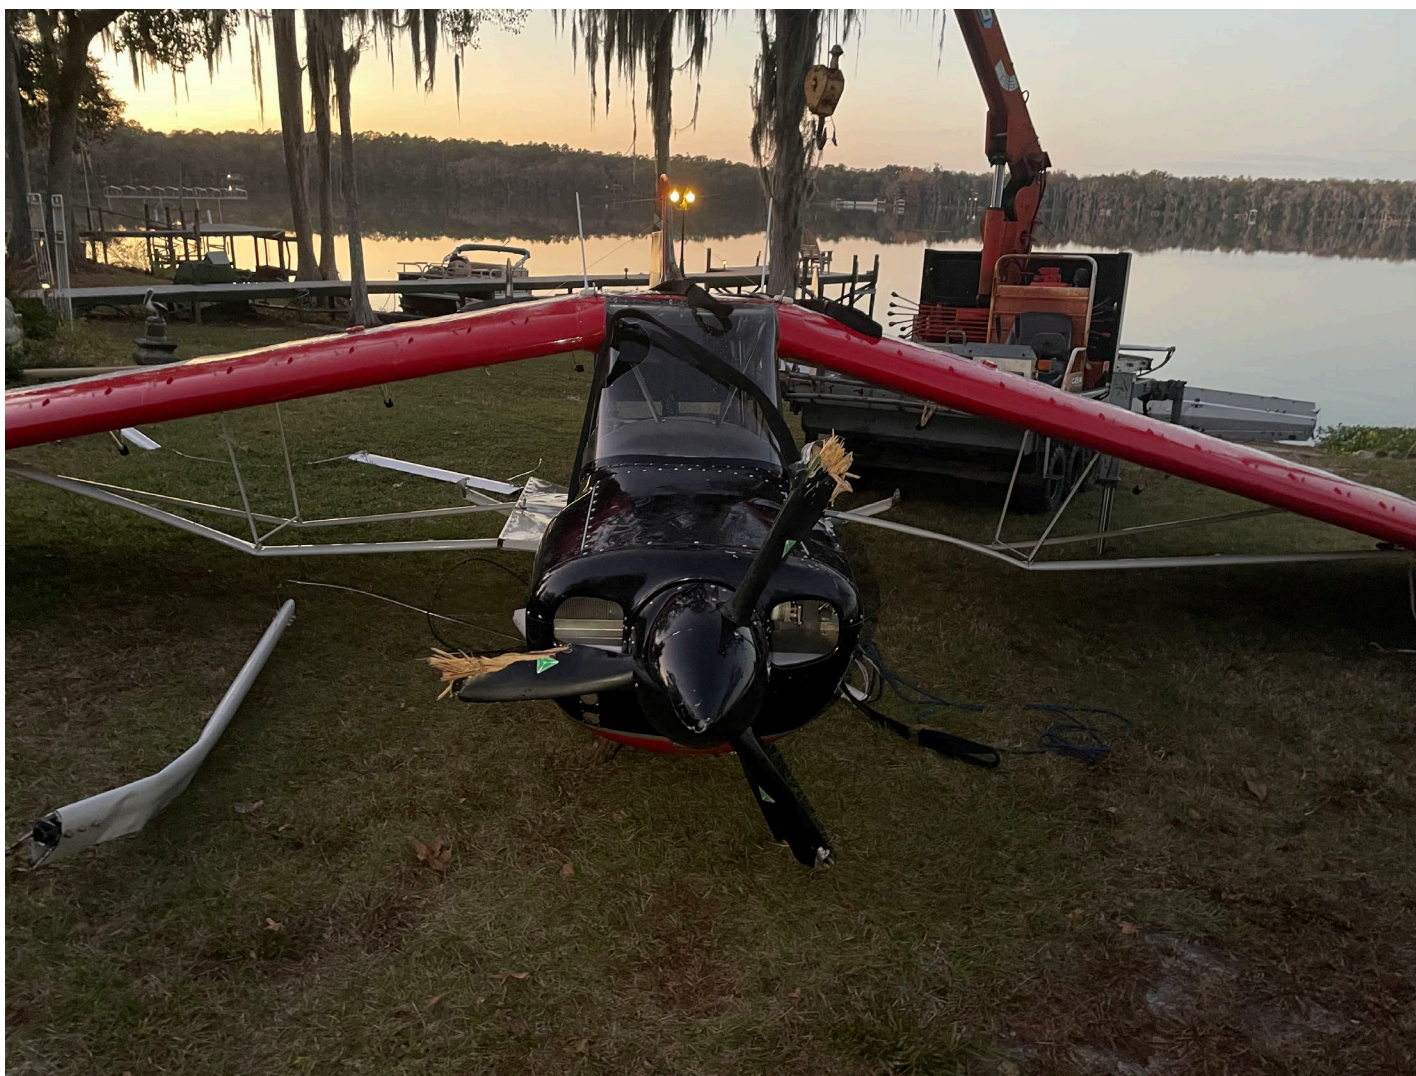
**Photograph 4 - Propeller, Fuselage, Windshield and Wing Strut Damage (Courtesy of FAA)**
