ERA26LA082

## INVESTIGATION PHOTOGRAPHS

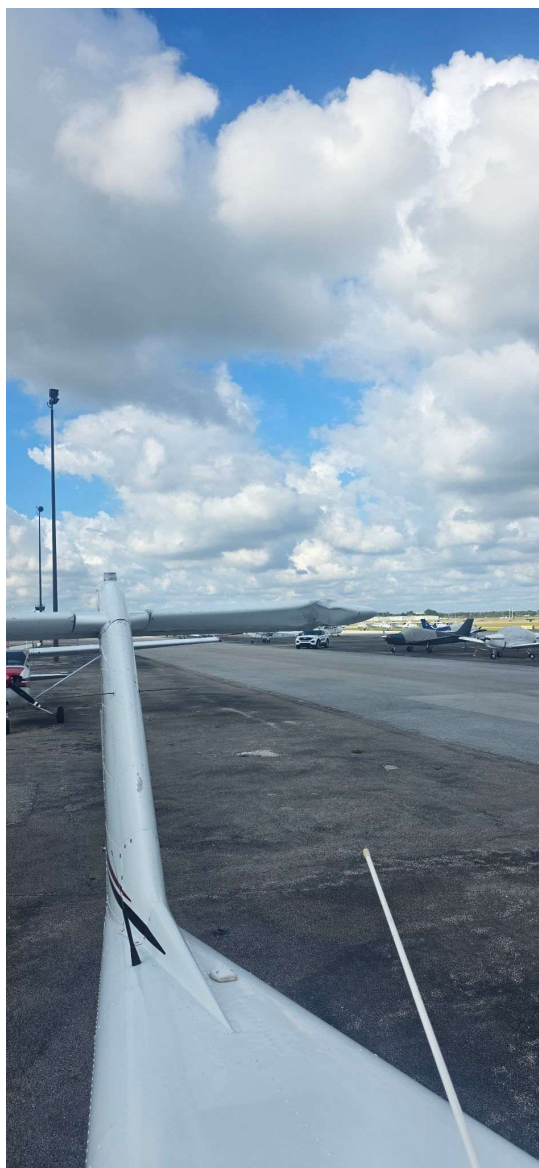
**Photograph 1 - View of tail showing damage (Courtesy of Pilot)**

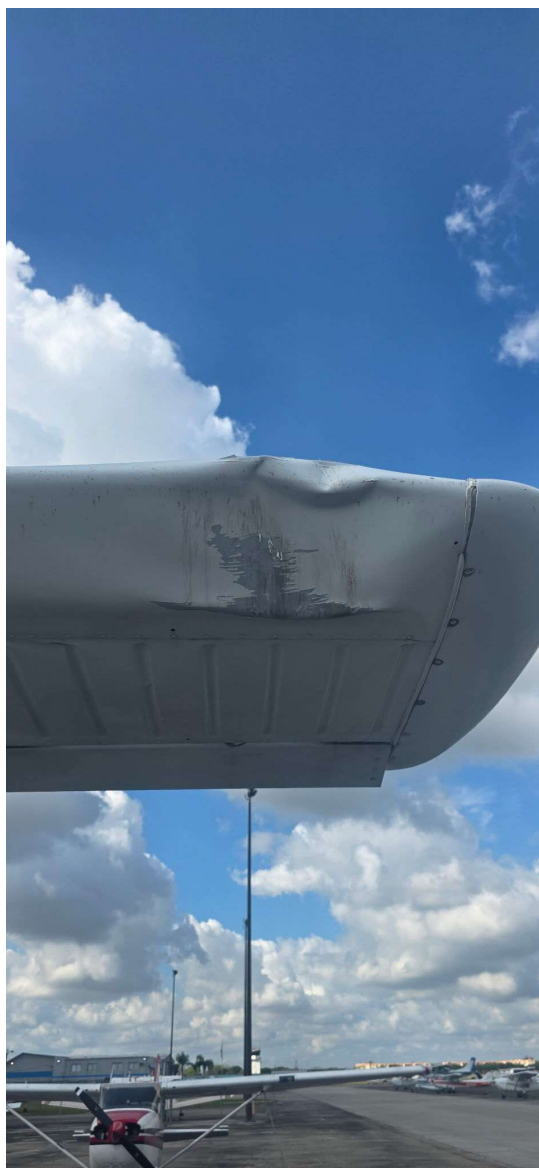
**Photograph 2 - Close up of damage to left side of horizontal stabilator (Courtesy of Pilot)**

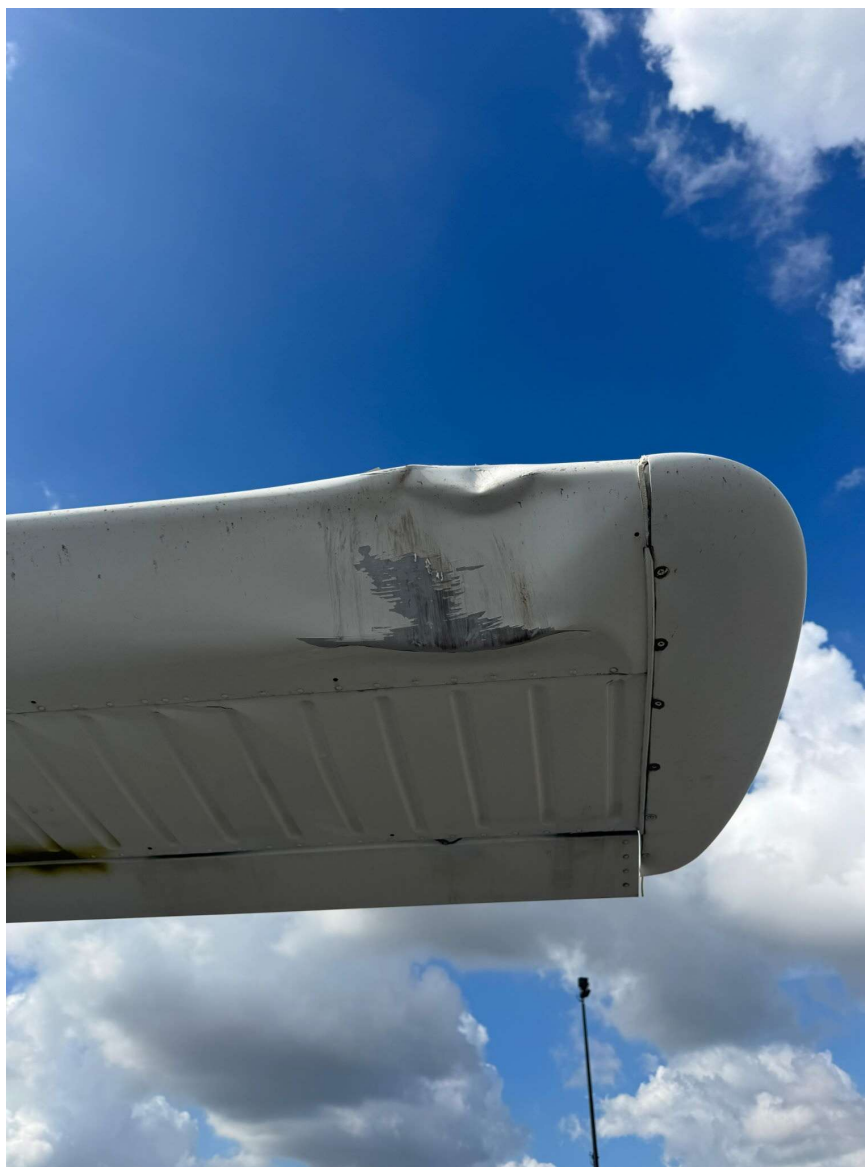
**Photograph 3 - Close up of damage to left side of horizontal stabilator (Courtesy of Pilot)**
