ERA26LA088

## INVESTIGATION PHOTOGRAPHS

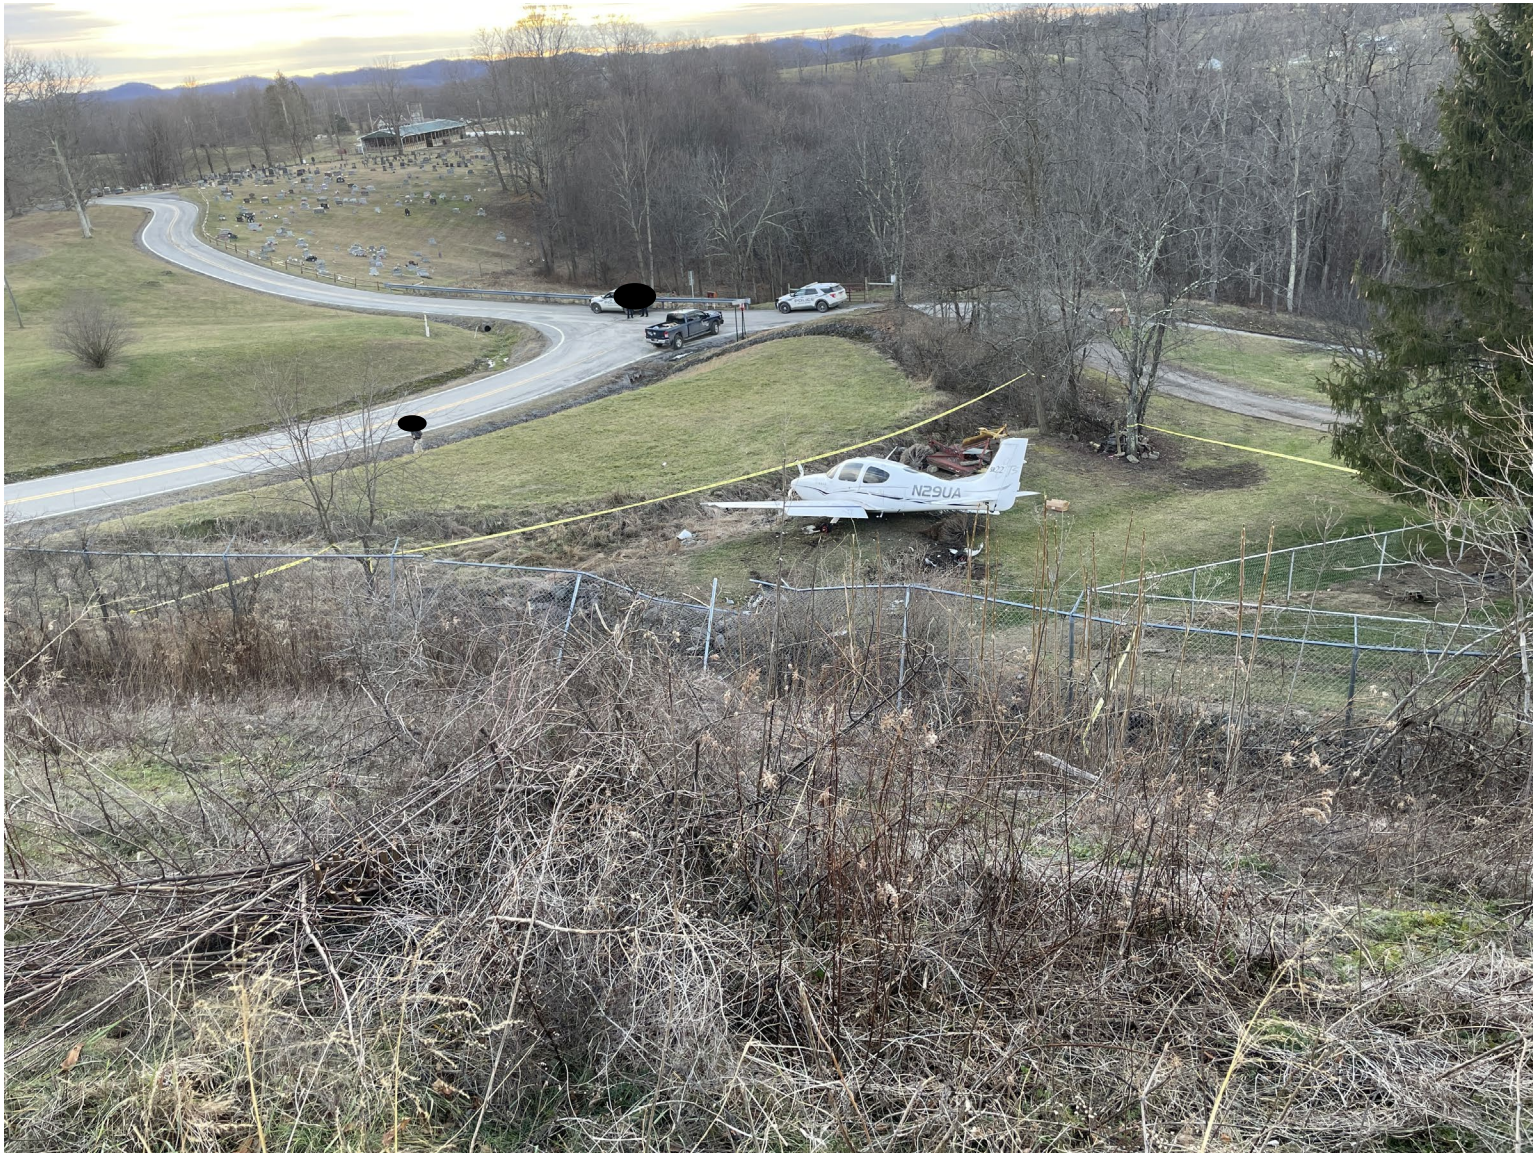
**Photograph 1 - Overview of the airplane at the accident site. (Courtesy of FAA)**

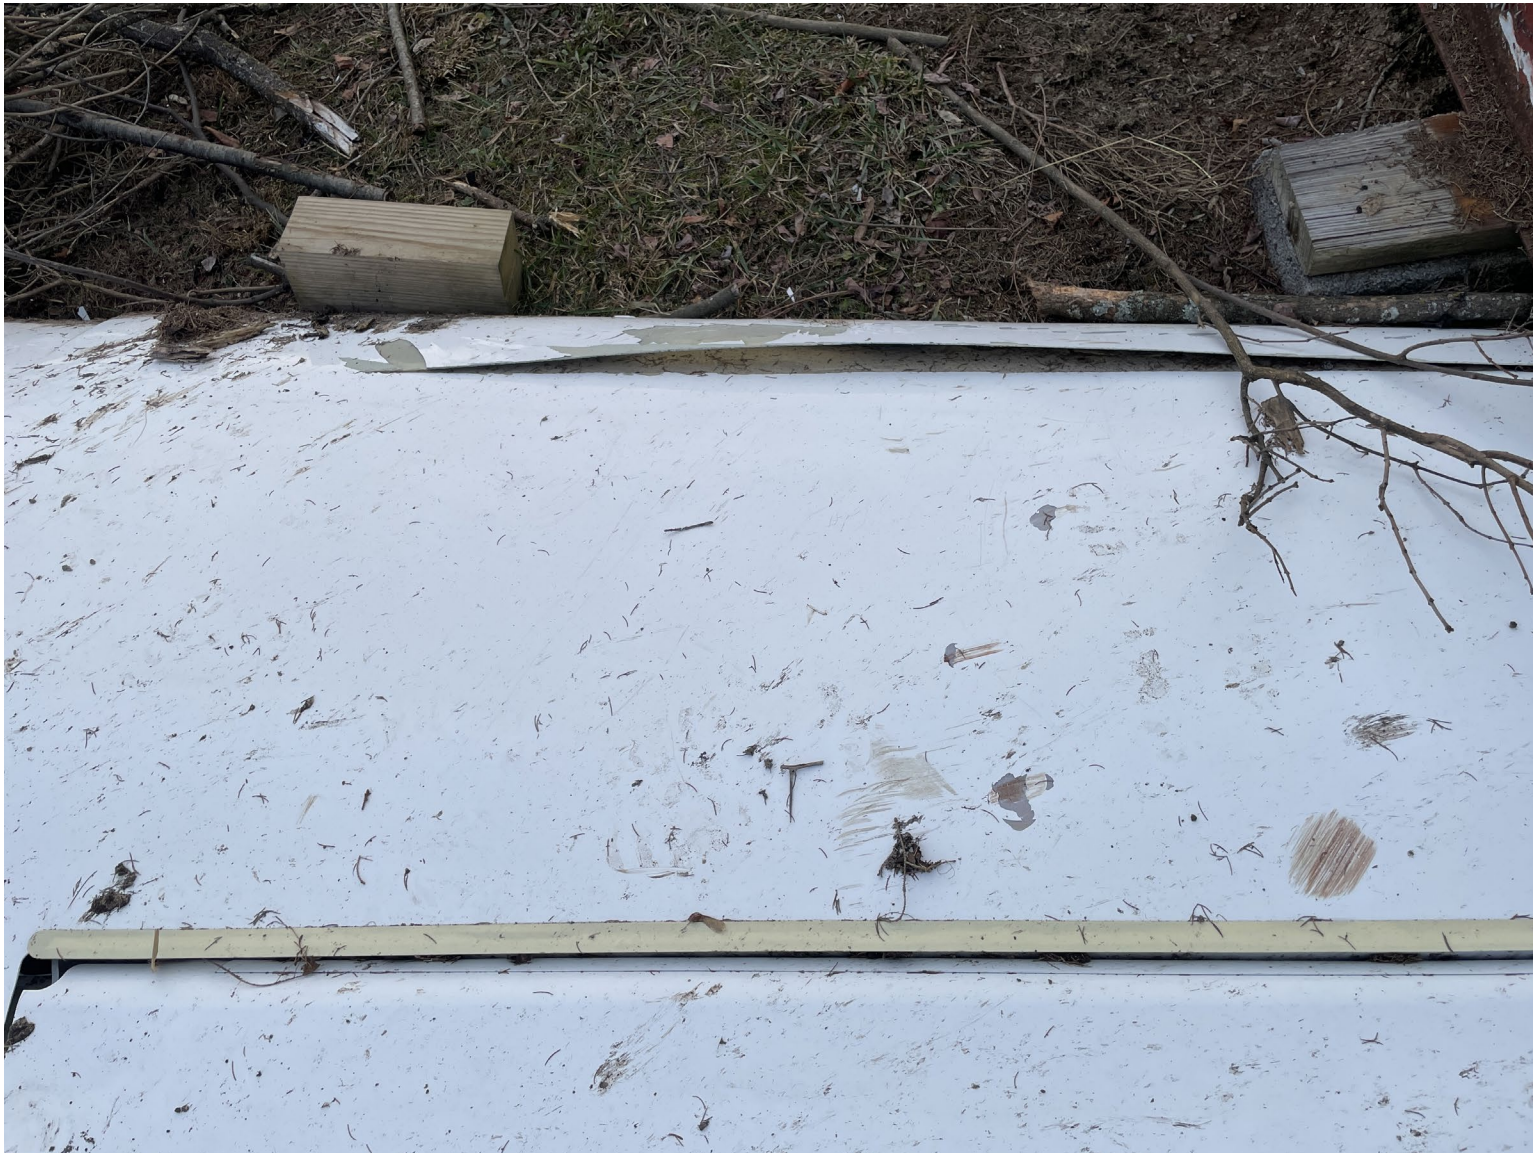
**Photograph 2 - View of damage to the right wing leading edge. (Courtesy of FAA)**

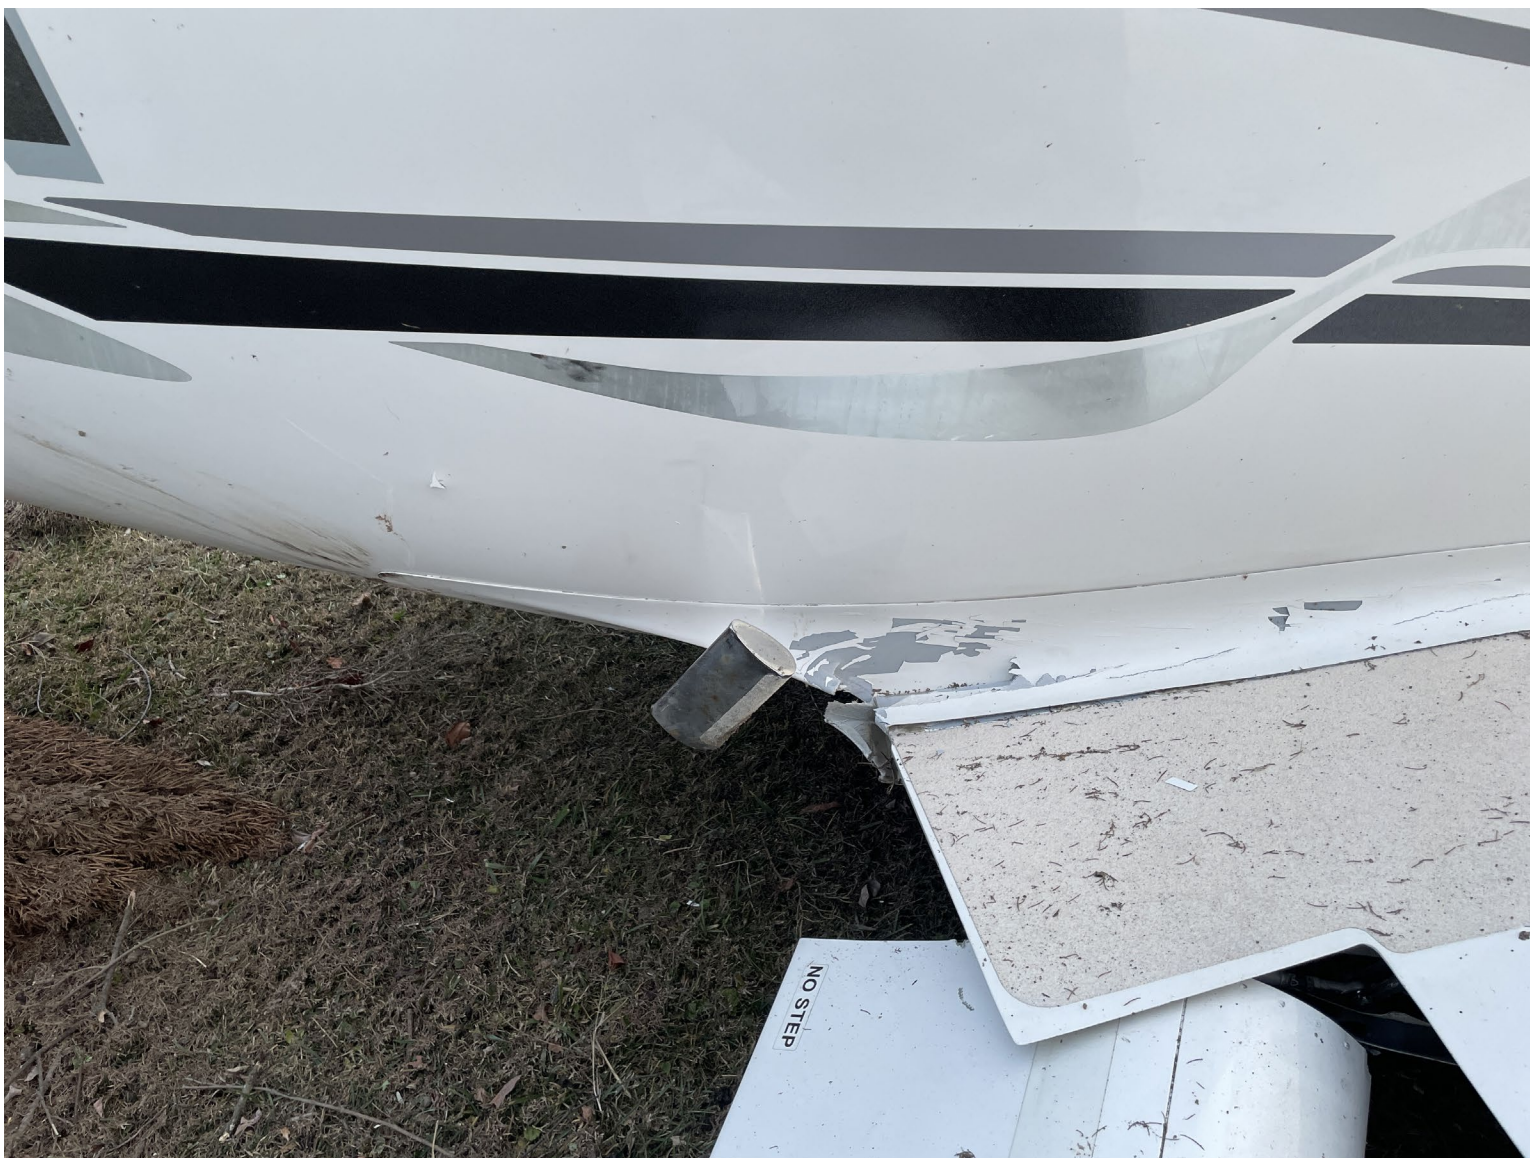
**Photograph 3 - View of damage to the right wing root. (Courtesy of FAA)**
