ERA26LA099

## INVESTIGATION PHOTOGRAPHS

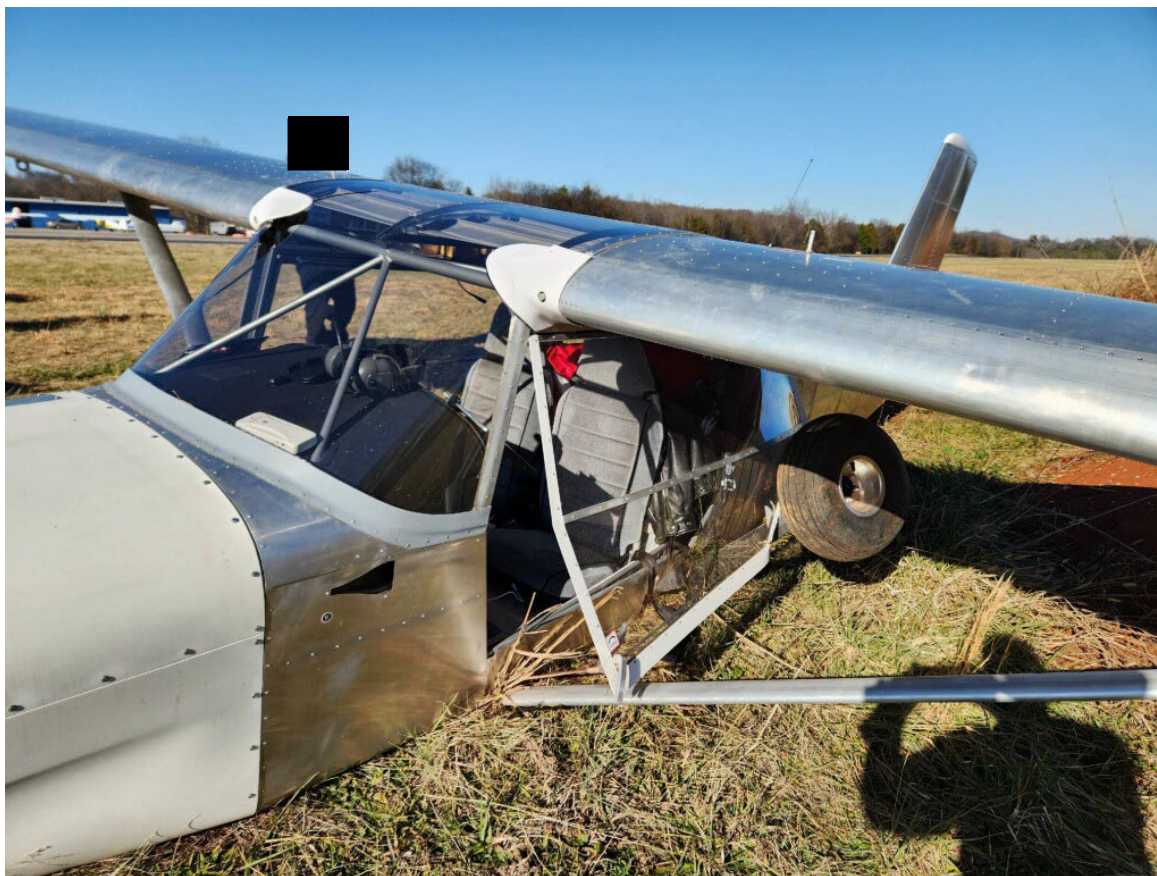
**Photograph 2 - Left side of fuselage (Courtesy of Owner)**

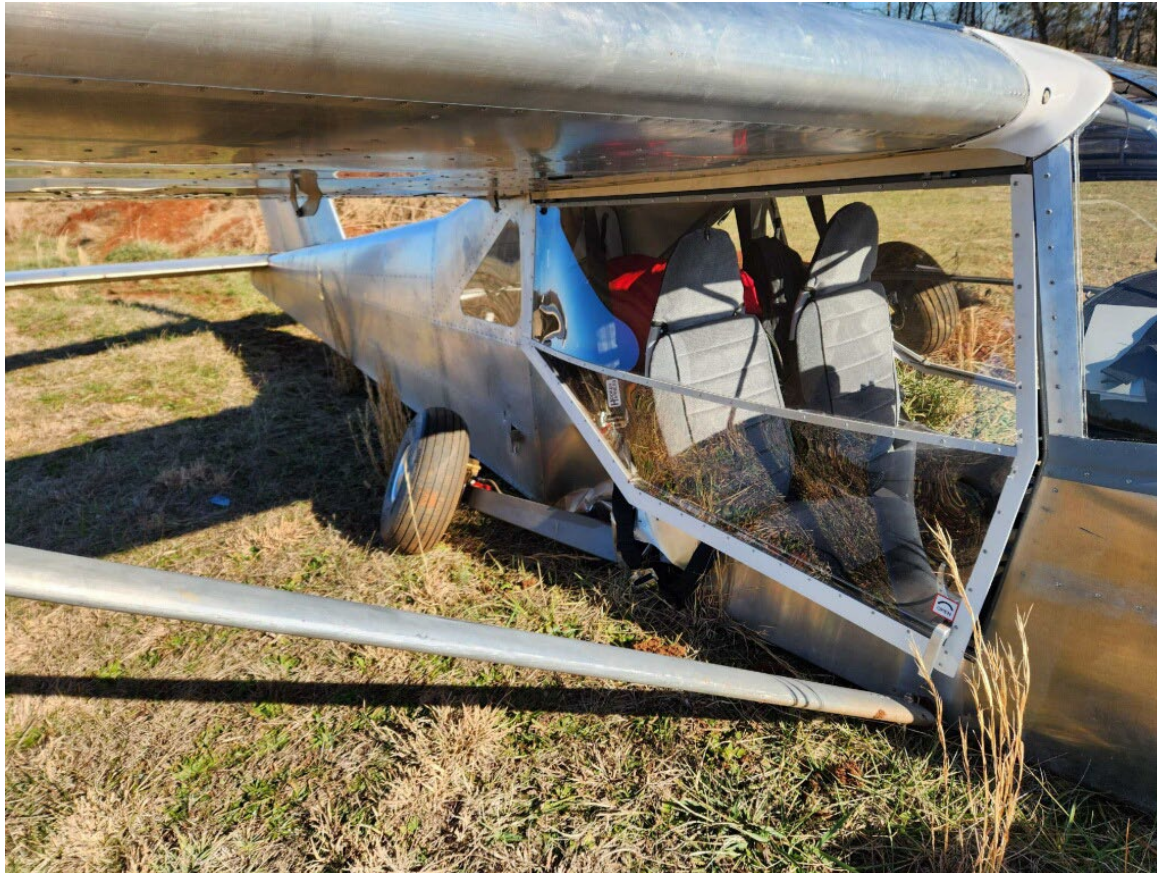
**Photograph 3 - Right side of fuselage (Courtesy of Owner)**

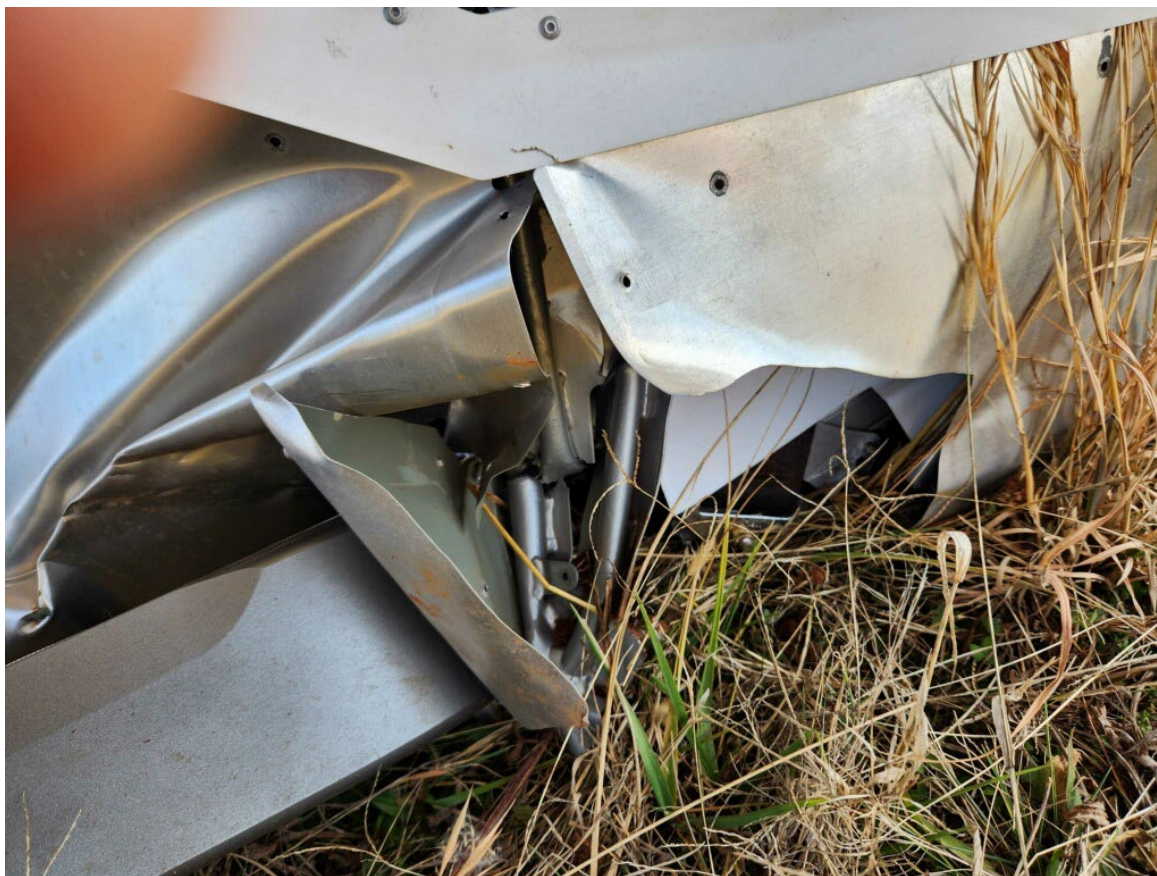
**Photograph 4 - Broken frame on left side of fuselage (Courtesy of Owner)**
