ERA26LA103

## INVESTIGATION PHOTOGRAPHS

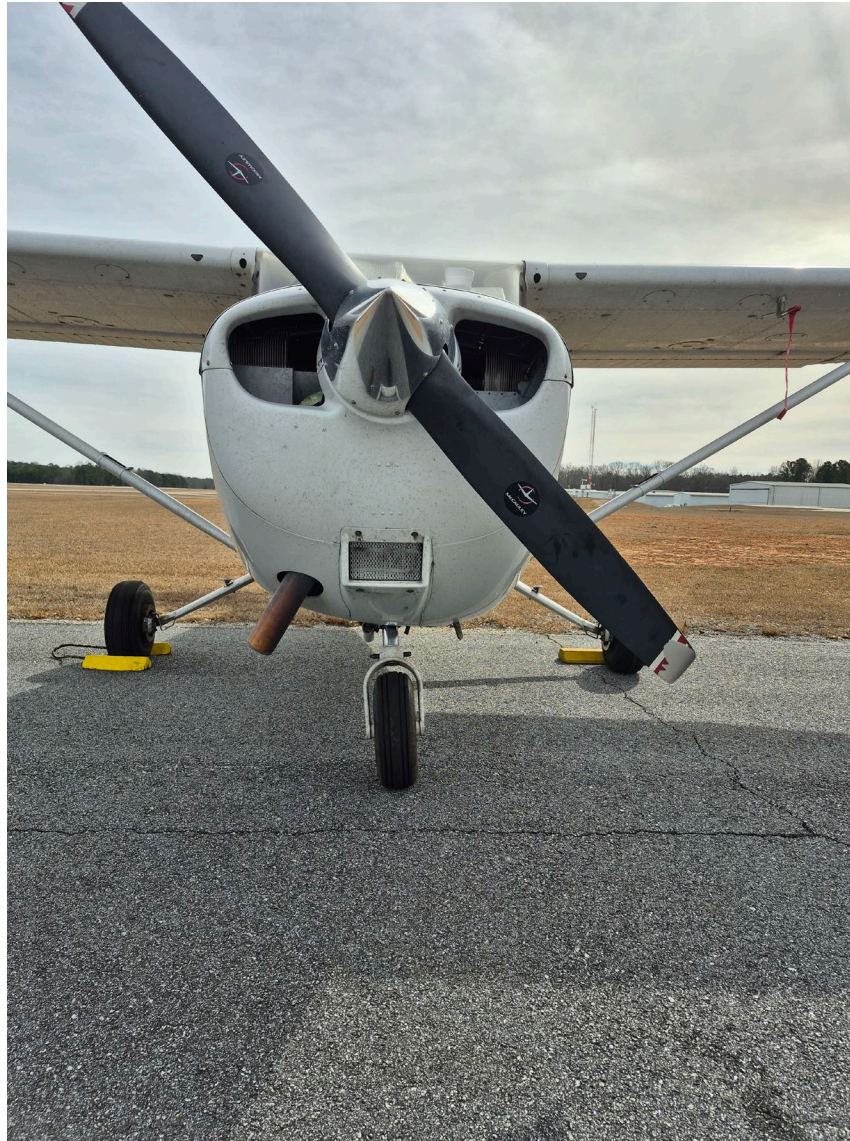
**Photograph 1 - Frontal View of the Airplane on the Ramp Note the damaged lower Propeller Blade (Courtesy of FAA)**

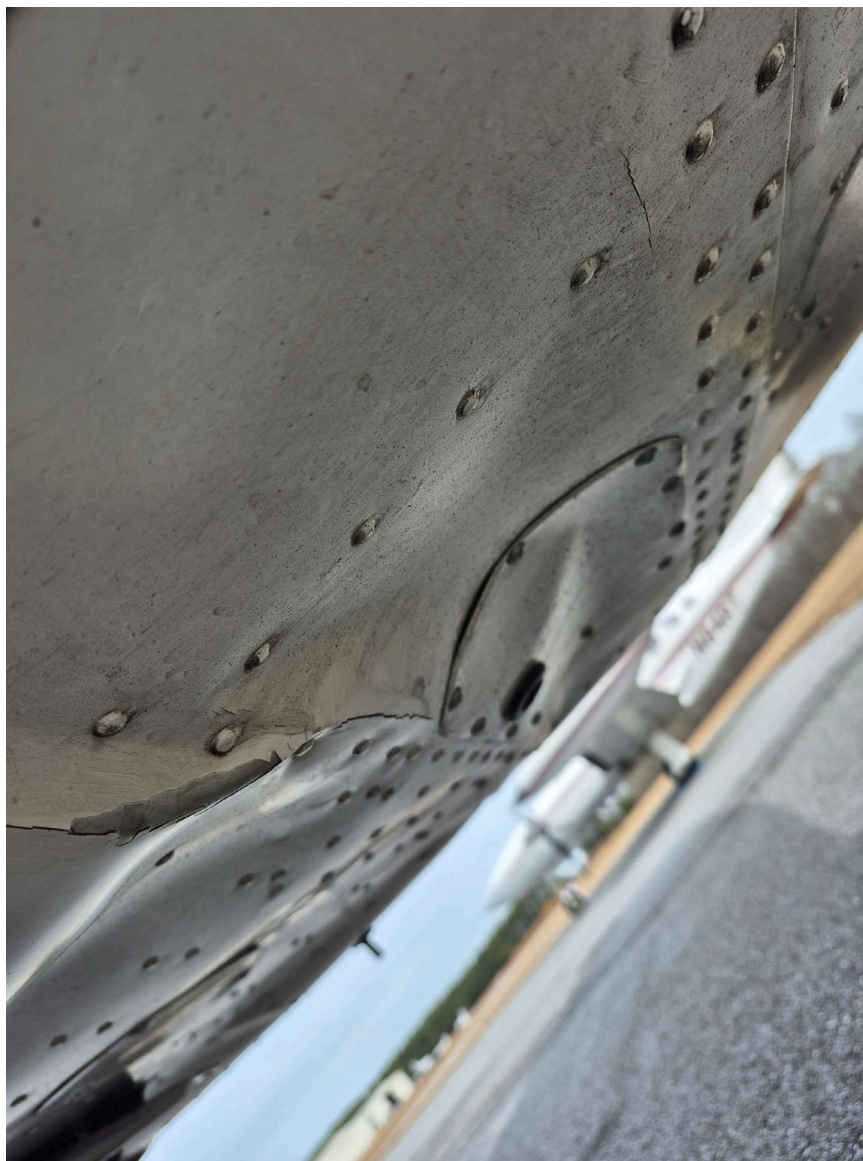
**Photograph 2 - View of the Bottom Fuselage Showing Structural Buckling Damage near Fuselage Station 17 (Courtesy of FAA)**

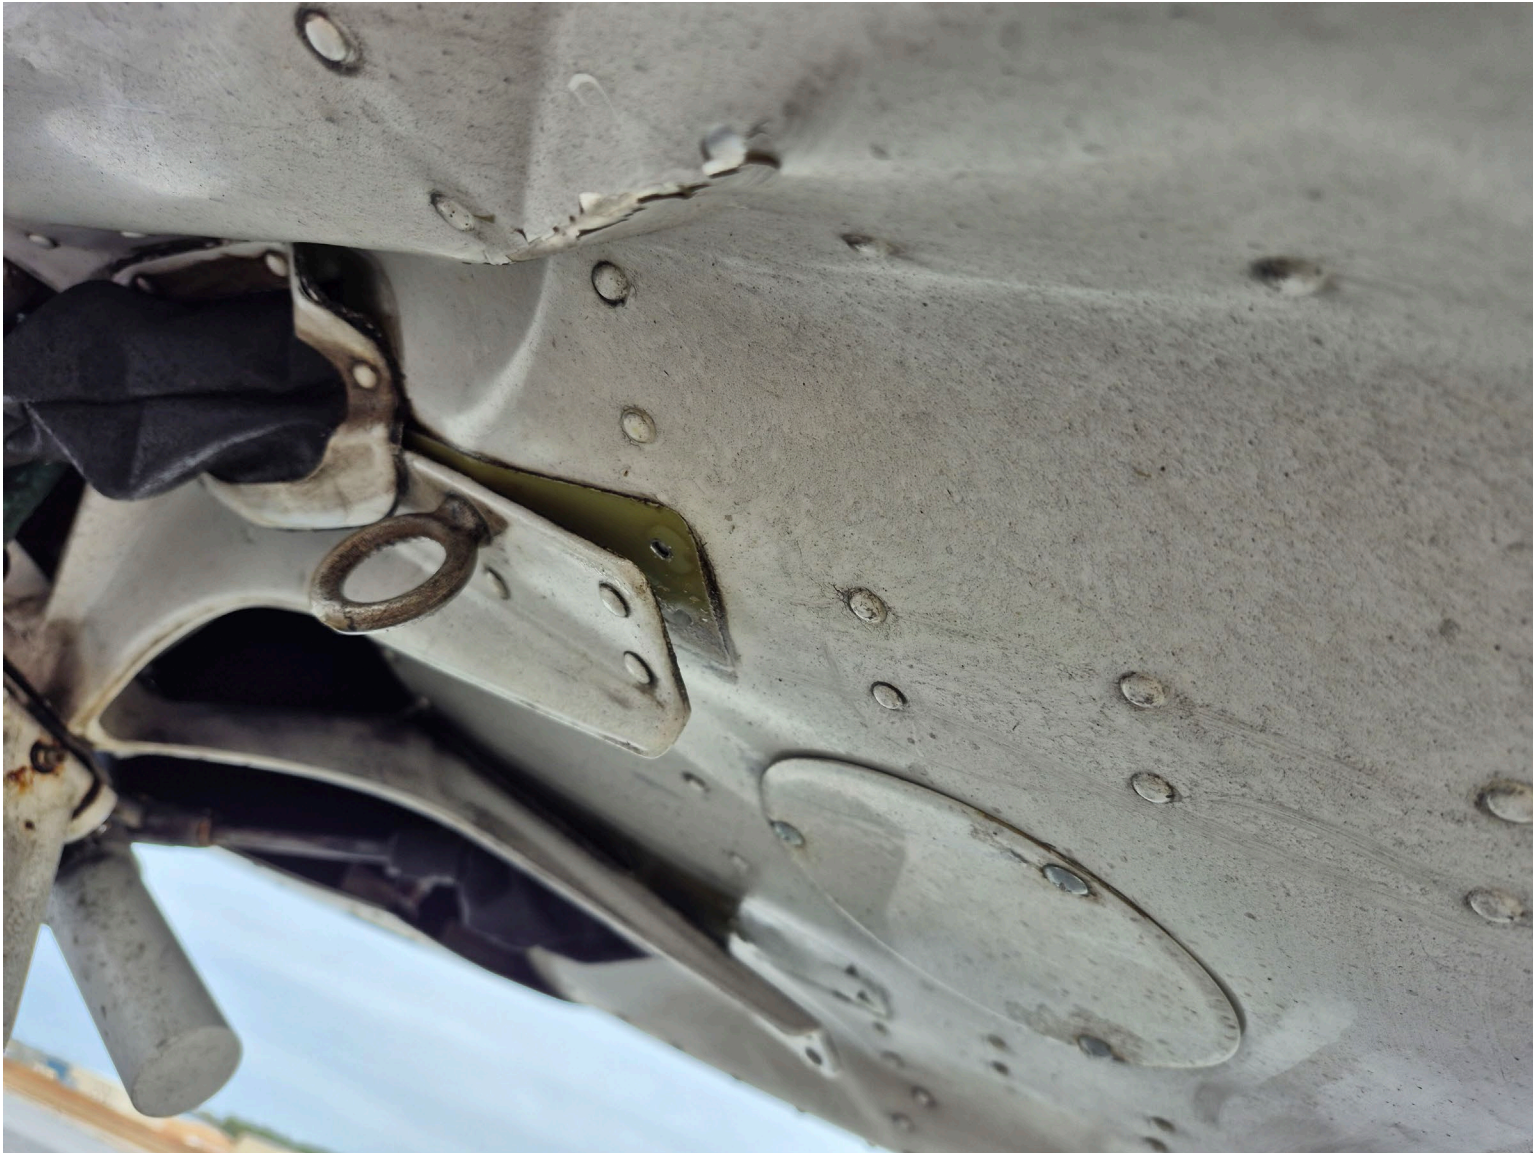
**Photograph 3 - View of the Bottom Fuselage Showing Structural Buckling Damage Adjacent to Lower Nose Gear Fitting, Near Fuselage Station 0 (Courtesy of FAA)**

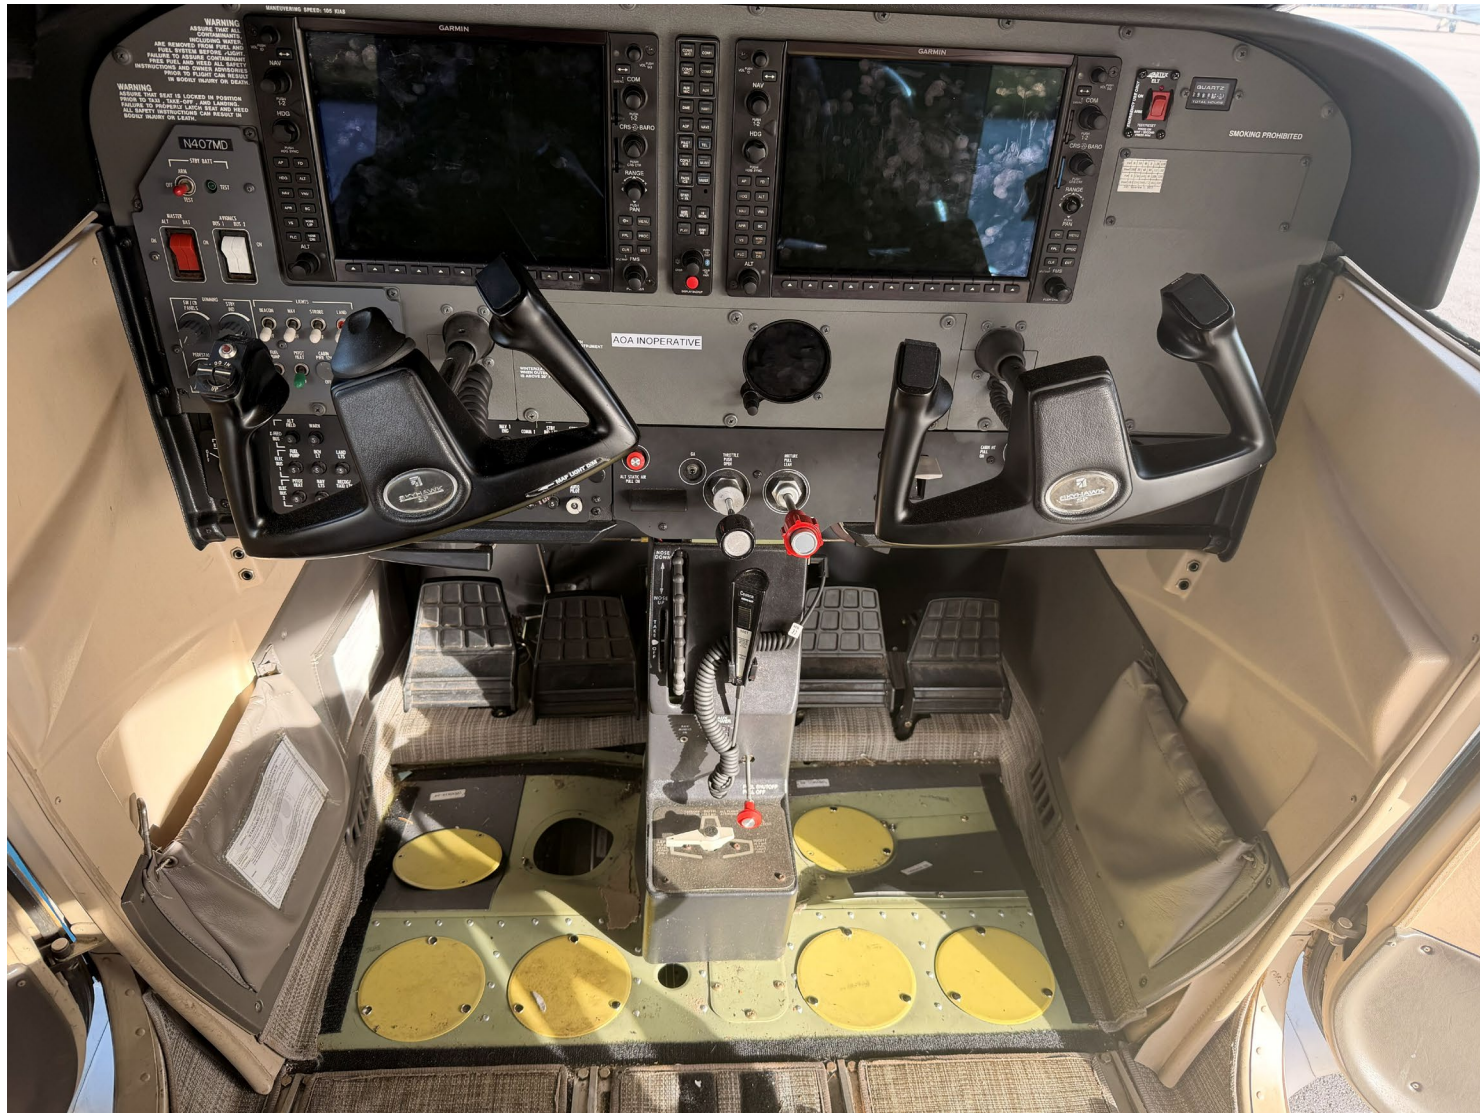
**Photograph 4 - View of the Cockpit Showing Buckling of Floor on Pilot and Co-Pilot Locations  
(Courtesy of Operator)**

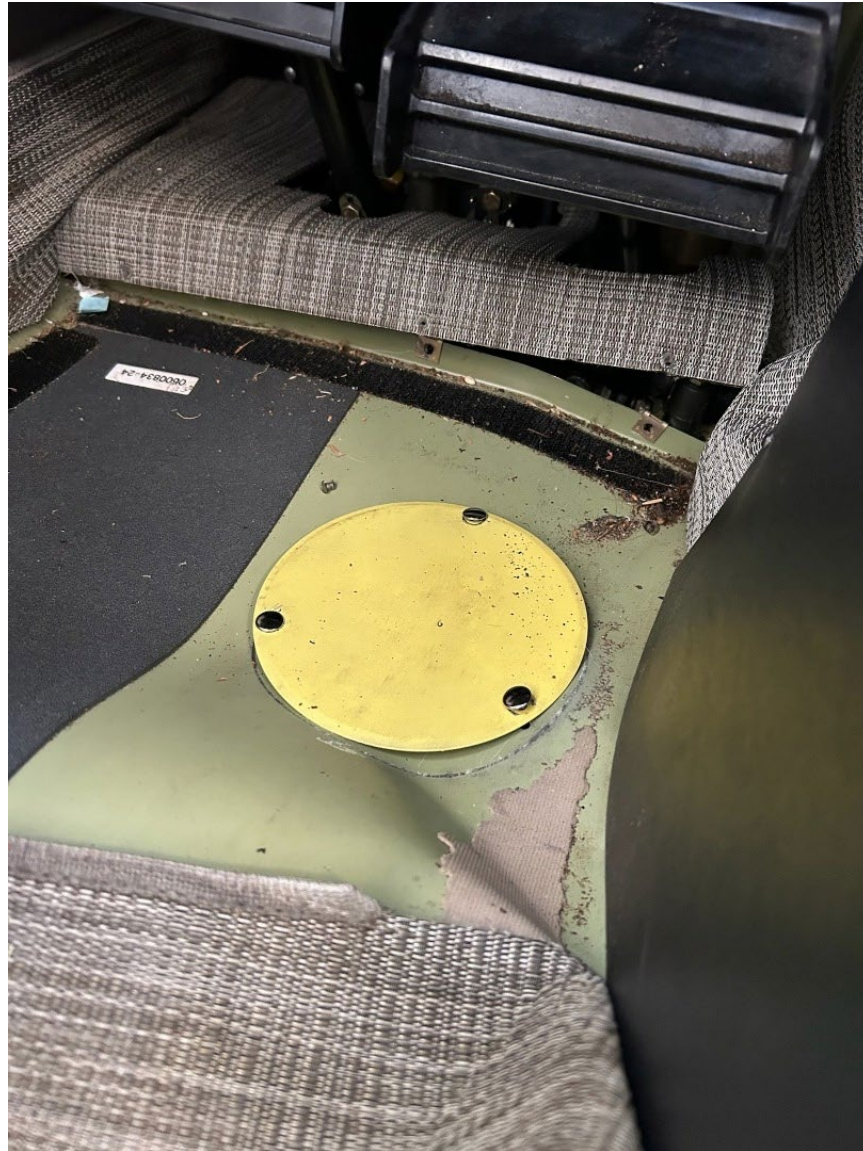
**Photograph 5 - Close-Up View Showing Buckling Damage to Pilot's Side Floor (Courtesy of Operator)**

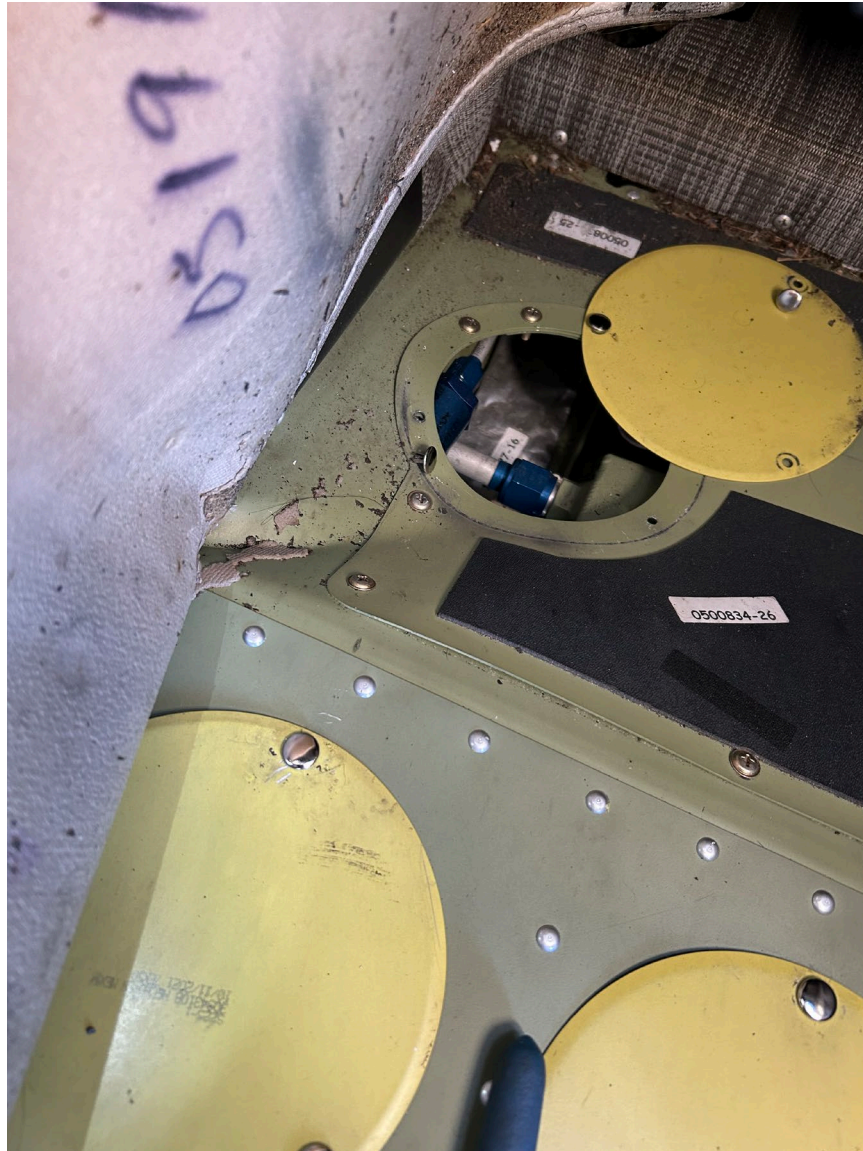
**Photograph 6 - Close-Up View Showing Buckling Damage to Co-Pilot's Side Floor (Courtesy of Operator)**
