ERA26LA122

## INVESTIGATION PHOTOGRAPHS

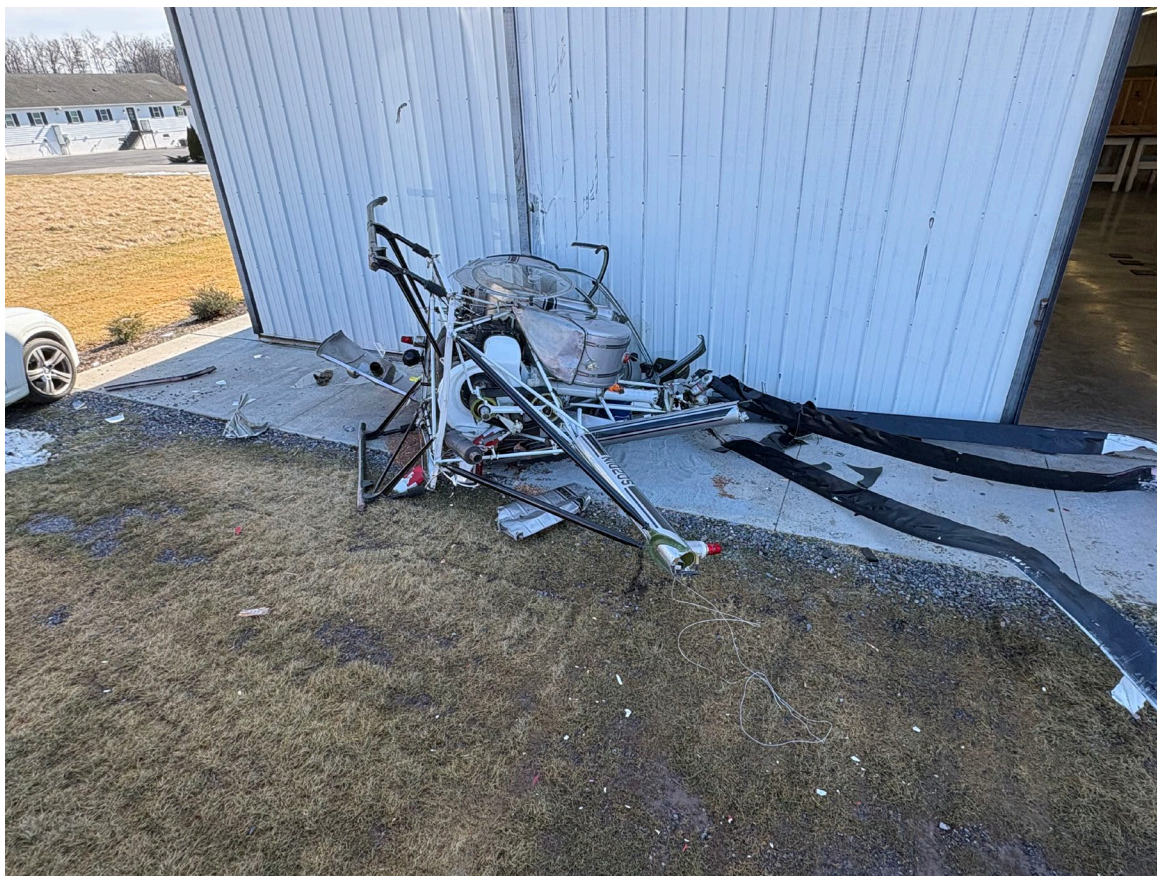
**Photograph 1 - View of Helicopter and Impacted Hangar (Courtesy of Mr. Dickerson)**

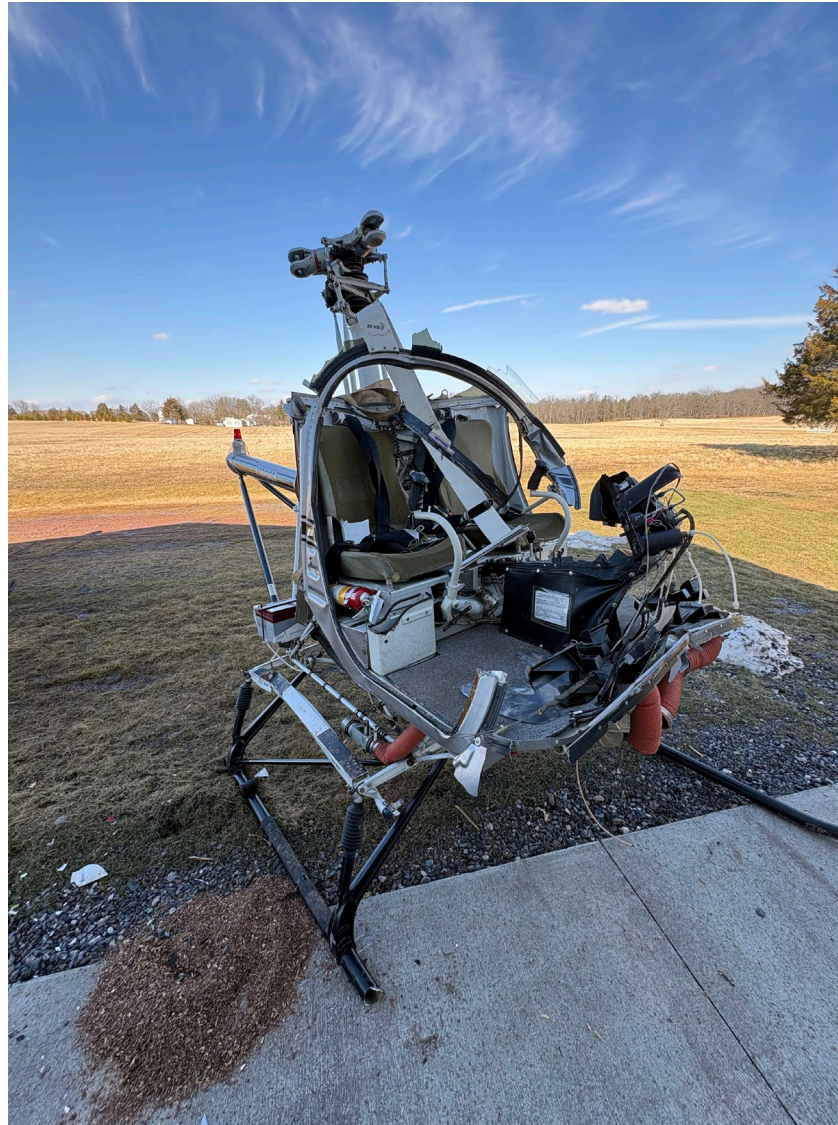
**Photograph 2 - View of the helicopter after being upright and main rotor blades removed  
(Courtesy of Mr. Dickerson)**

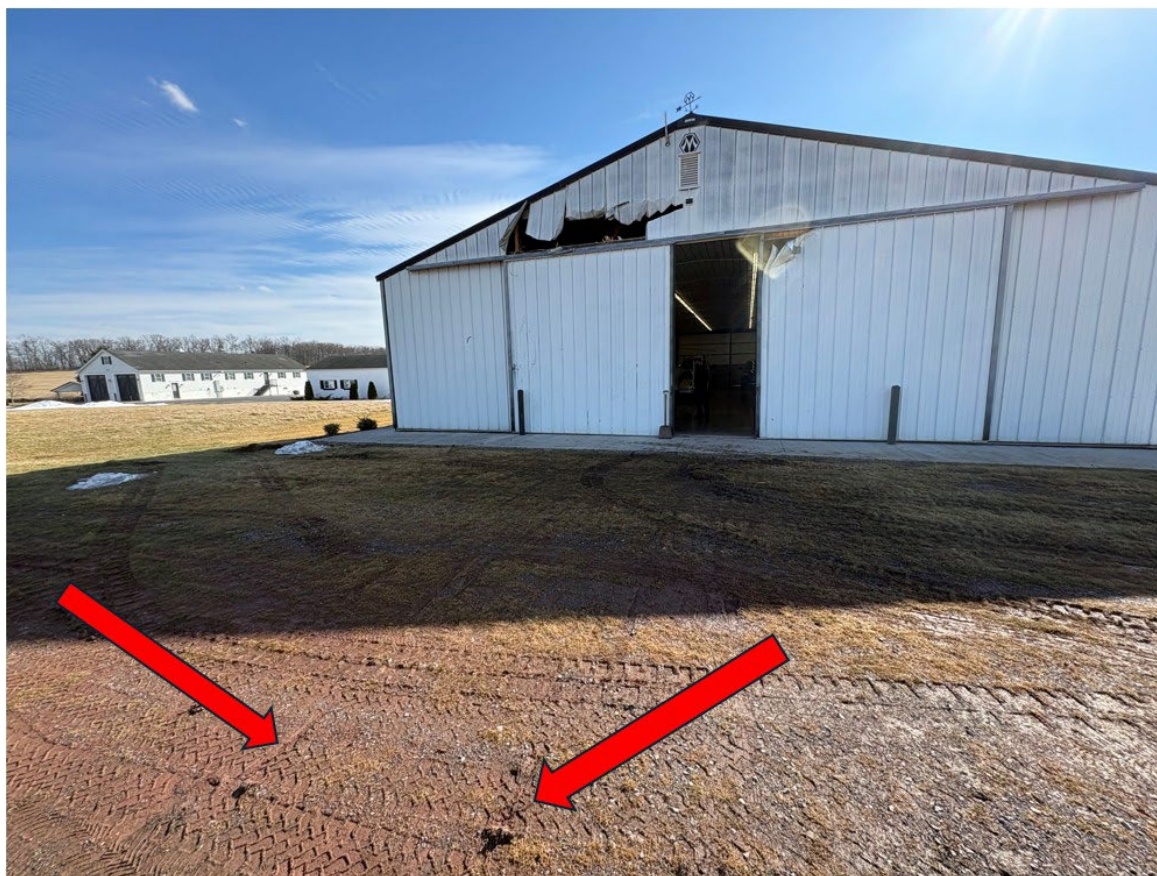
**Photograph 3 - View of the Impacted Hangar and Area Where Helicopter was Located at Start of Liftoff. Arrows Point to Marks From Both Skids (Courtesy of Mr. Dickerson)**
