ERA26LA123

## INVESTIGATION PHOTOGRAPHS

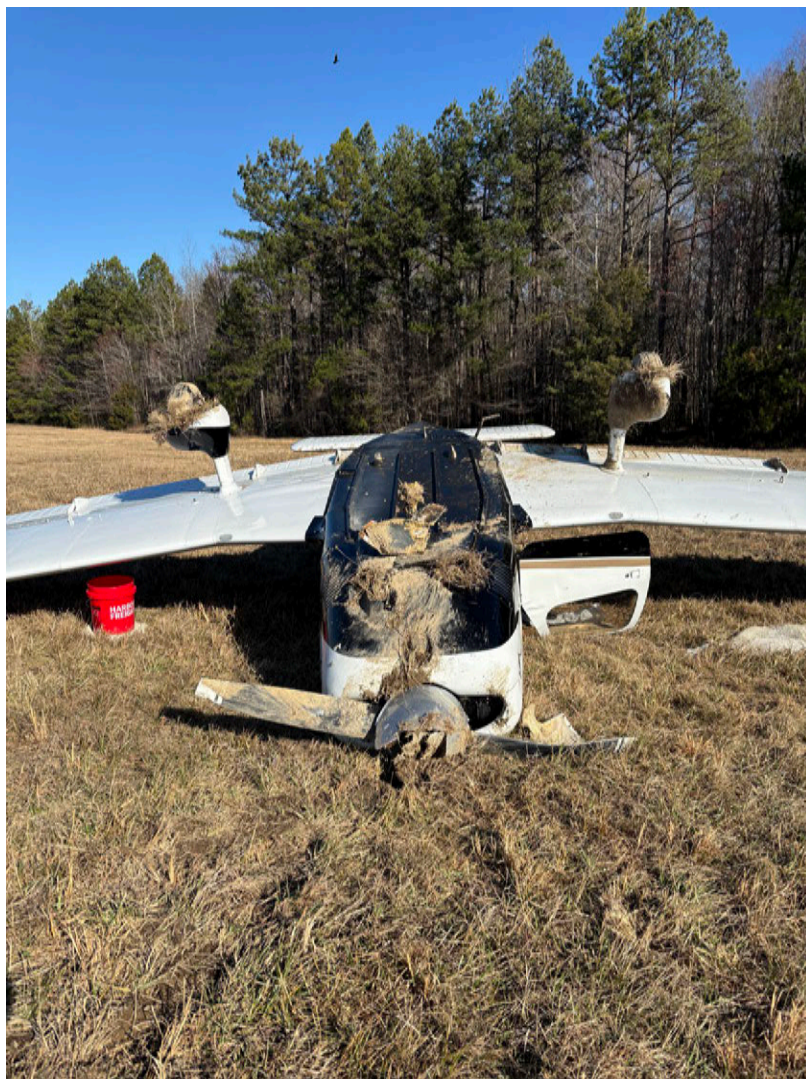
**Photograph 1 - Airplane postaccident with fuselage damage at the step and across to the other side of the belly. (Courtesy of FAA)**

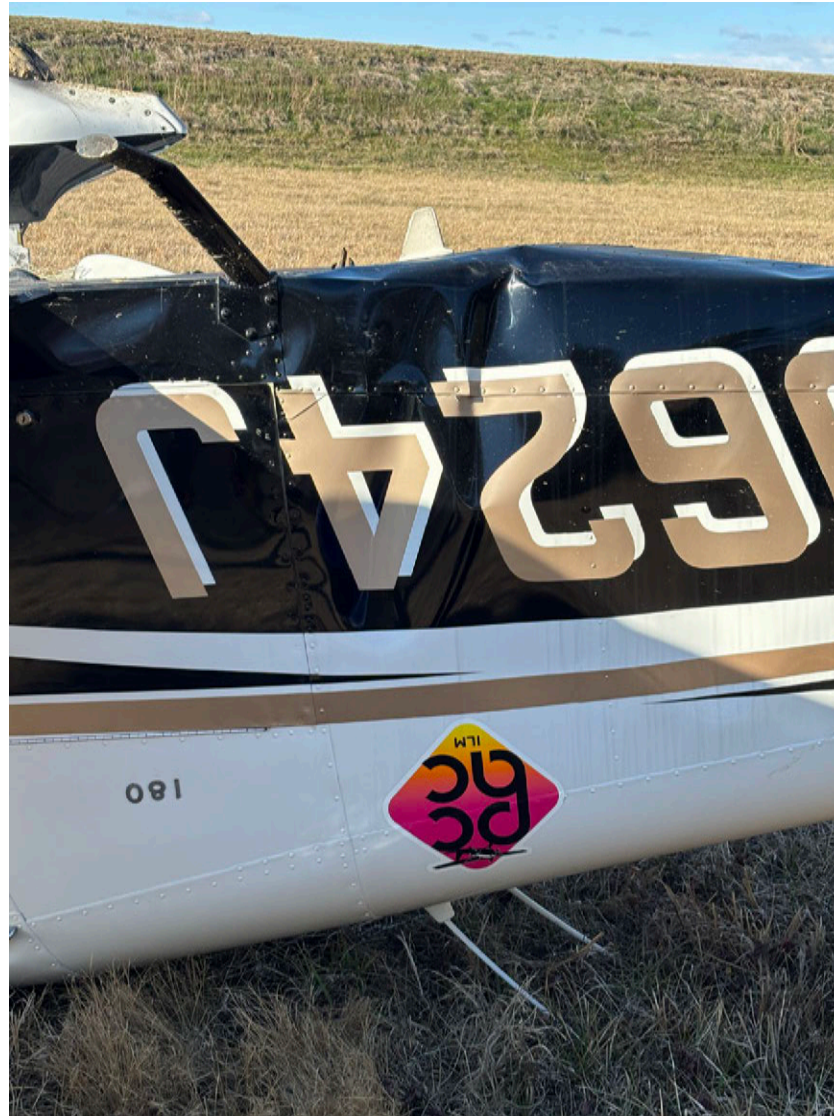
**Photograph 2 - Right side fuselage damage. (Courtesy of FAA)**

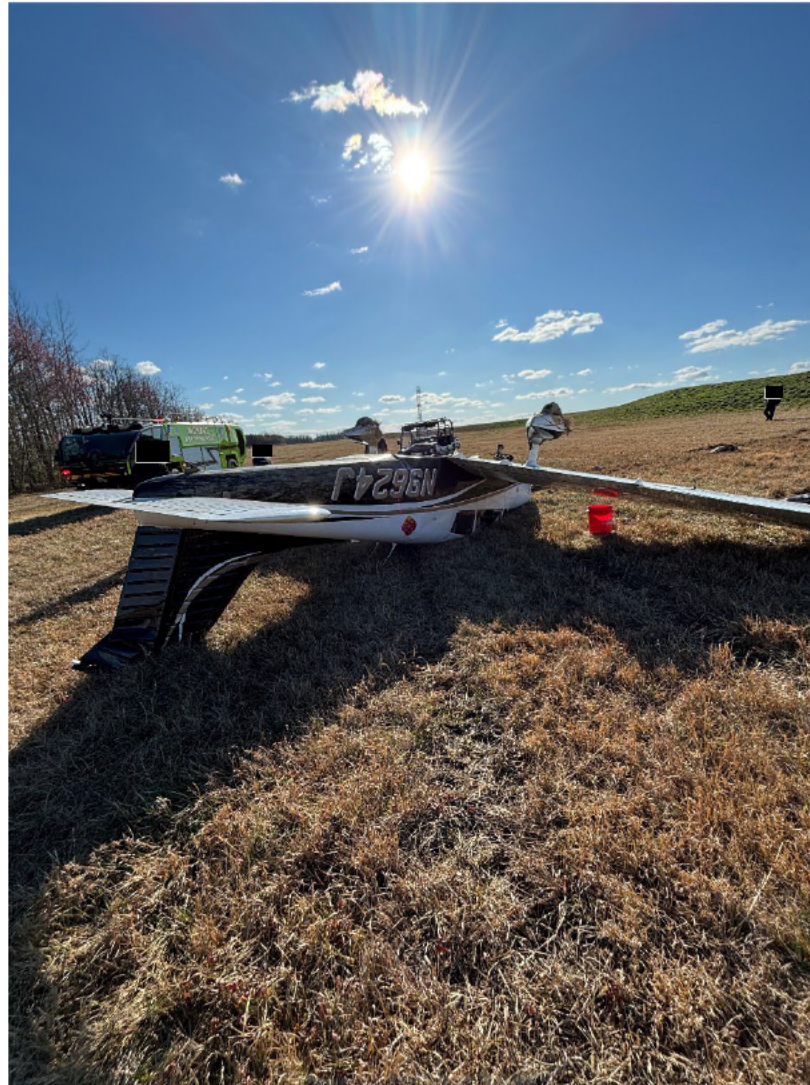
**Photograph 3 - Aft view of airplane with damage to vertical stabilizer and rudder.  
(Courtesy of FAA)**

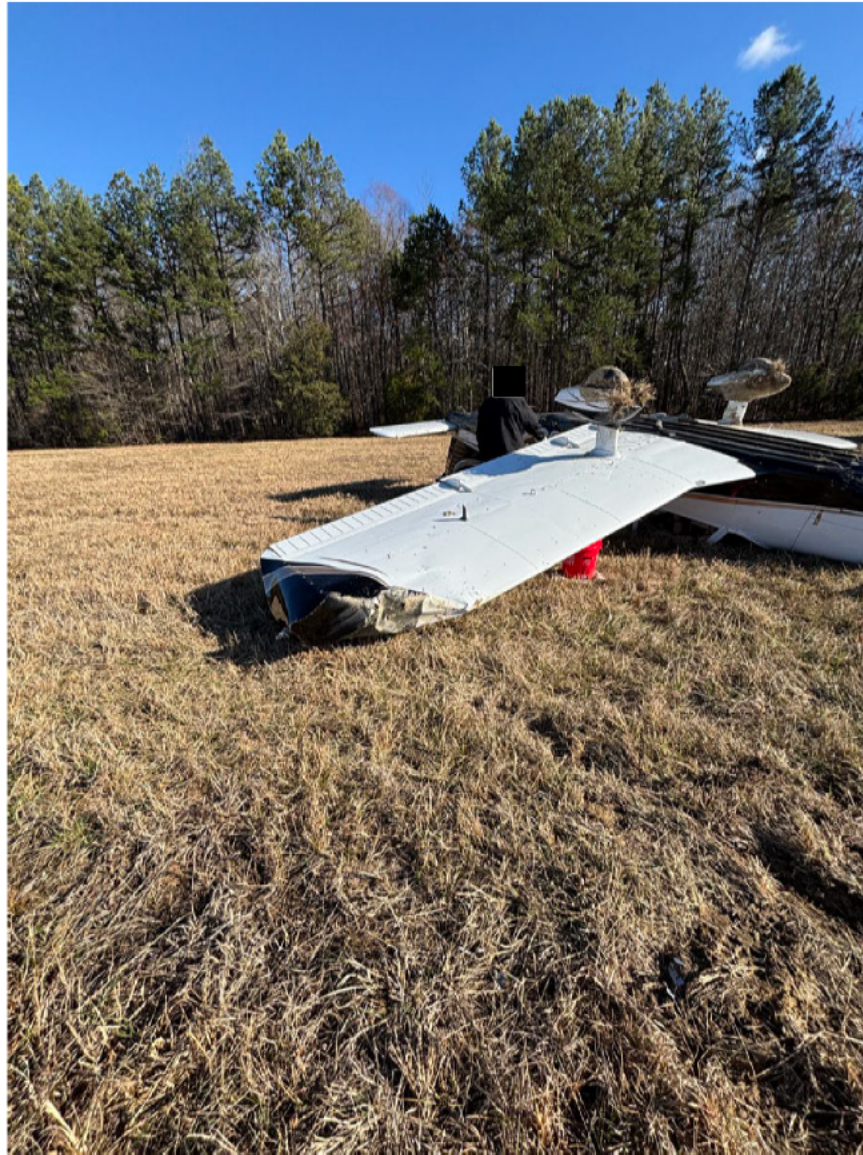
**Photograph 4 - Left wing and tip damage. (Courtesy of FAA)**
