ERA26LA138

## INVESTIGATION PHOTOGRAPHS

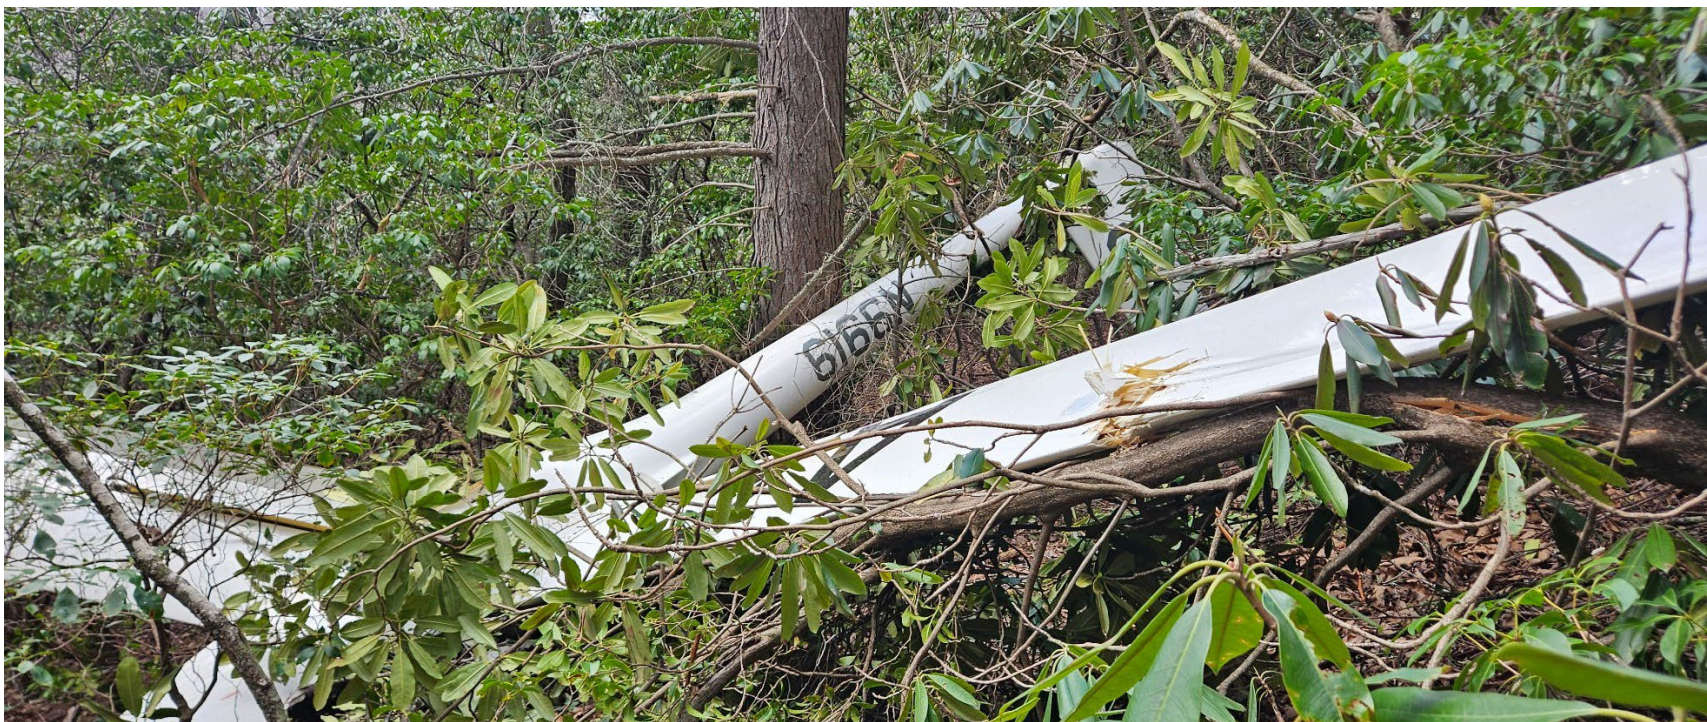
**Photograph 1 - Right Forward Quartering View of the Inverted Glider at the Accident Site. Note the Partial Chordwise Fracture of the Right Wing (Courtesy of FAA)**

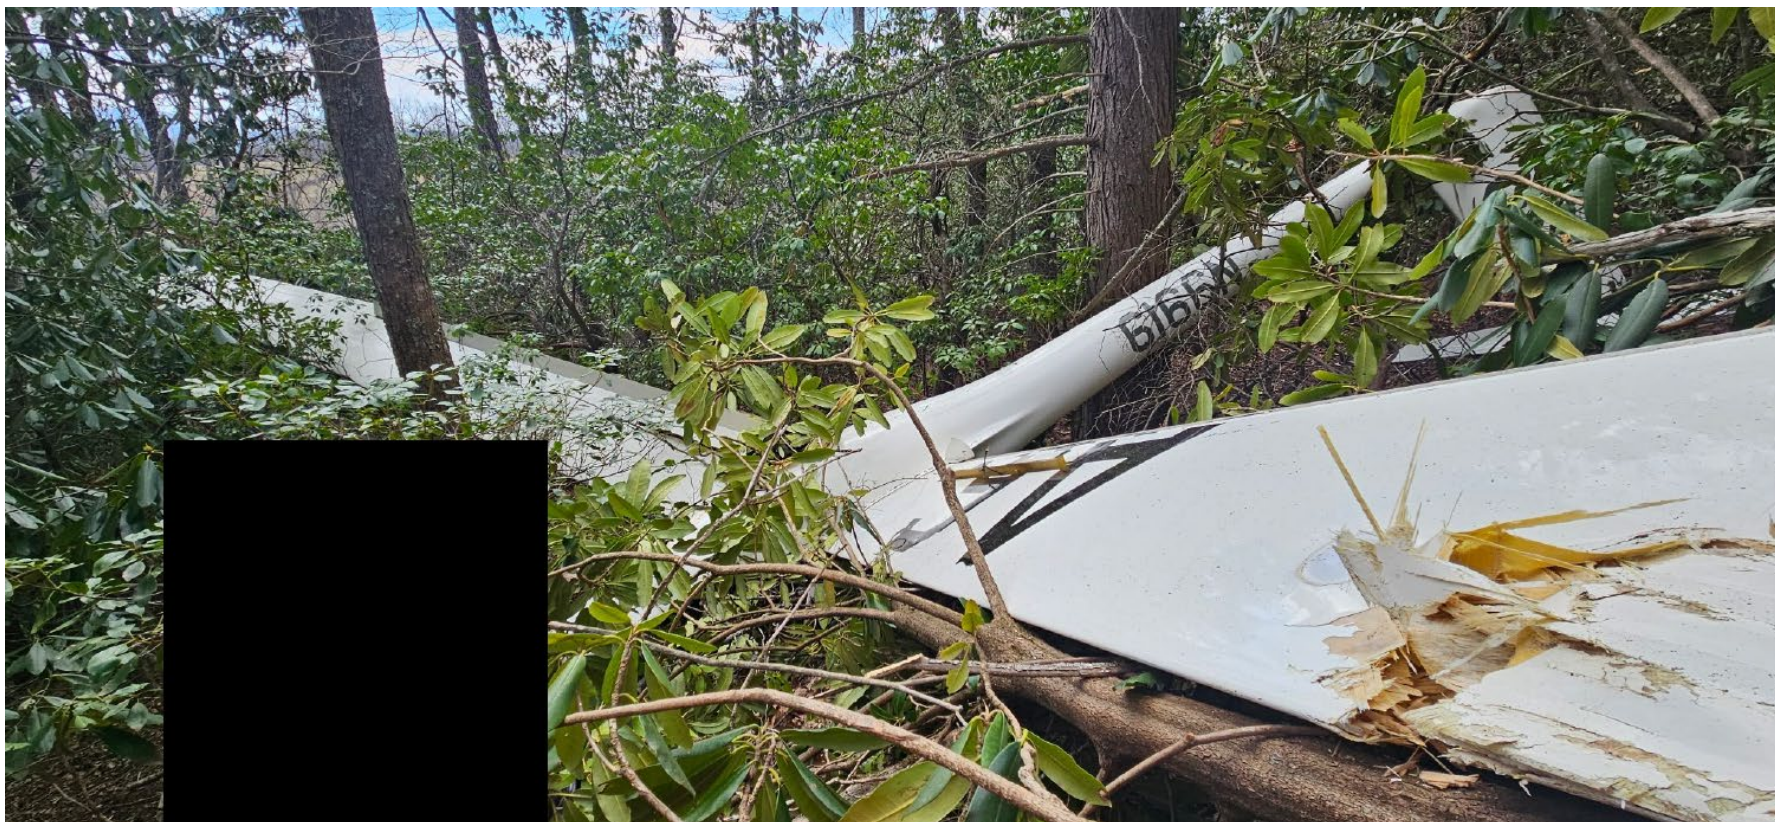
**Photograph 2 - Right Forward Quartering View of the Inverted Glider at the Accident Site. Note the Partial Chordwise Fracture of the Right Wing (Courtesy of FAA)**
