## FACTUAL OBSERVATIONS

Aircraft: N7573P

Serial Number: 24-2783

Inspection Date/Time: 03/19/2026 at 0900

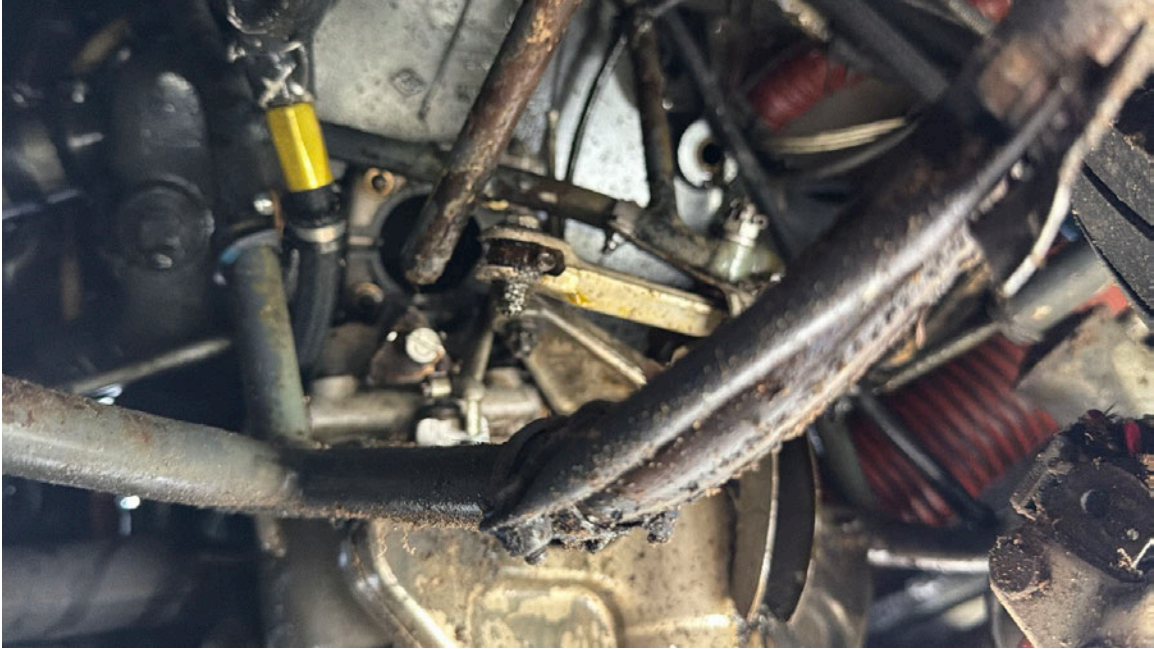
- Both nose gear steering pushrods were observed sheared at the steering collar linkage.
- The separation resulted in a discontinuity between the rudder pedal inputs and the nose wheel steering mechanism.
- The failure was localized at the steering collar interface.
- Upstream linkage components remained intact and continuous up to the point of separation.
- No binding or restriction was noted in the intact portions of the linkage system.

Figure 1: Nose landing gear steering linkage showing sheared pushrods at steering collar interface.

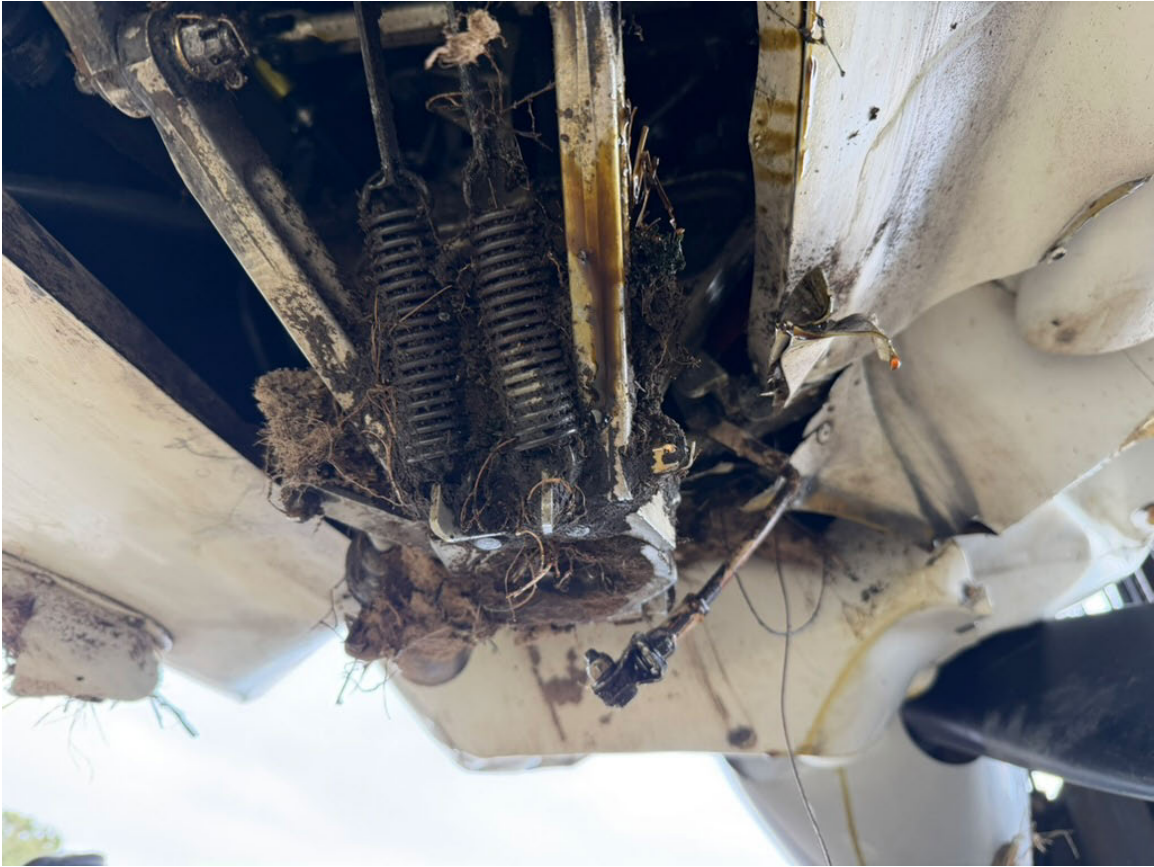
Figure 2: Nose landing gear assembly showing separation and structural damage at the nose gear attachment area.

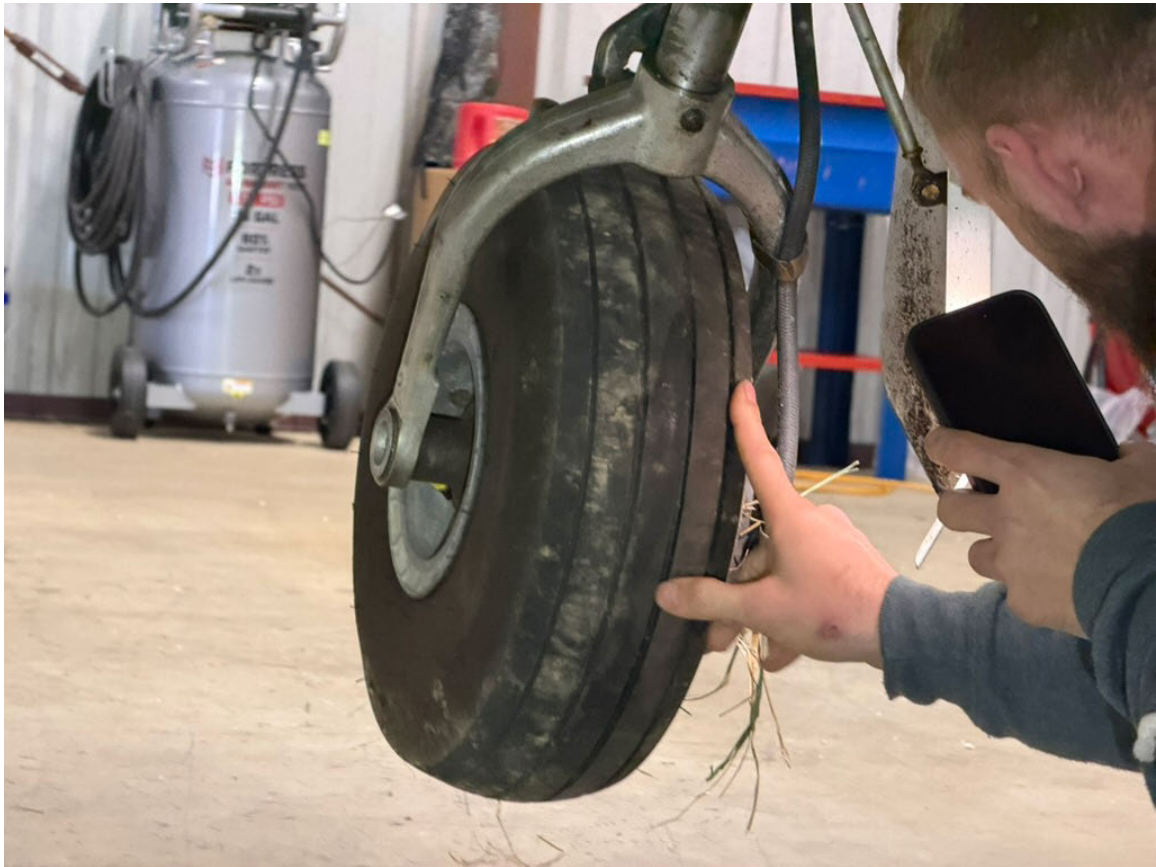
- The left main landing gear remained attached at the time of inspection.
- The left main wheel rotated freely without restriction.
- No flat spots or abnormal tire wear were observed.
- No visible mechanical abnormalities were noted on the accessible portions of the left main landing gear assembly.

- Brake system evaluation was conducted on the left main landing gear (only remaining attached wheel).
- The wheel assembly rotated freely when no brake input was applied.
- Application of brake input resulted in immediate stopping of the wheel.
- Upon release of brake input, the wheel returned to free and unrestricted rotation.
- No evidence of binding, sticking, or abnormal brake response was observed during functional checks.

Figure 3: Left main landing gear assembly observed in the down and locked position; this was the only fully intact landing gear assembly on the aircraft.

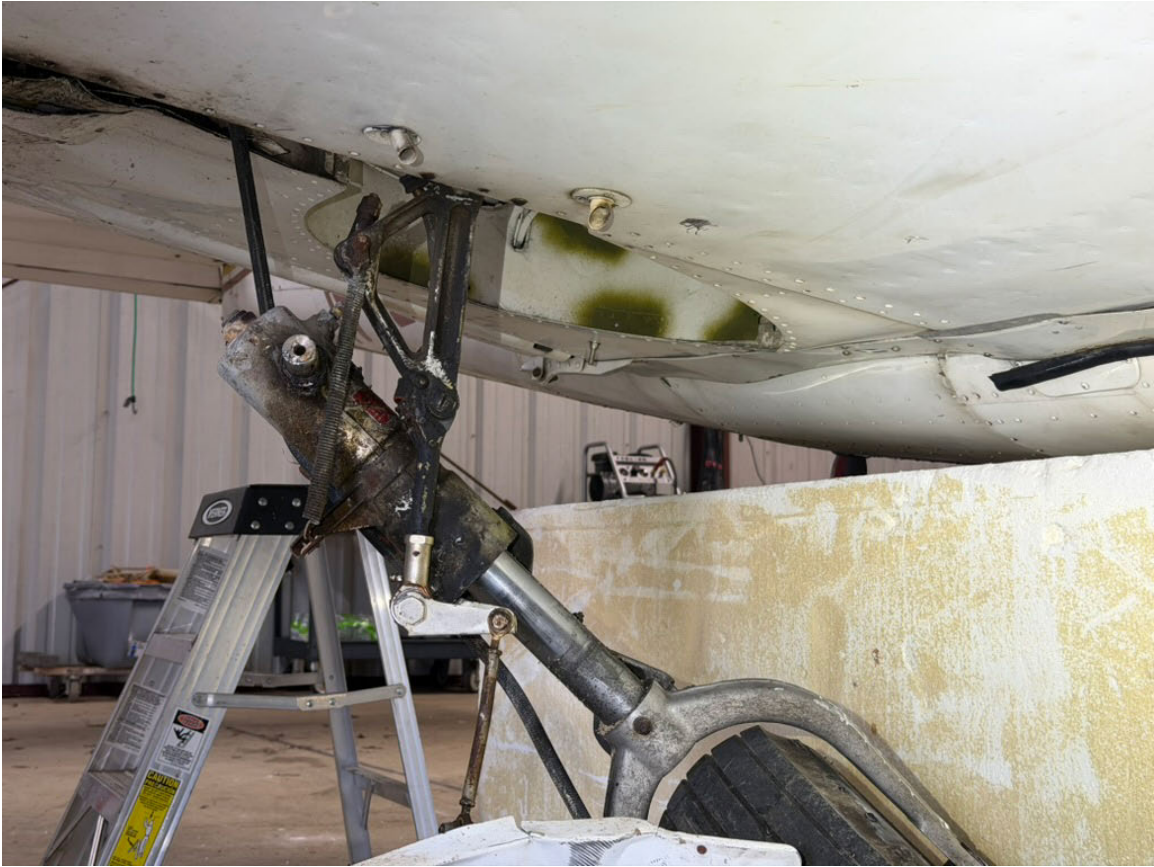
Figure 4: Right main landing gear assembly showing structural separation and damage.

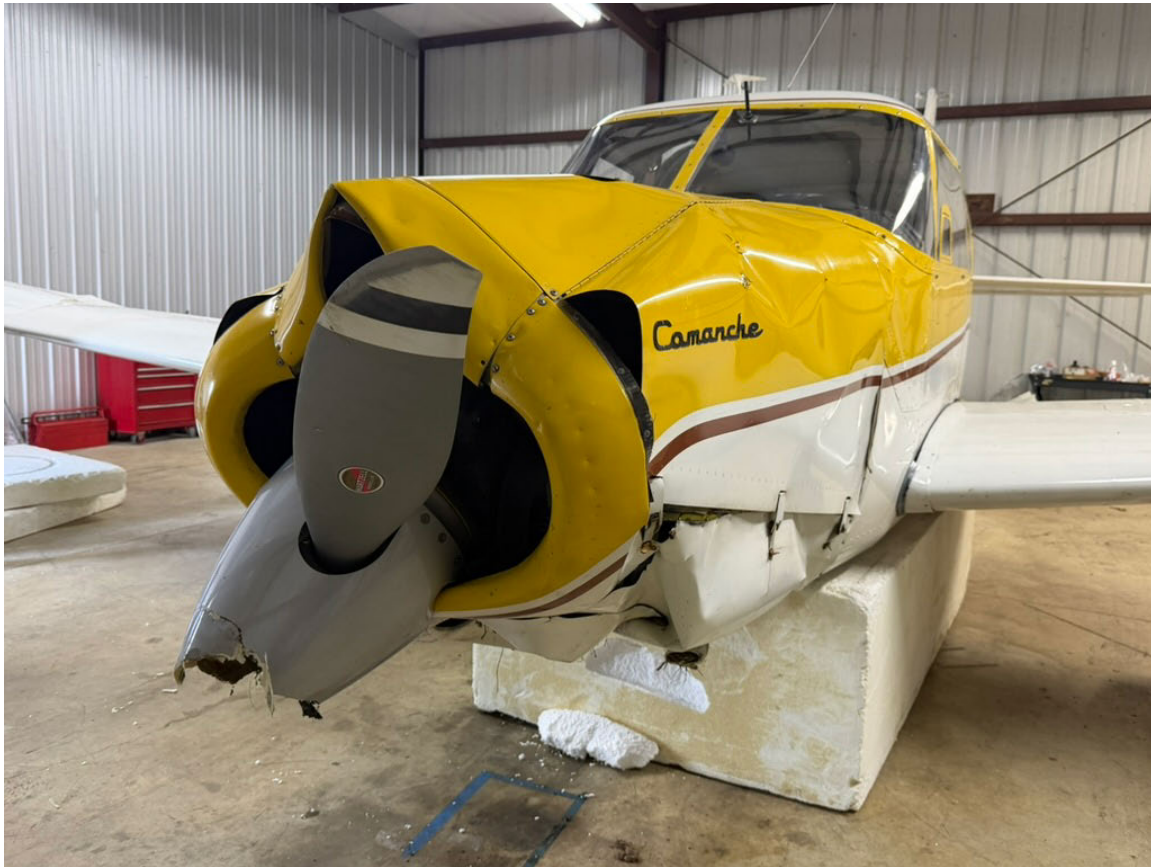
Figure 5: Forward fuselage and nose section of the aircraft showing impact-related deformation and damage.
