ERA26LA158

## INVESTIGATION PHOTOGRAPHS

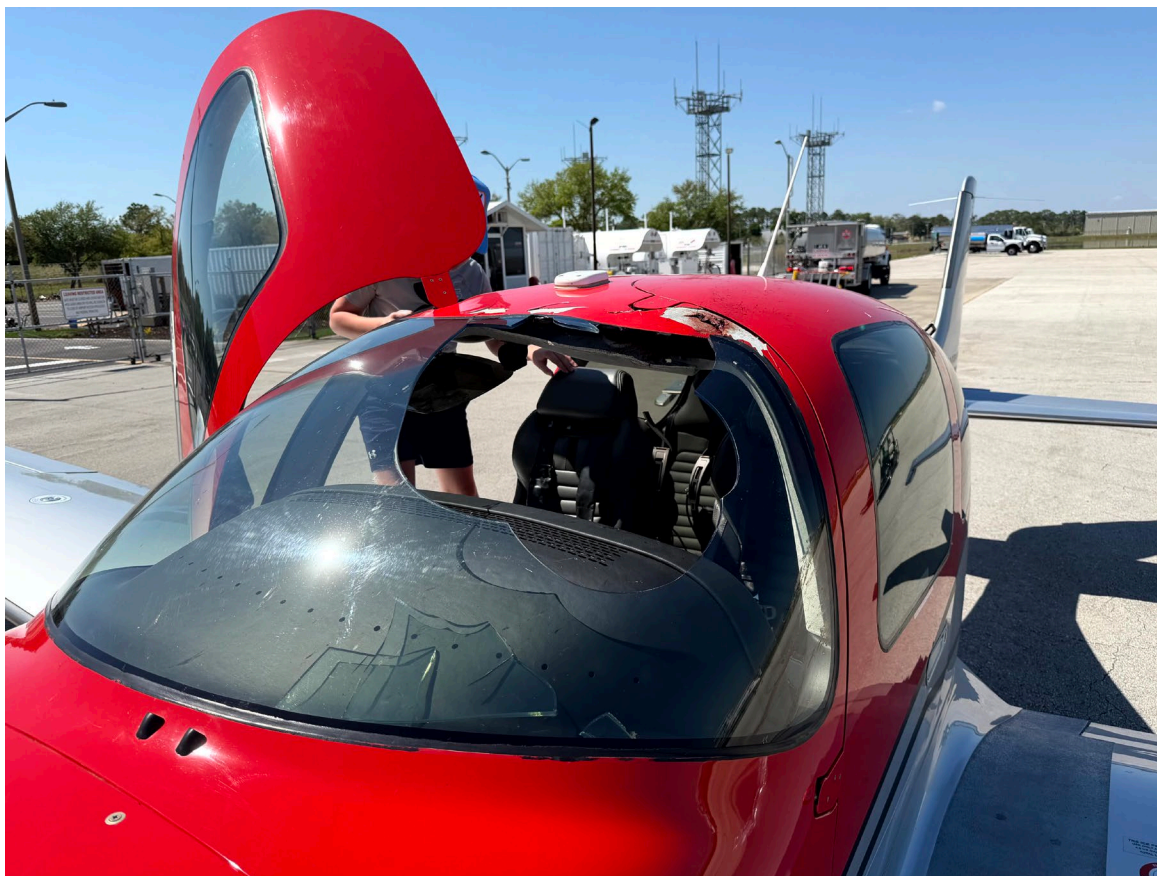
**Photograph 1 - Impact damage noted to windshield and roof structure (Courtesy of FAA)**
