ERA26LA176

## INVESTIGATION PHOTOGRAPH

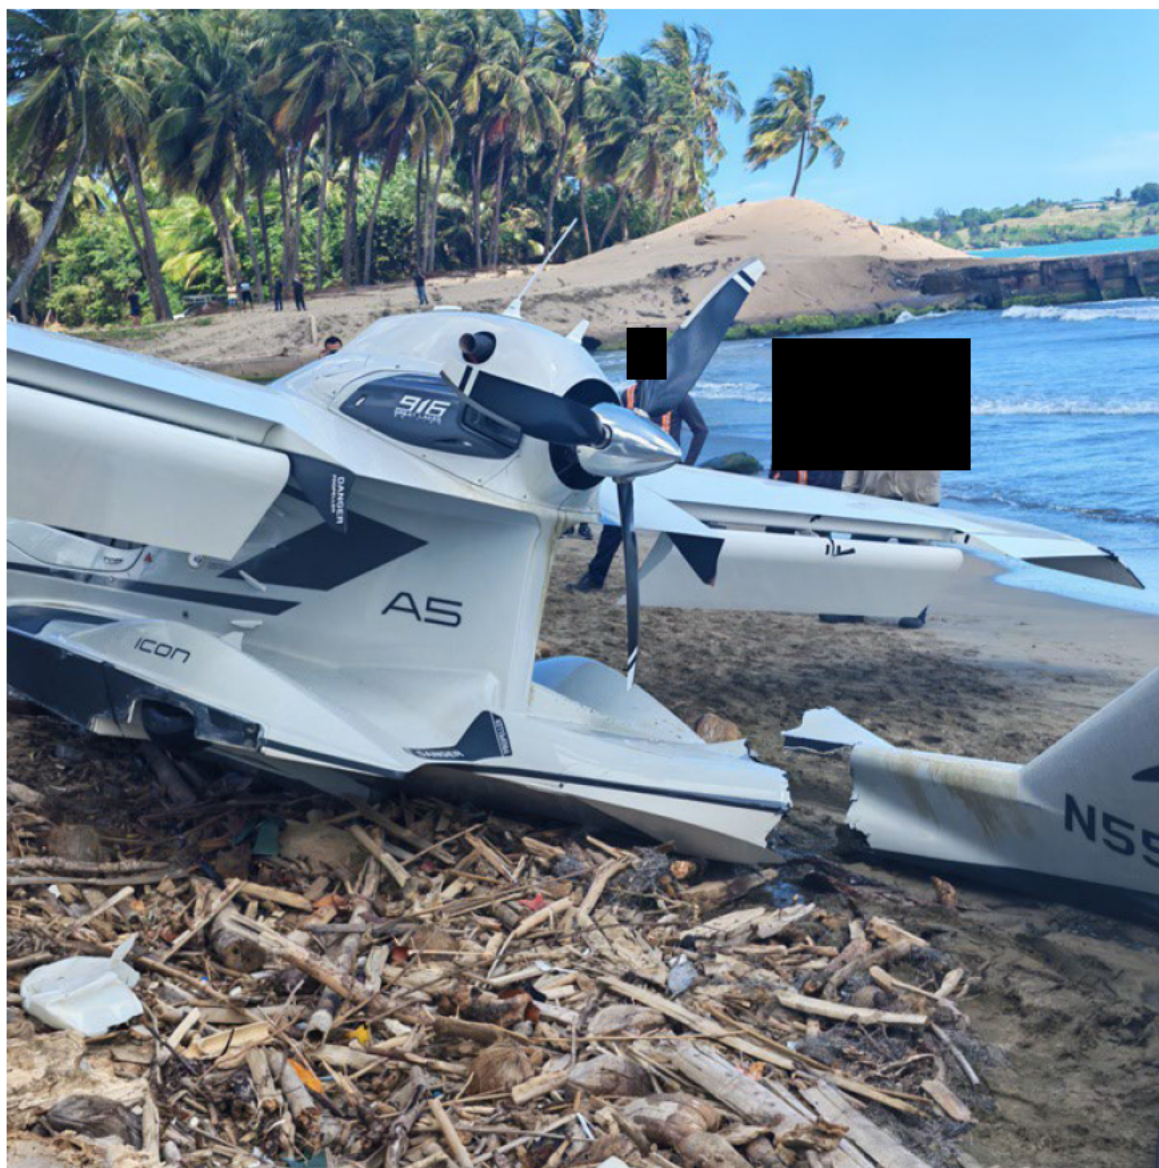
**Photograph 1 - Main Wreckage (Courtesy of Pilot)**

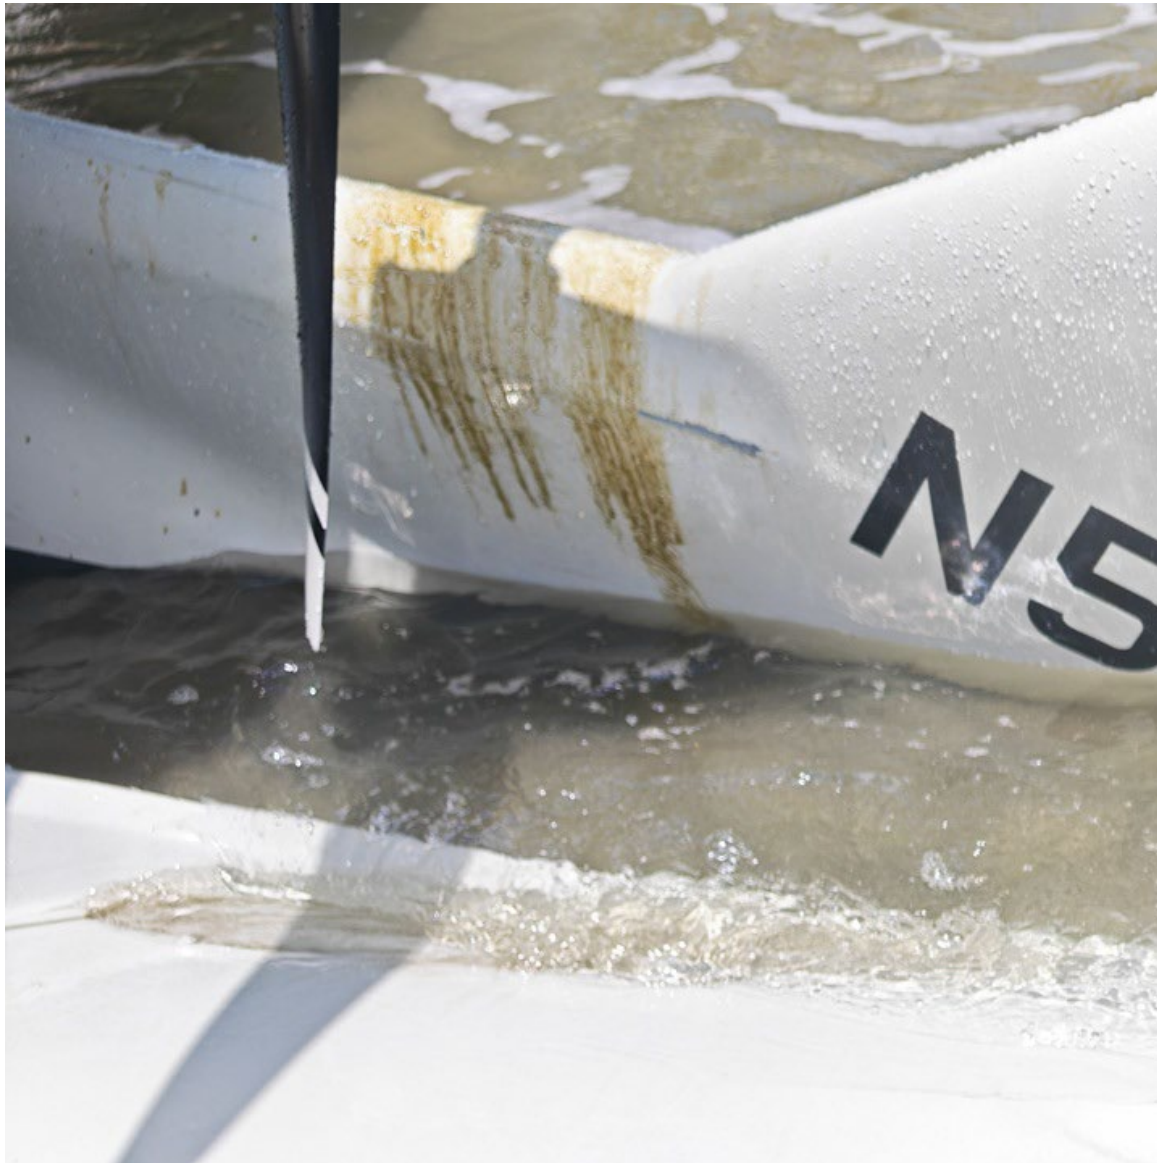
**Photograph 2 - Oil Spray (Courtesy of Pilot)**

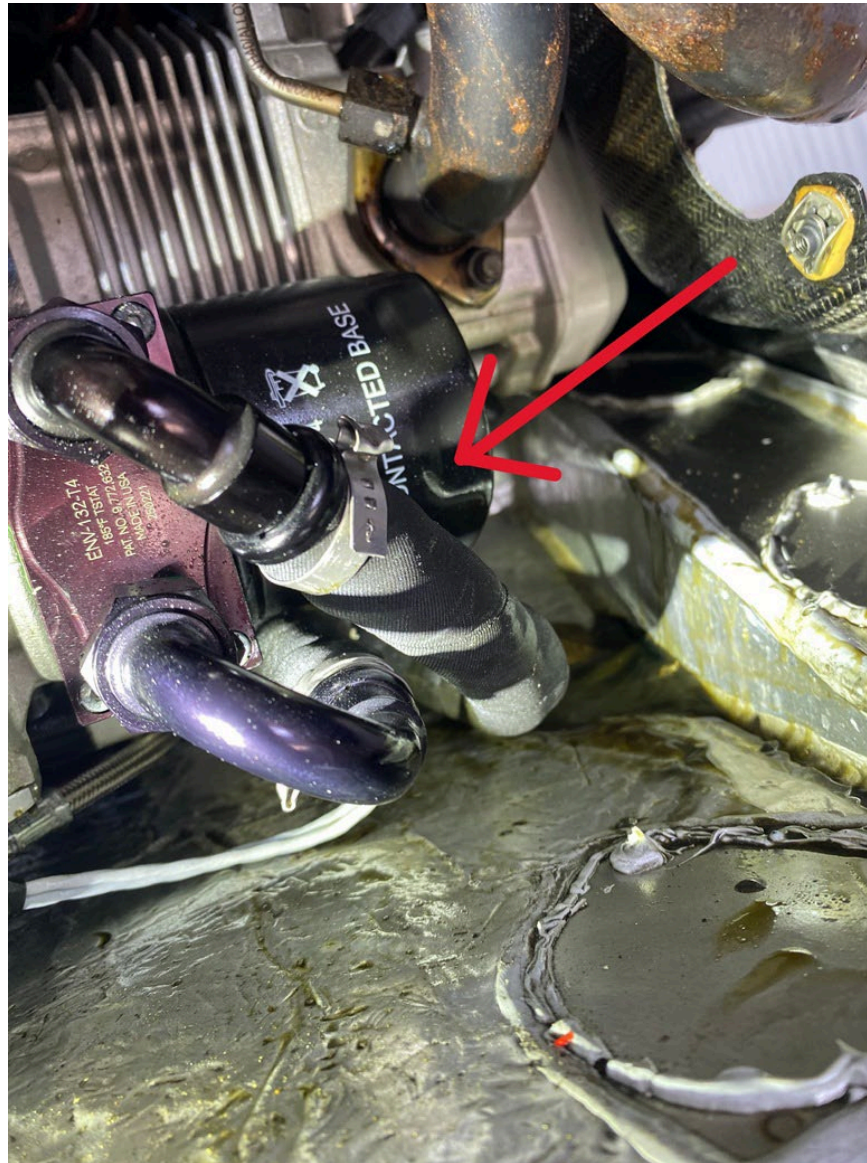
**Photograph 3 - Oil Line Attached With Clamp at Oil Pump Fitting (Courtesy of FAA)**

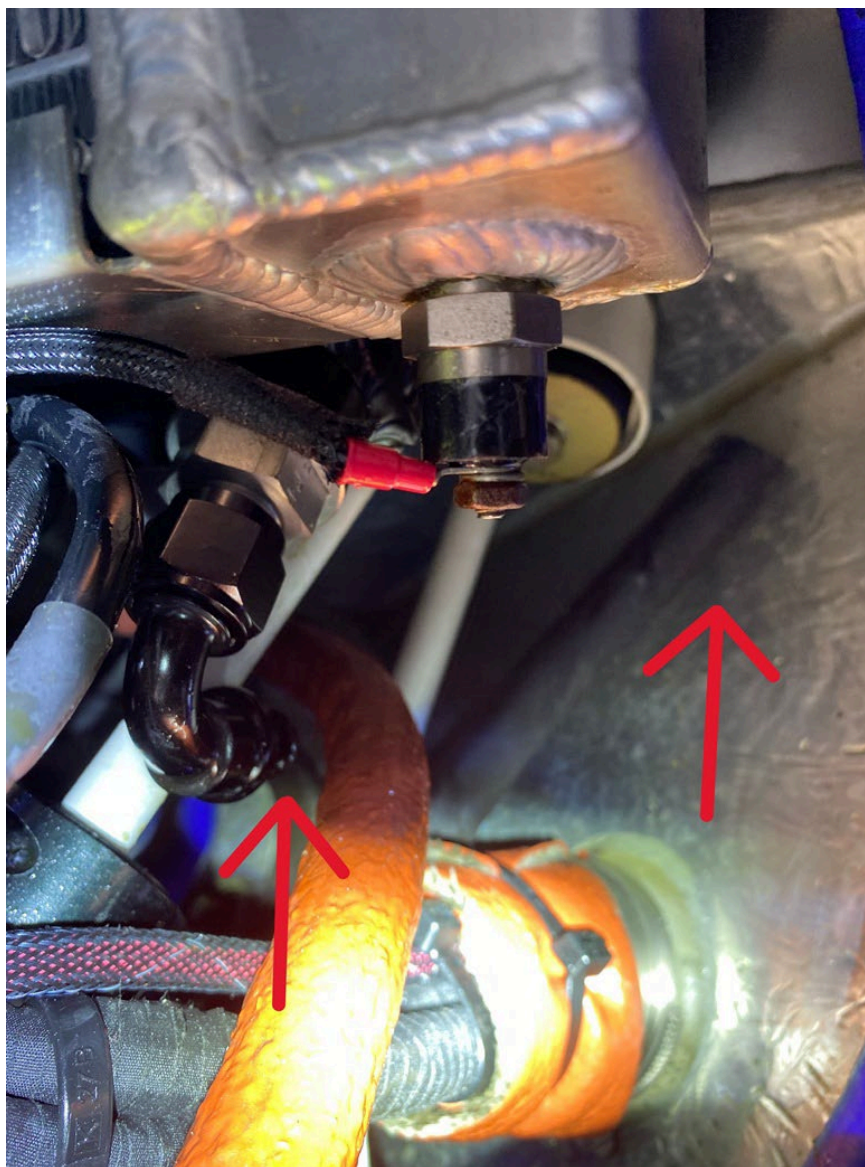
**Photograph 4 - Separated Oil Line And Oil Cooler Fitting (Courtesy of FAA)**

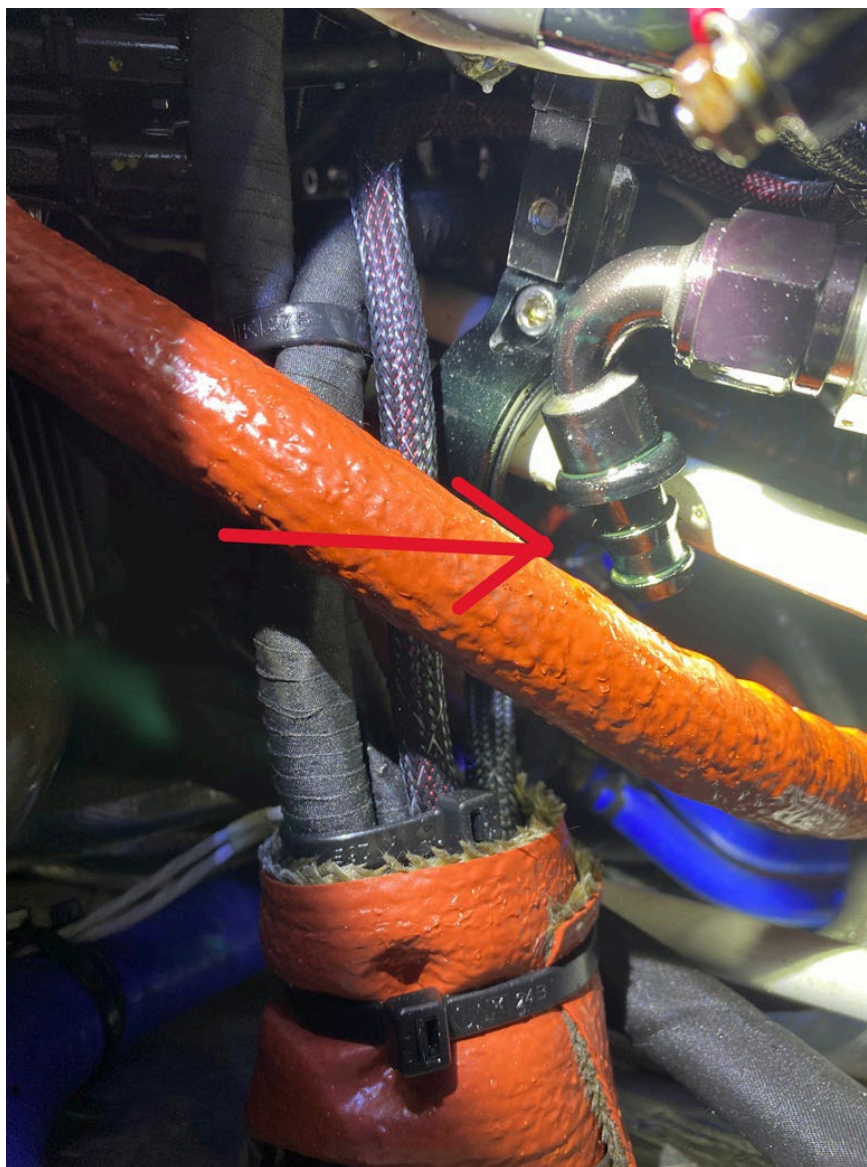
**Photograph 5 - Close-up of Oil Cooler Fitting (Courtesy of FAA)**
