ERA26LA185

## INVESTIGATION PHOTOGRAPHS

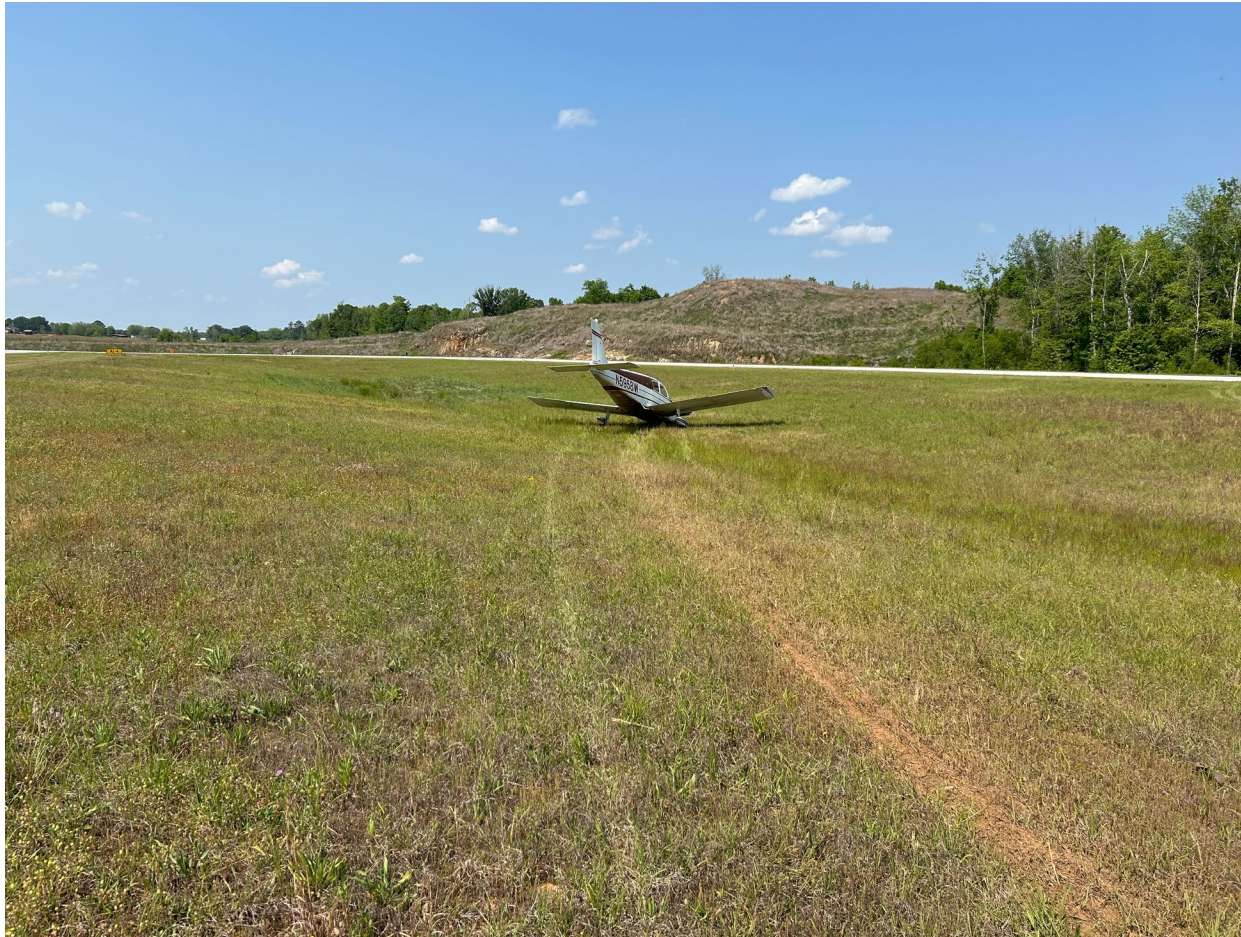
**Photograph 1 - Landing gear tracks in the ground leading up to airplane accident location.  
(Courtesy of FAA)**

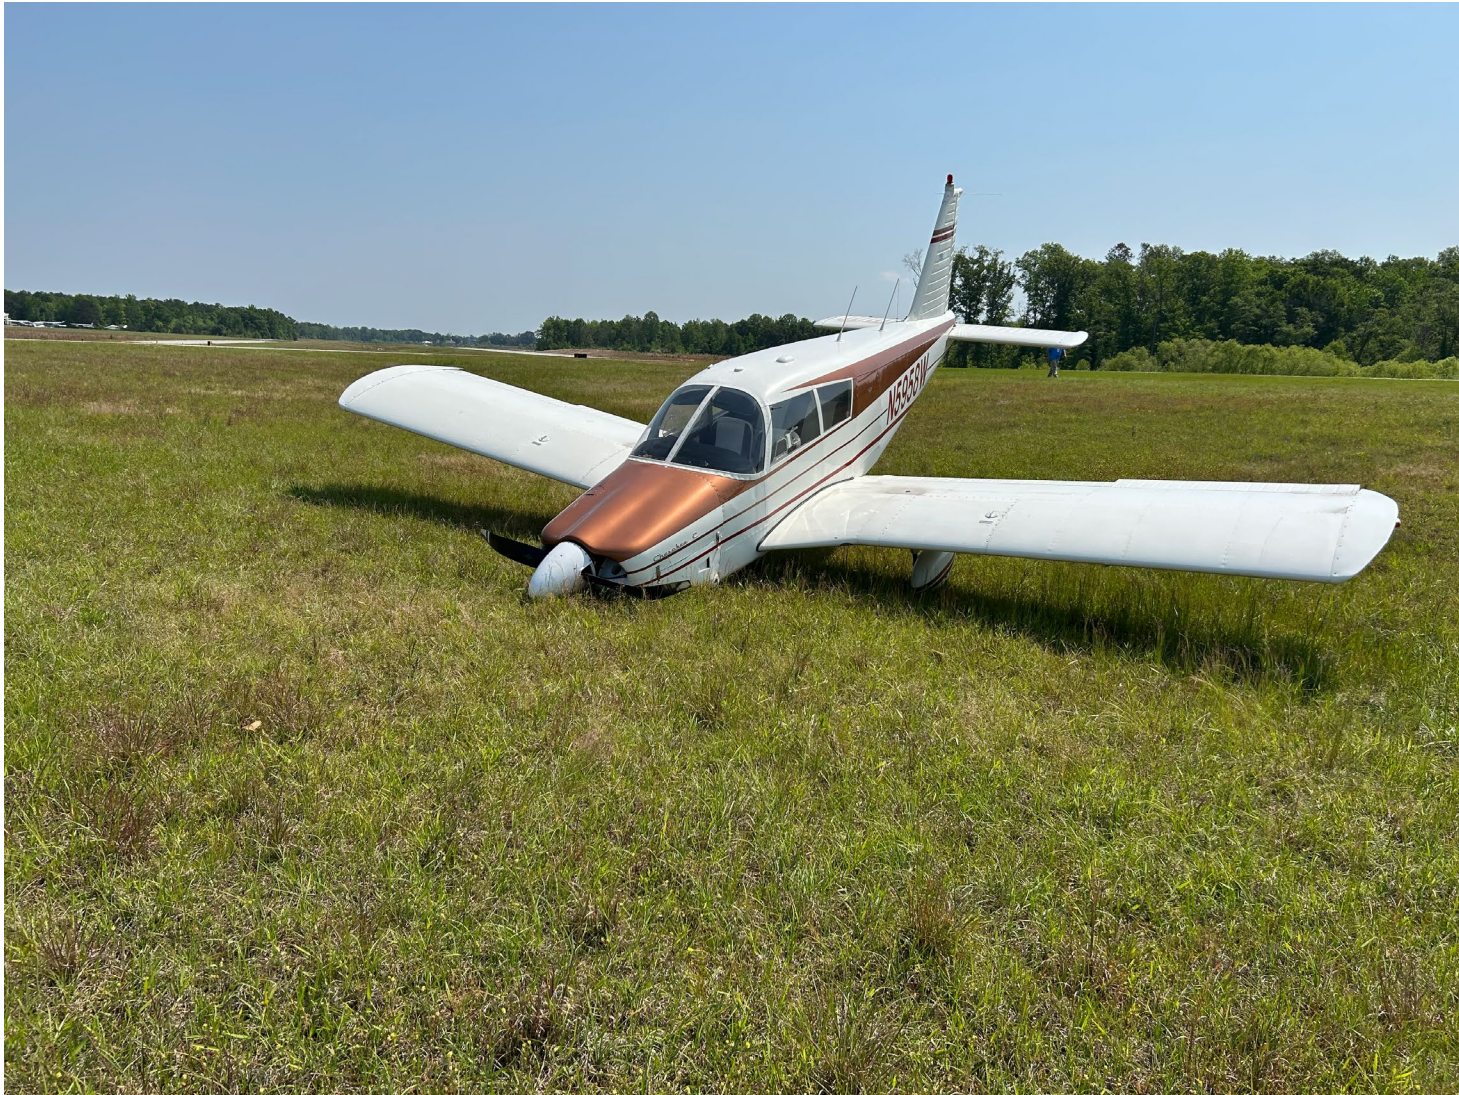
**Photograph 2 - Left front view of airplane showing collapsed nose gear. (Courtesy of FAA)**

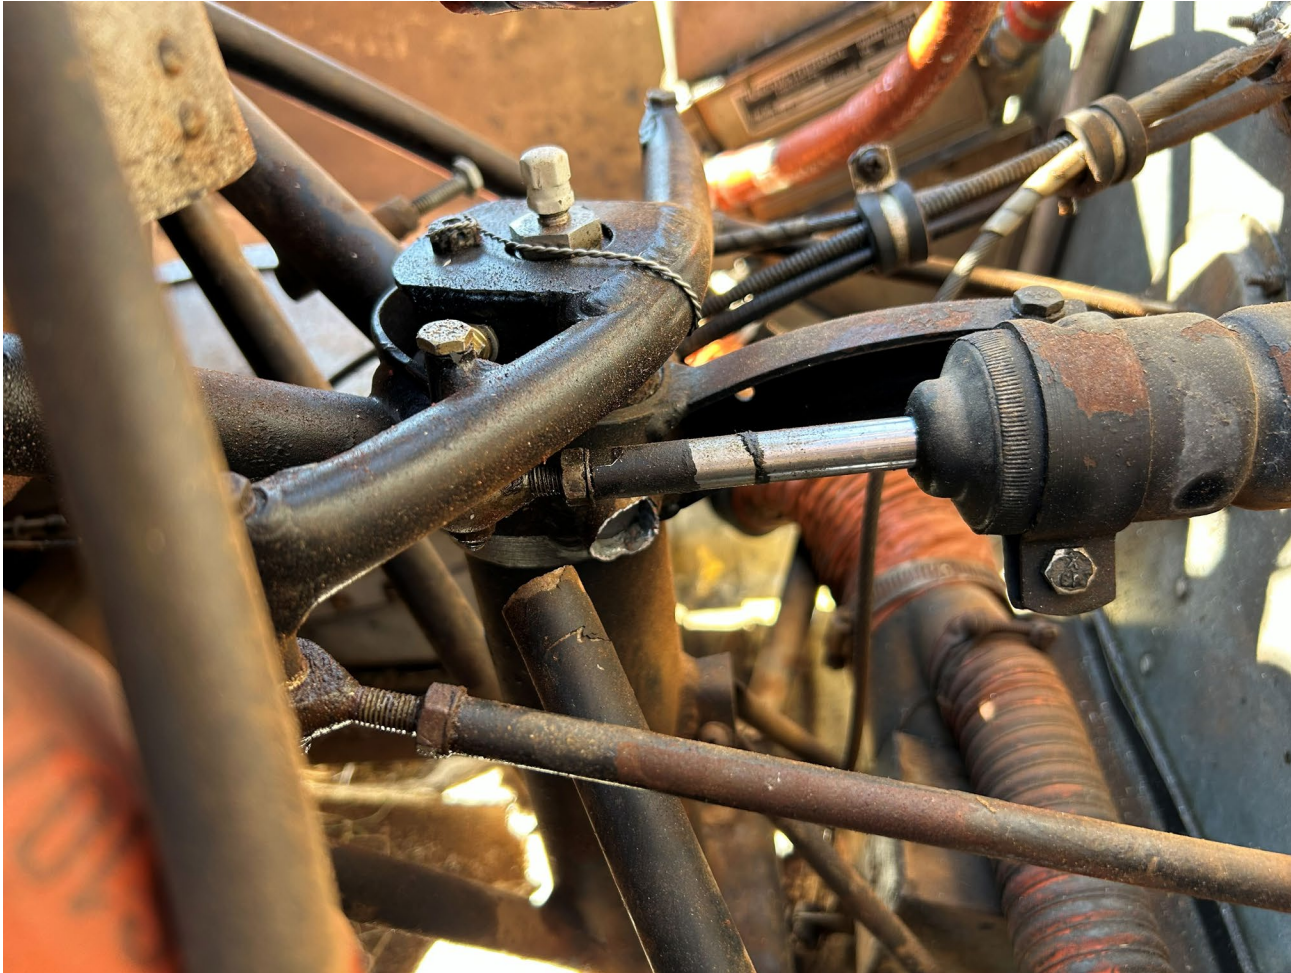
**Photograph 3 - View of broken engine mount. (Courtesy of FAA)**
