ERA26LA187

## INVESTIGATION PHOTOGRAPHS

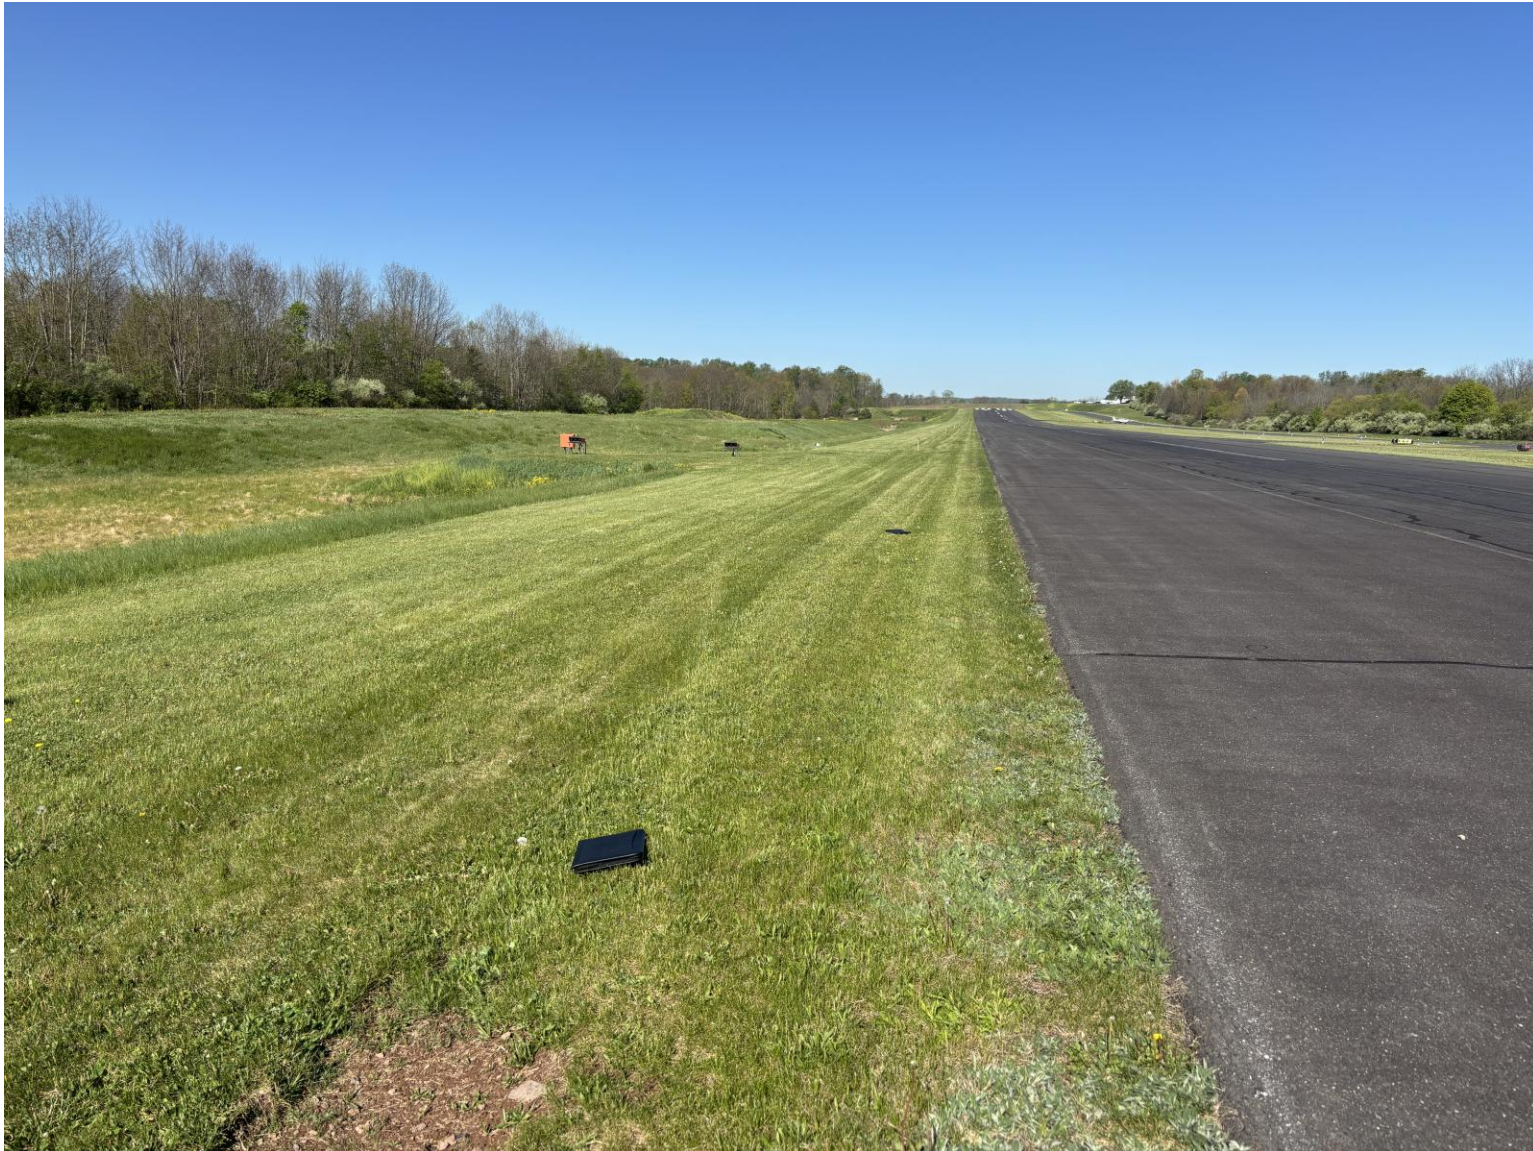
**Photograph 1 - View of tire marks approaching the PAPI lights. (Courtesy of FAA)**

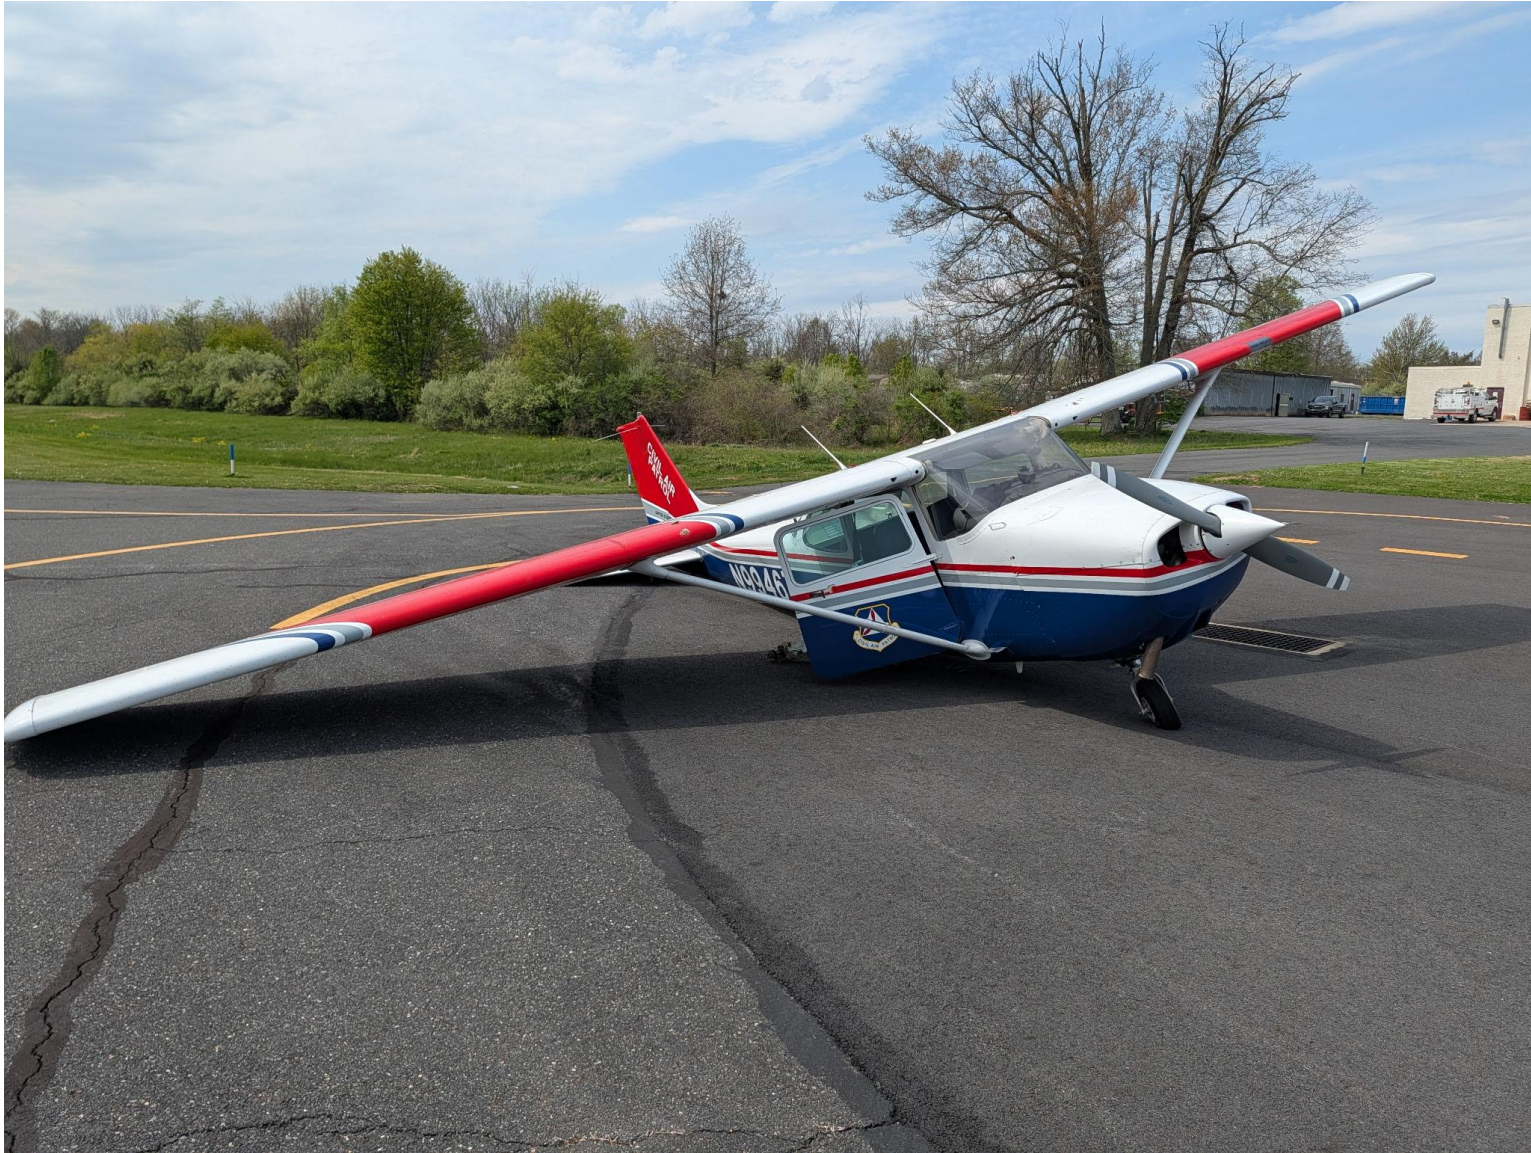
**Photograph 2 - Overview of the accident airplane. (Courtesy of FAA)**

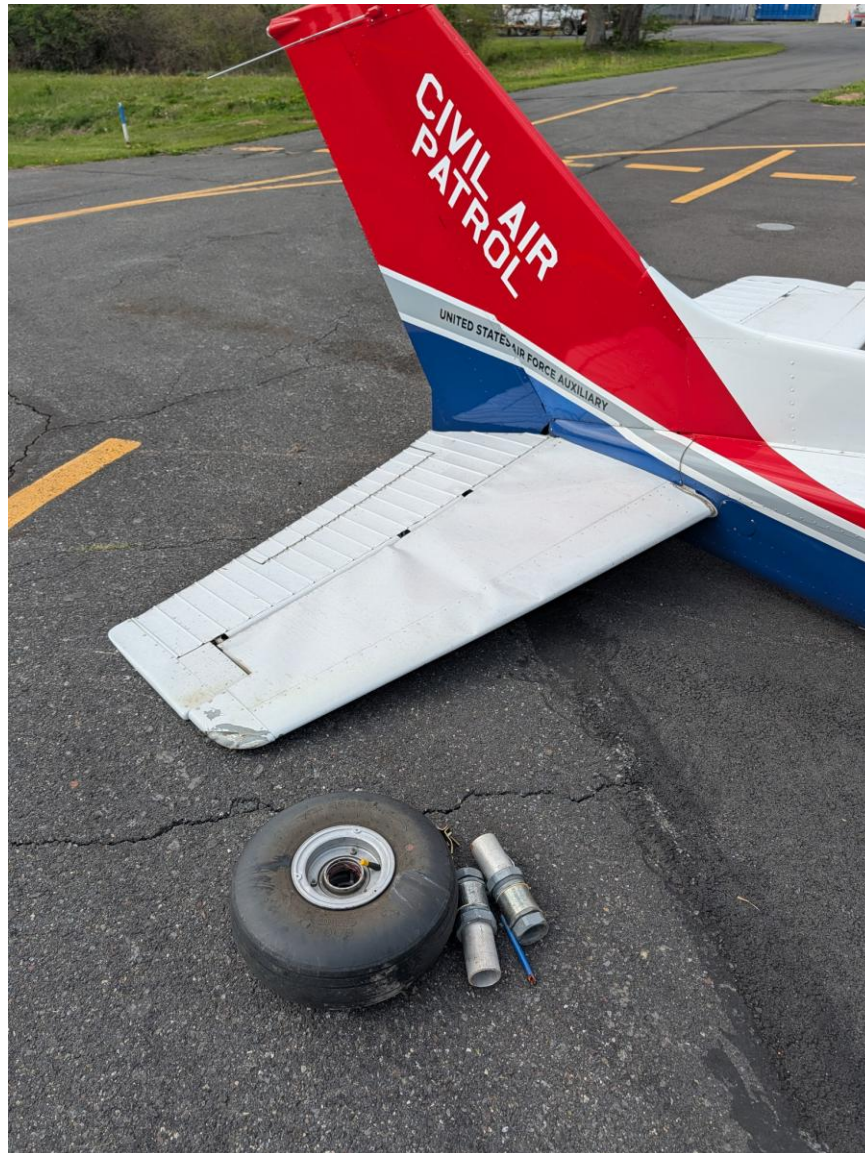
**Photograph 3 - View of damage to the right horizontal stabilizer. (Courtesy of FAA)**
