ERA26LA201

## INVESTIGATION PHOTOGRAPHS

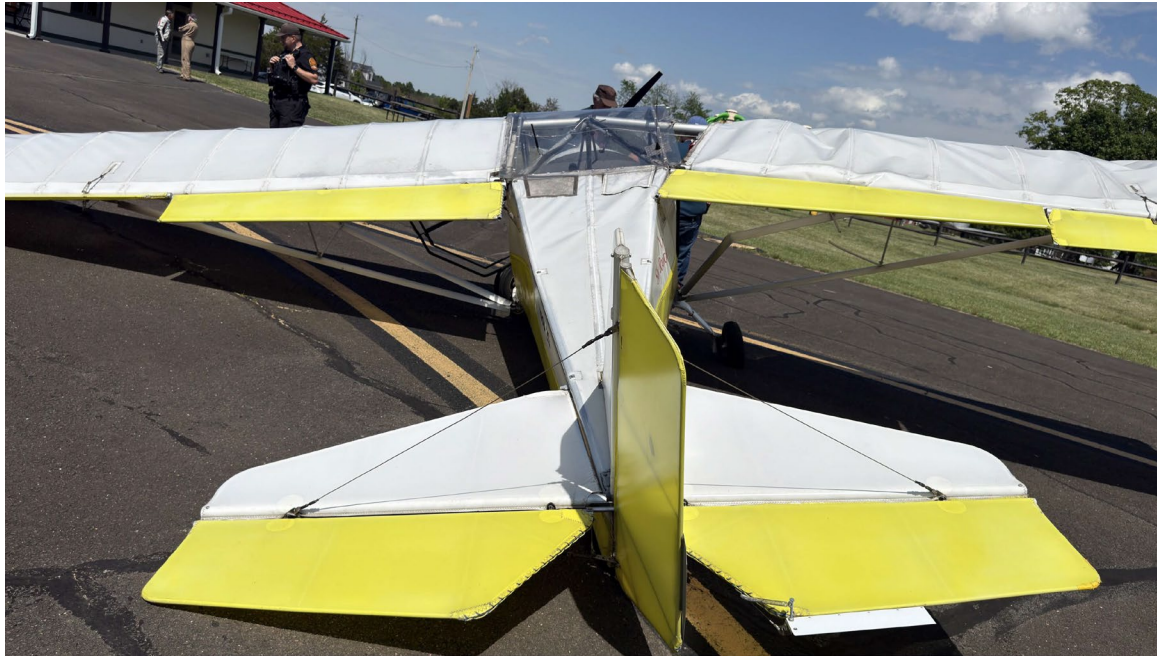
**Photograph 1 -Aft view of airplane showing damage to right wing root.  
(Courtesy of FAA)**

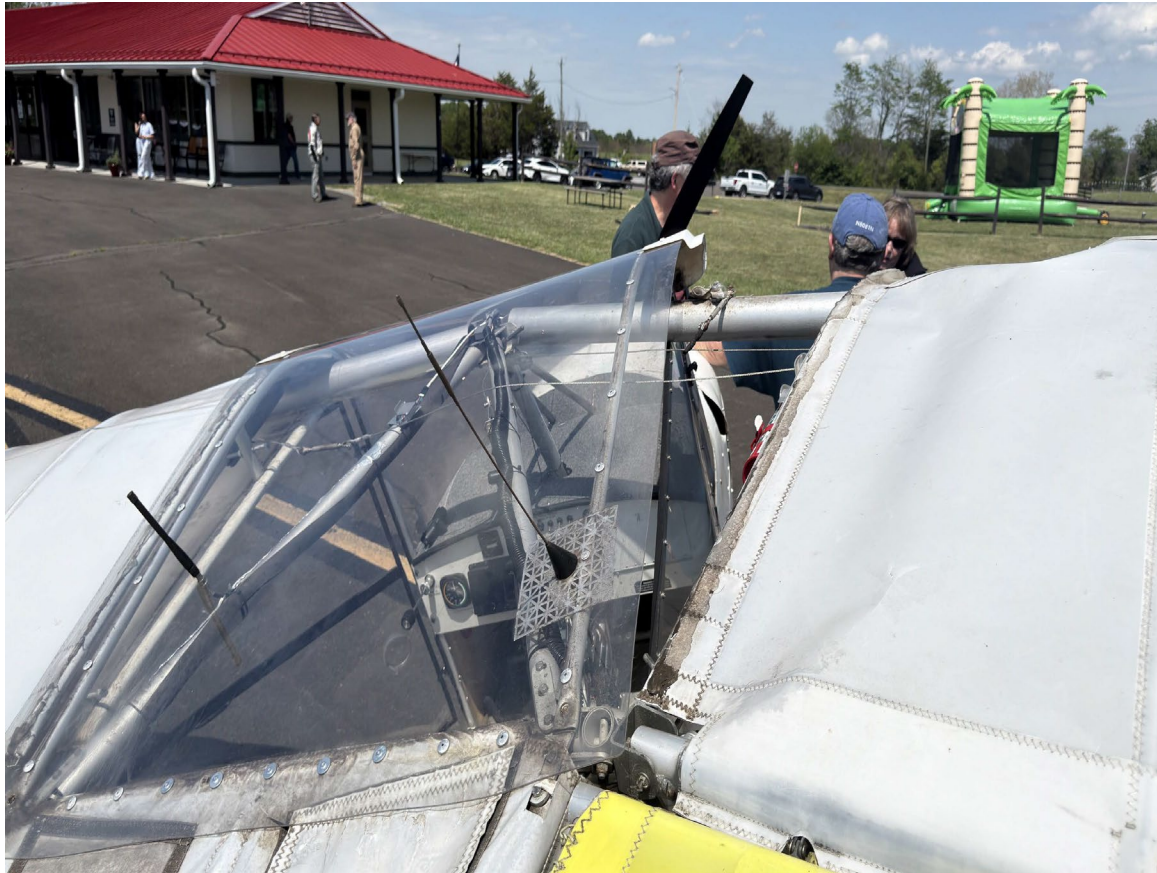
**Photograph 2 - Close up view of right damaged wing root.  
(Courtesy of FAA)**

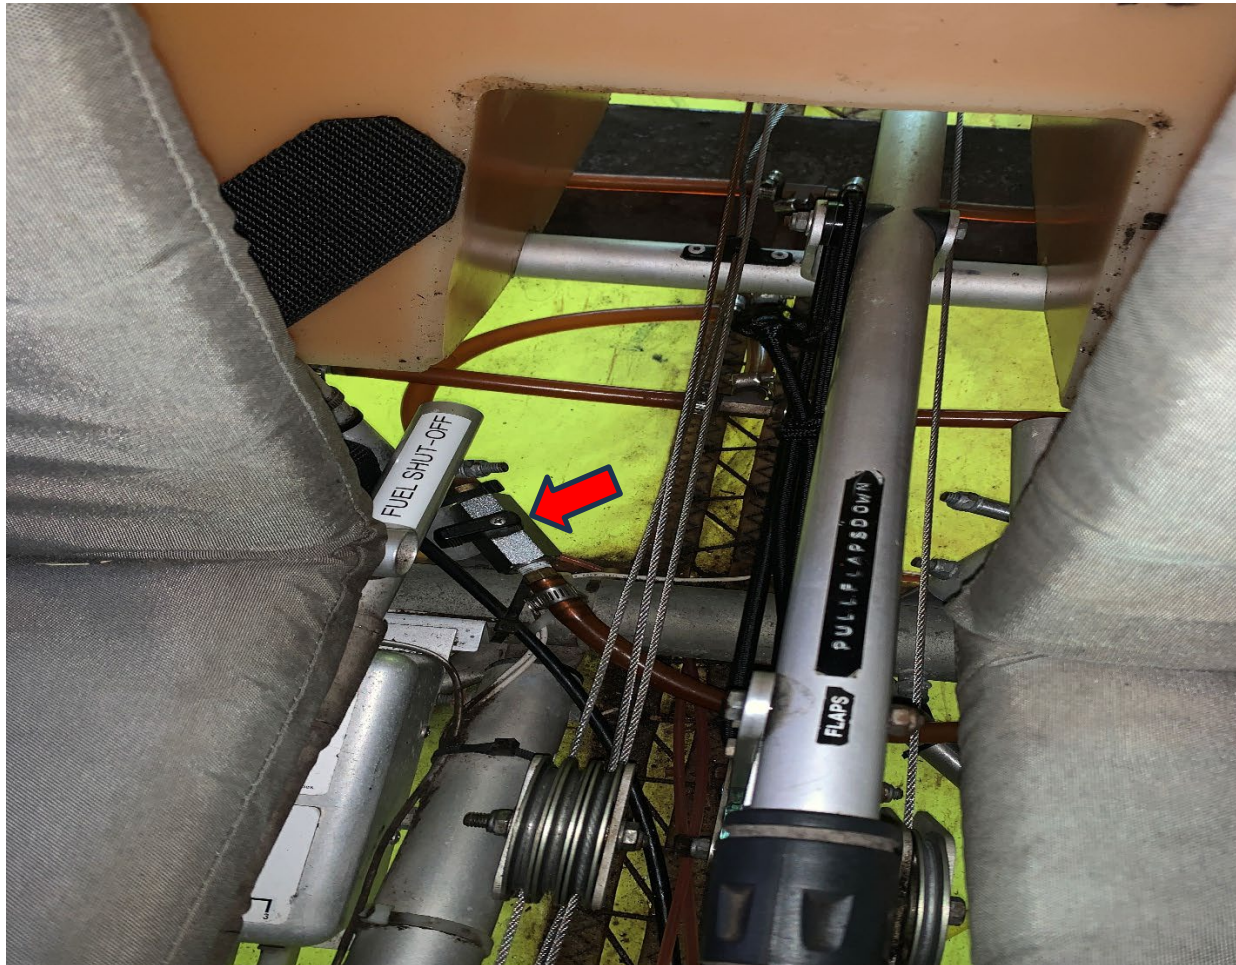
**Photograph 3 - View of fuel selector behind seat in the off position.  
Shown with a red arrow pointing to it.  
(Courtesy of FAA)**
