ERA26LA228

## INVESTIGATION PHOTOGRAPHS

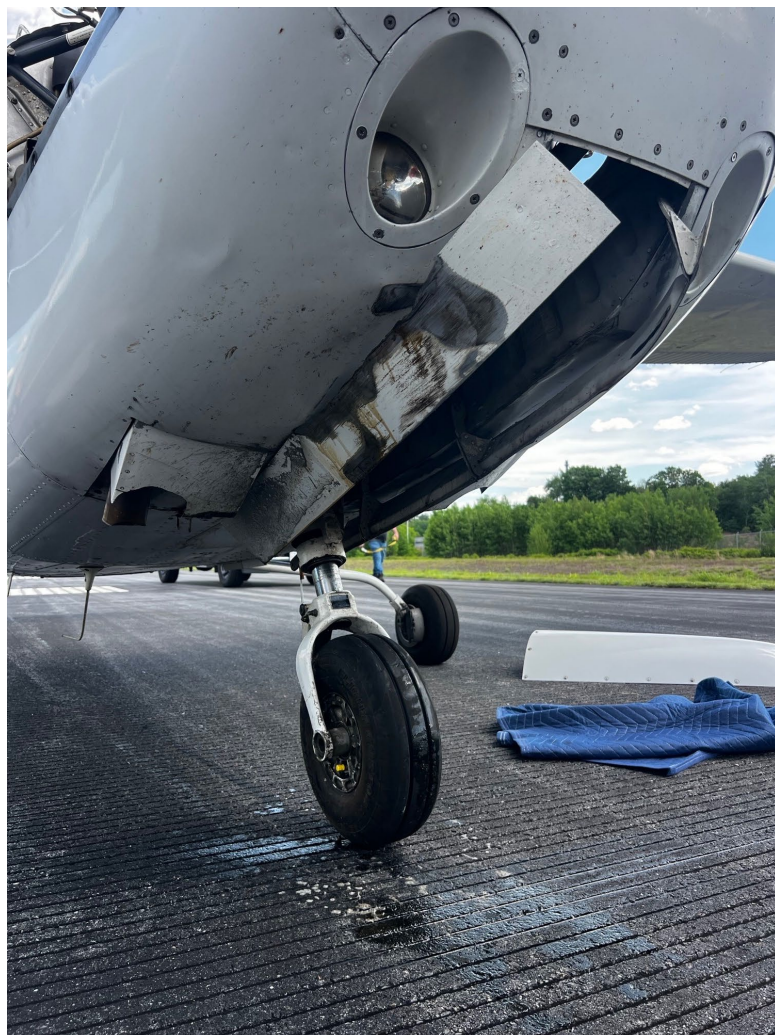
**Photograph 1 - Nose landing gear and lower forward fuselage damage (Courtesy of FAA)**

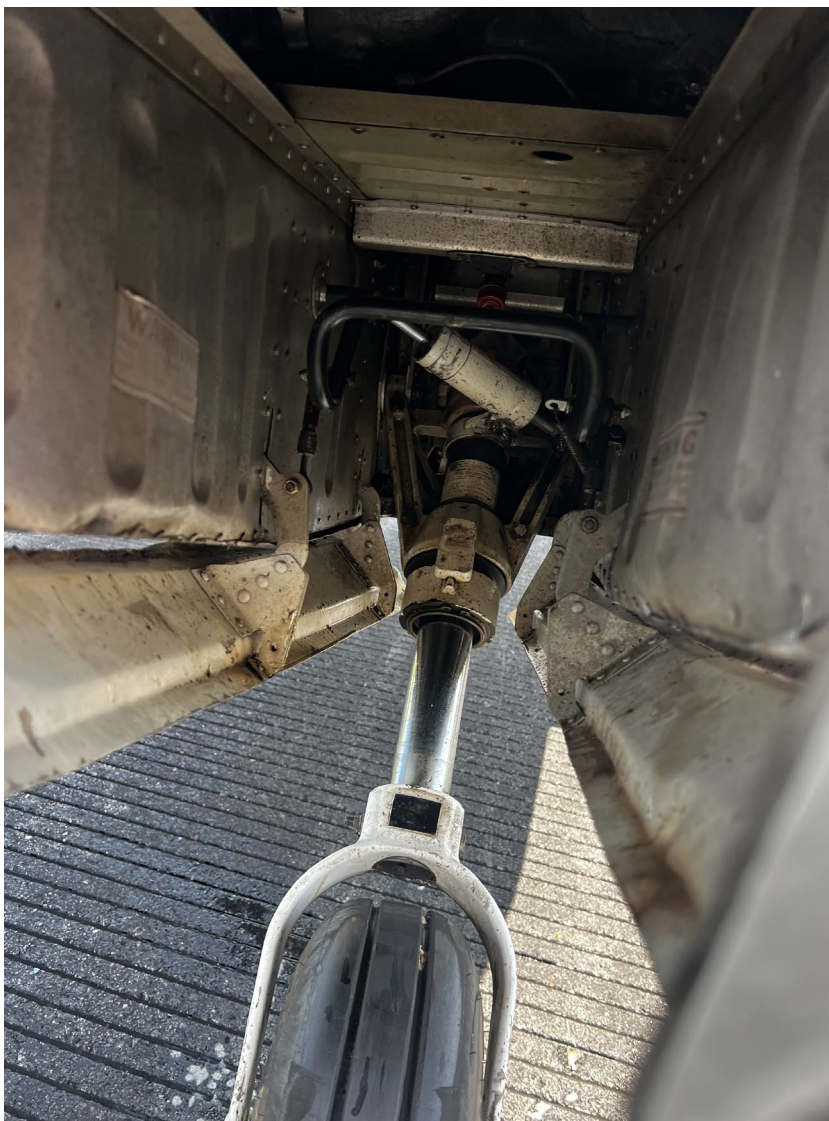
**Photograph 2 - NLG tunnel damage (Courtesy of FAA)**

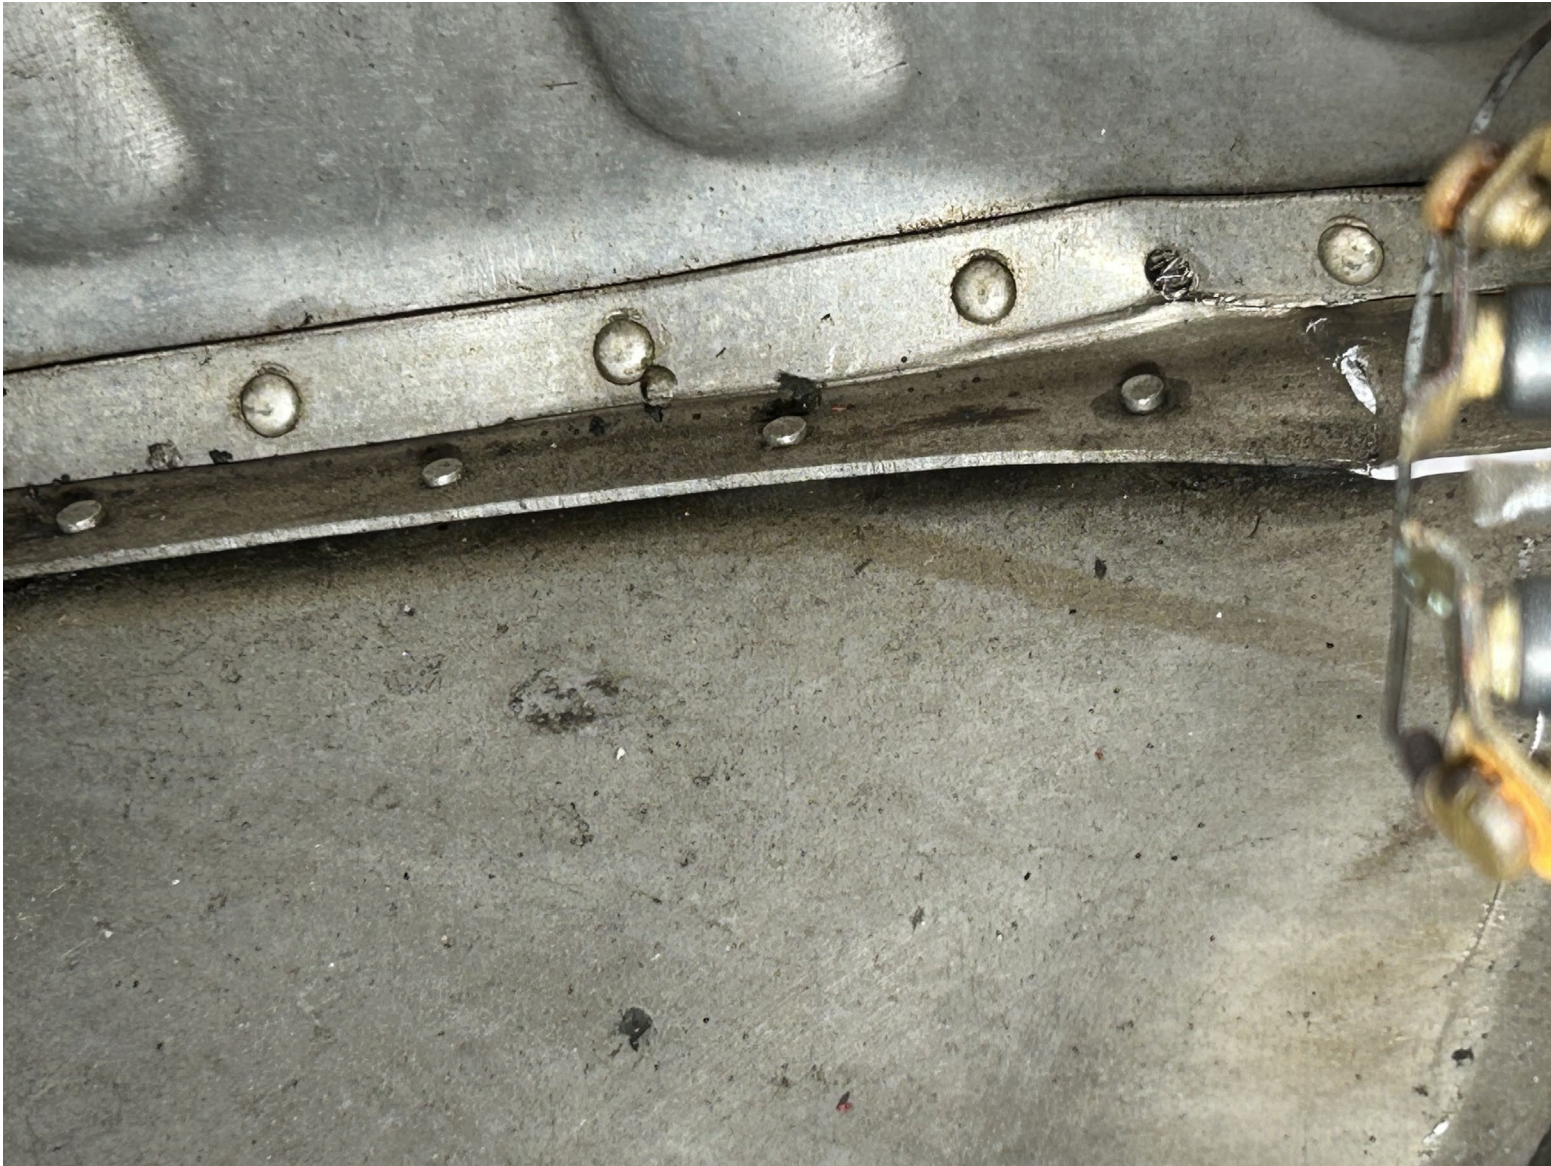
**Photograph 3 - Forward fuselage structure damage (Courtesy of FAA)**
