ERA26LA237

## INVESTIGATION PHOTOGRAPHS

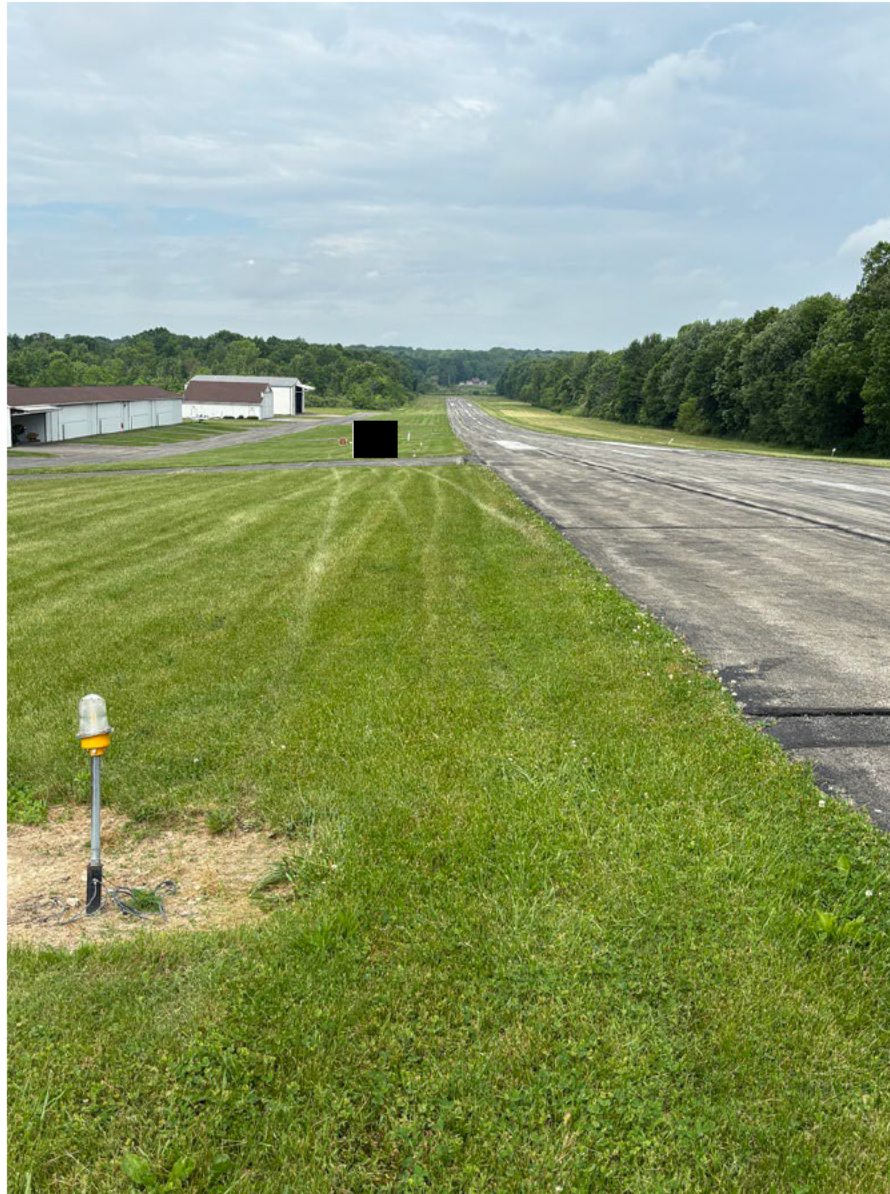
**Photograph 1 - Main Landing Gear Impressions Off Left Side of Runway (Courtesy of FAA)**

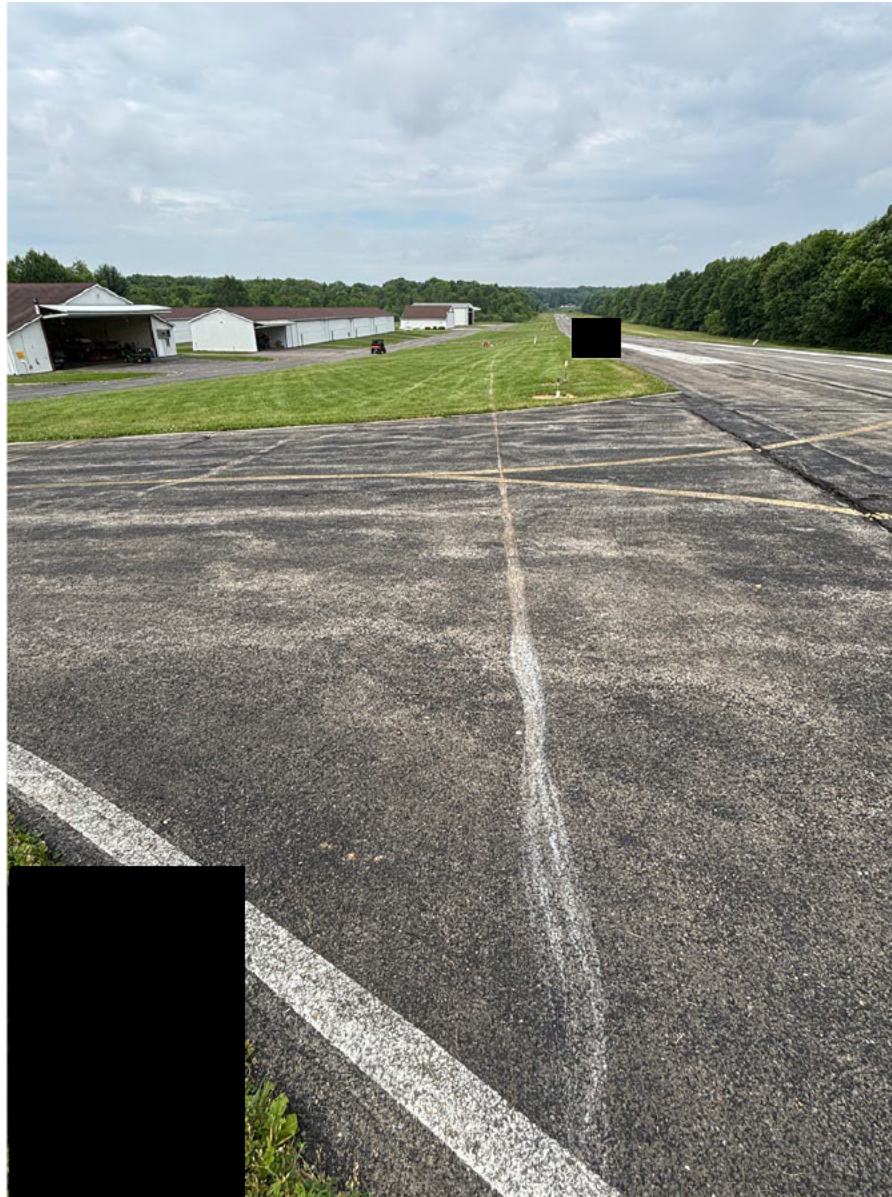
**Photograph 2 - Right Main Landing Gear Fairing Scrape Across Taxiway**

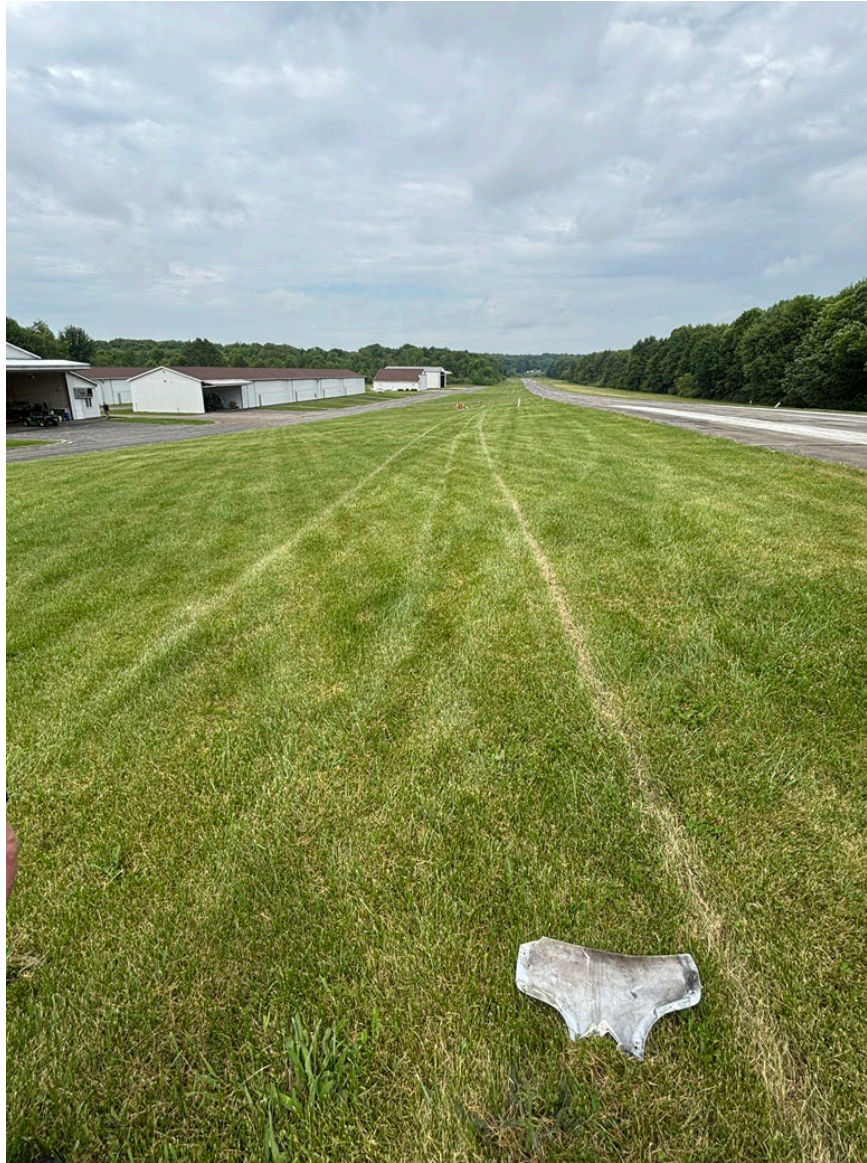
**Photograph 3 - Right Main Landing Gear Separated Fairing (Courtesy of FAA)**

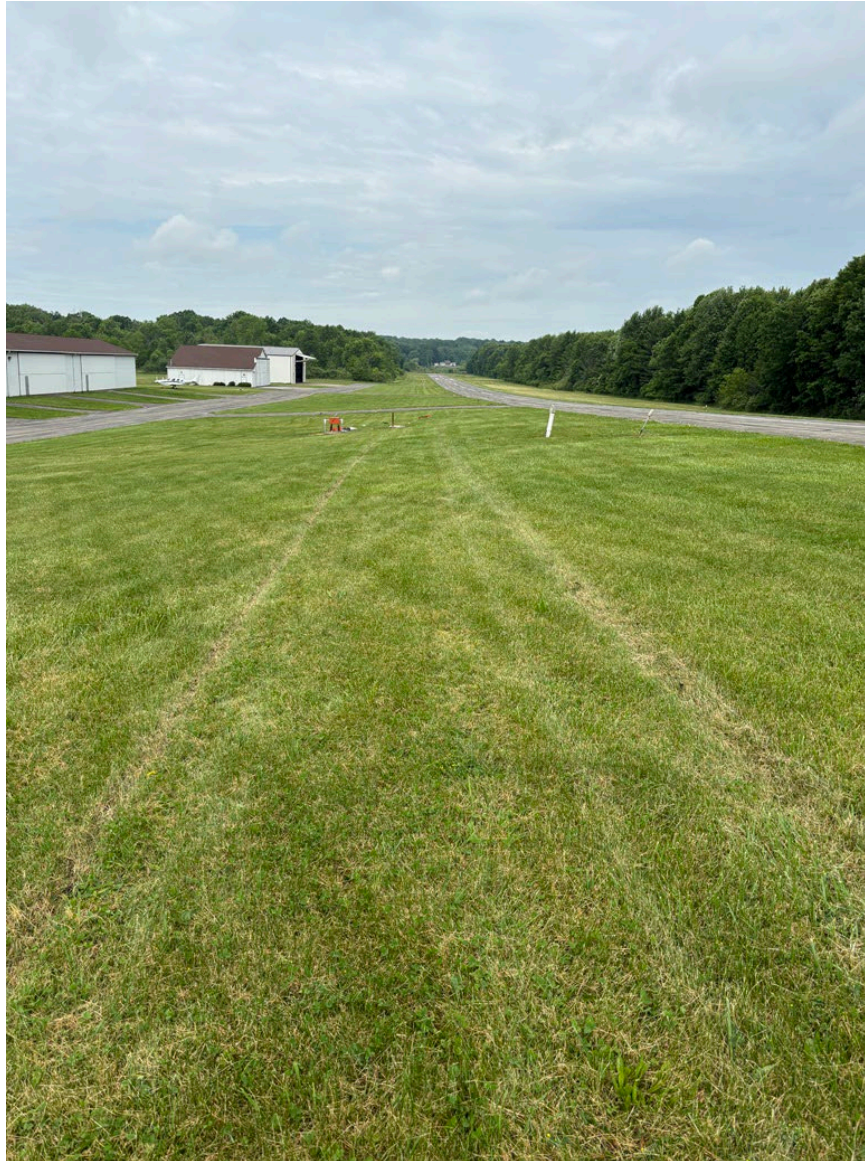
**Photograph 4 - Landing Gear Grass Impressions Toward VASI Light (Courtesy of FAA)**

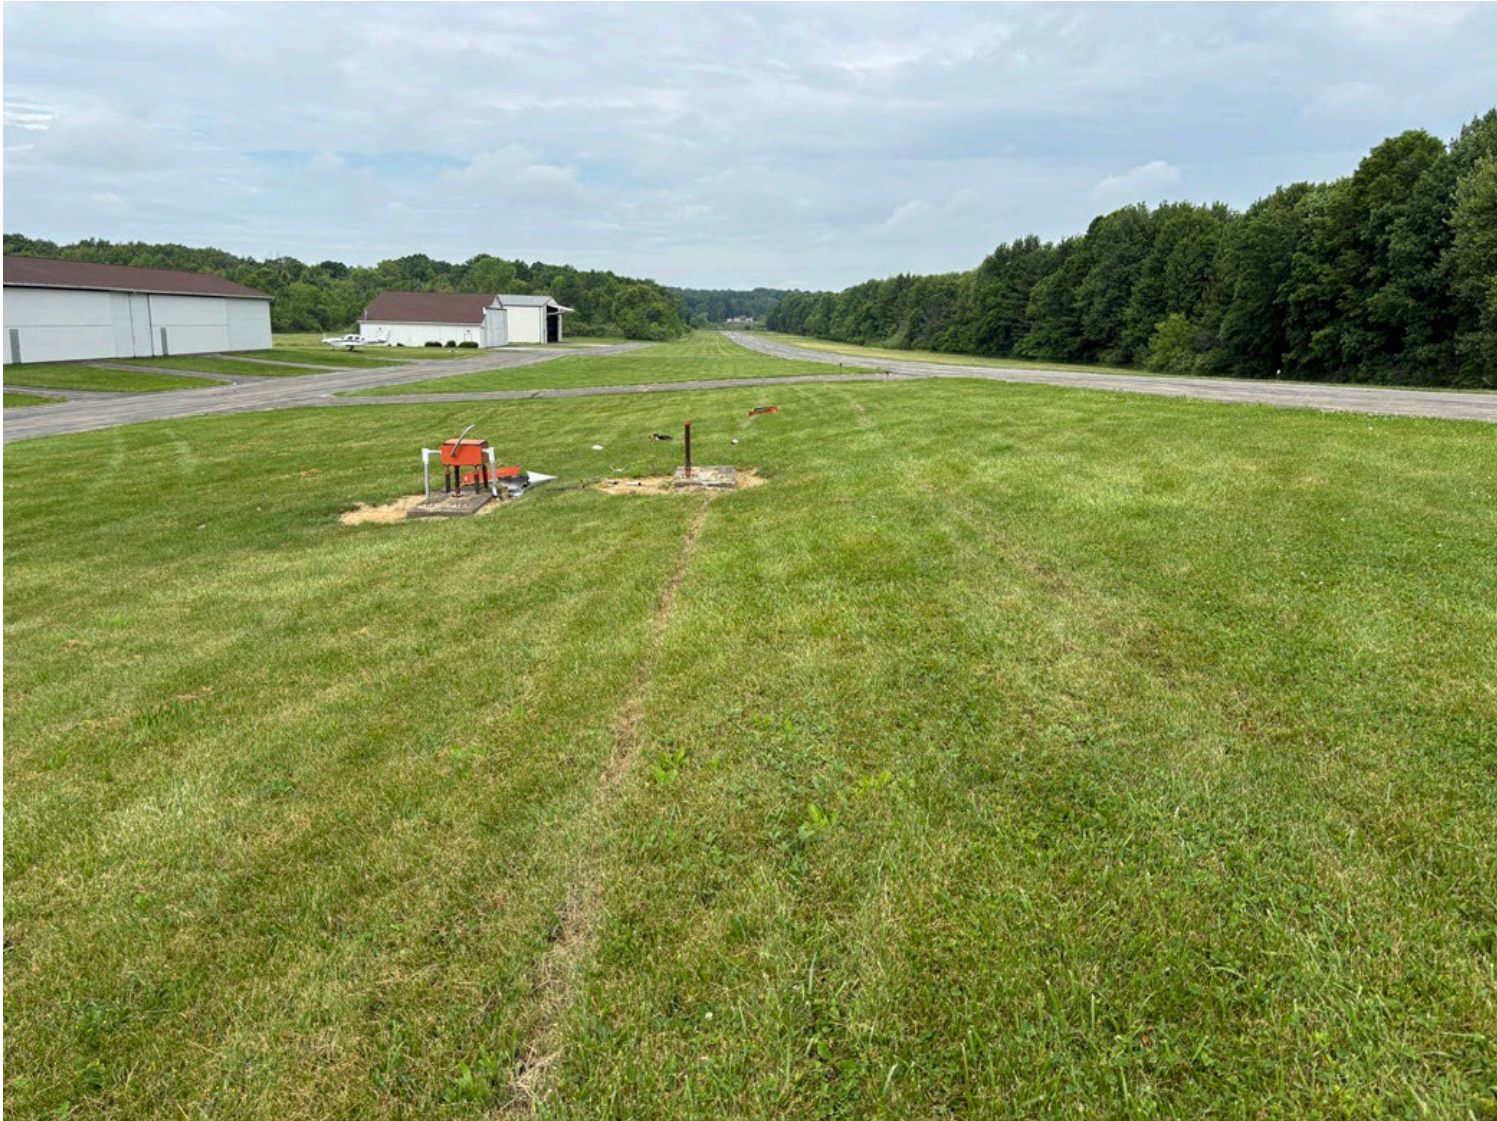
**Photograph 5 - Left Main Landing Gear Grass Impression Toward VASI Light (Courtesy of FAA)**

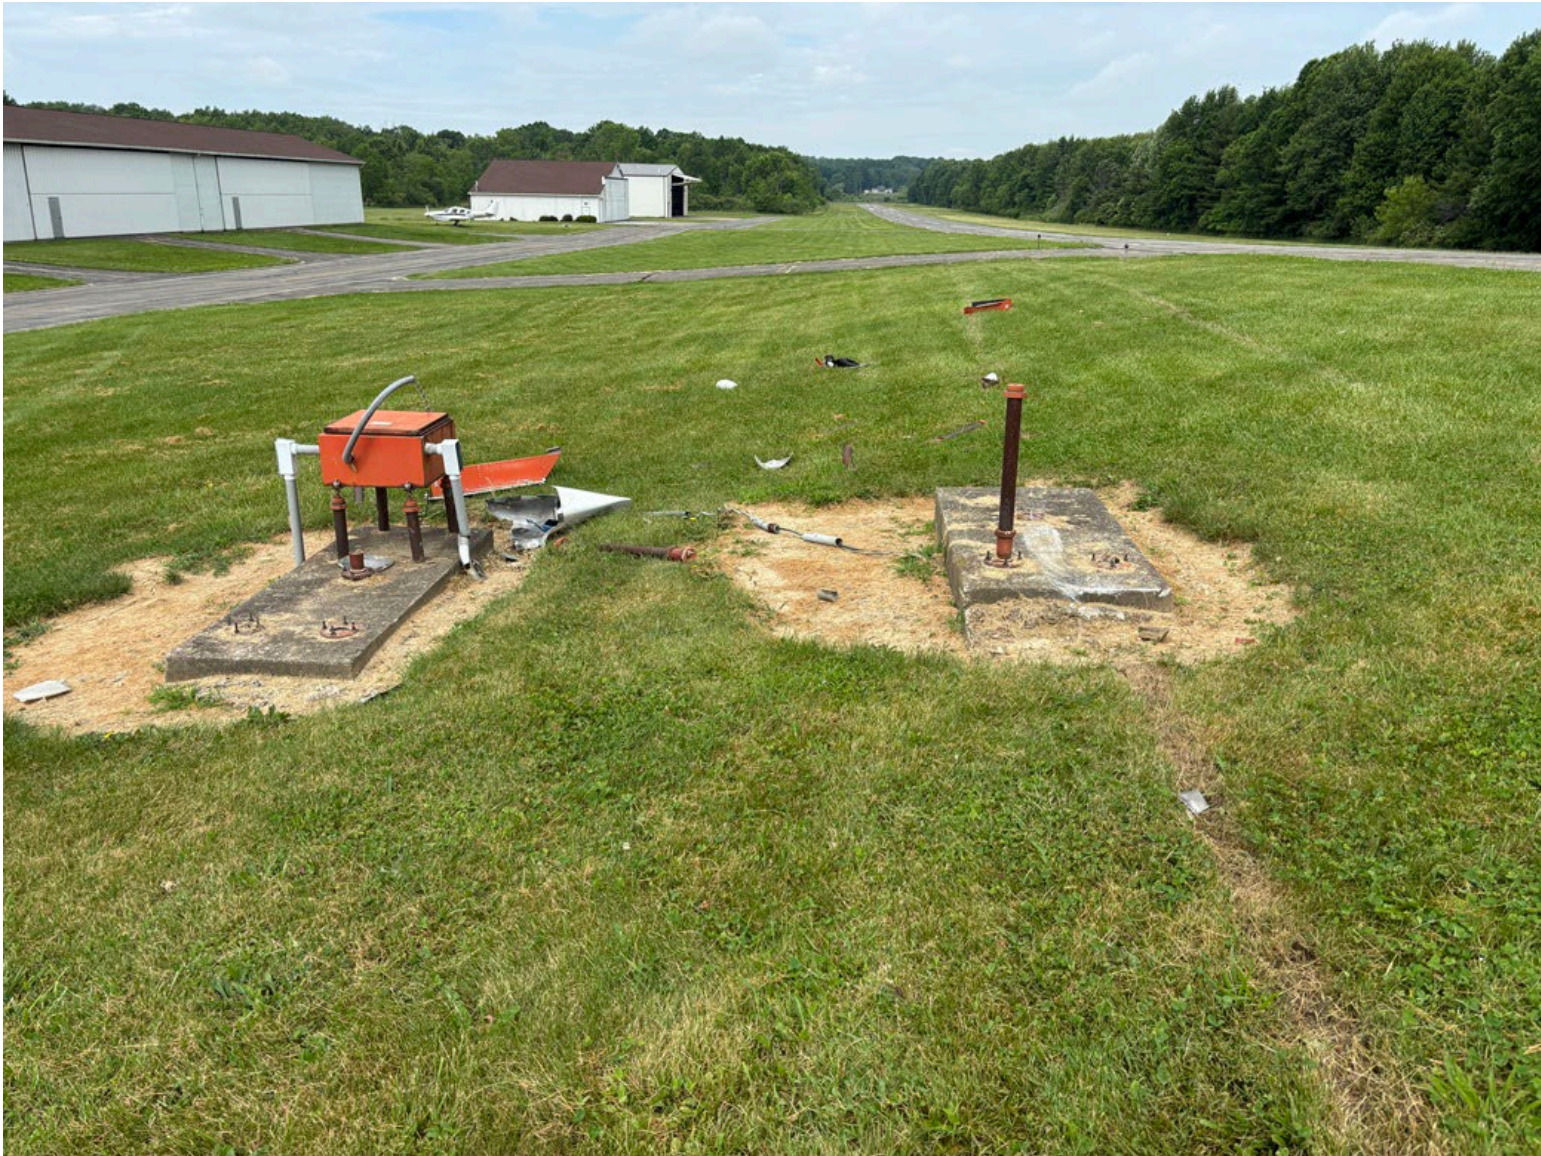
**Photograph 6 - Left Main Landing Grass Impression And Contact With VASI Light (Courtesy of FAA)**

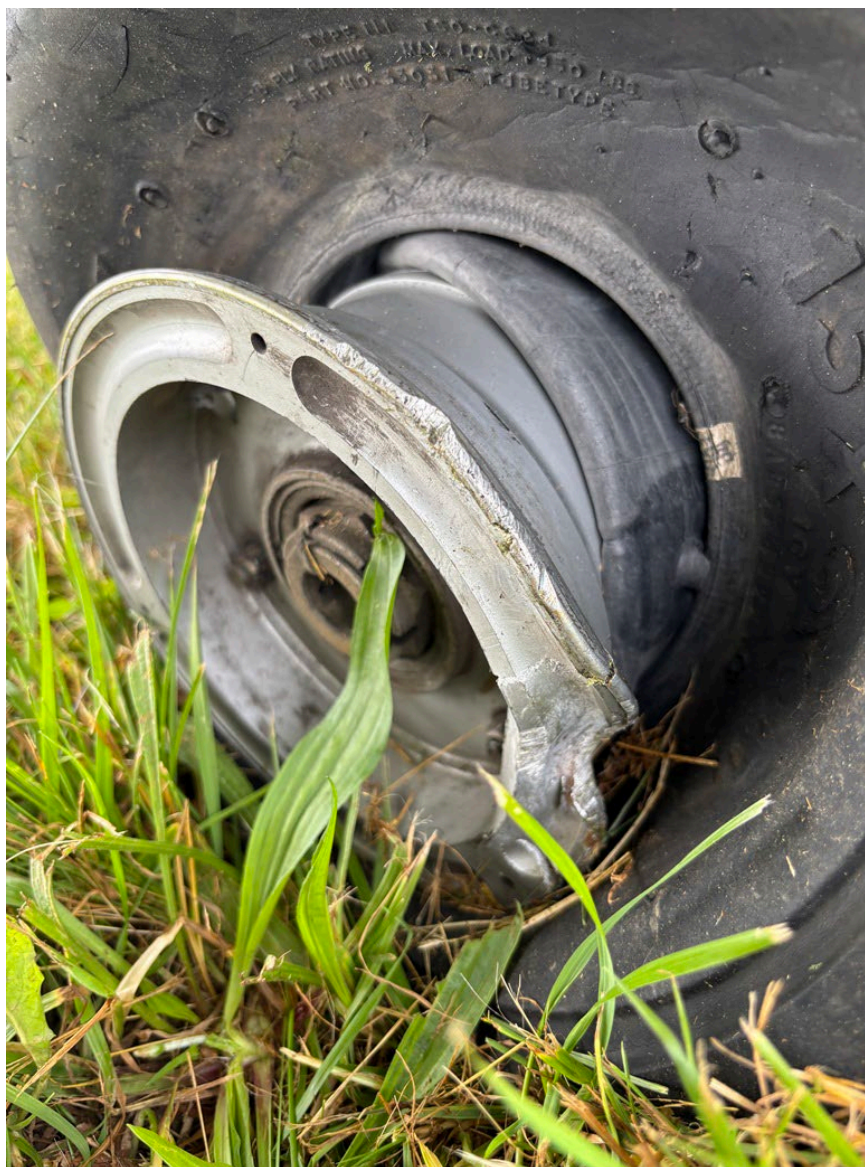
**Photograph 7 - Left Main Landing Gear Rim Damage And Deflated Tire (Courtesy of FAA)**

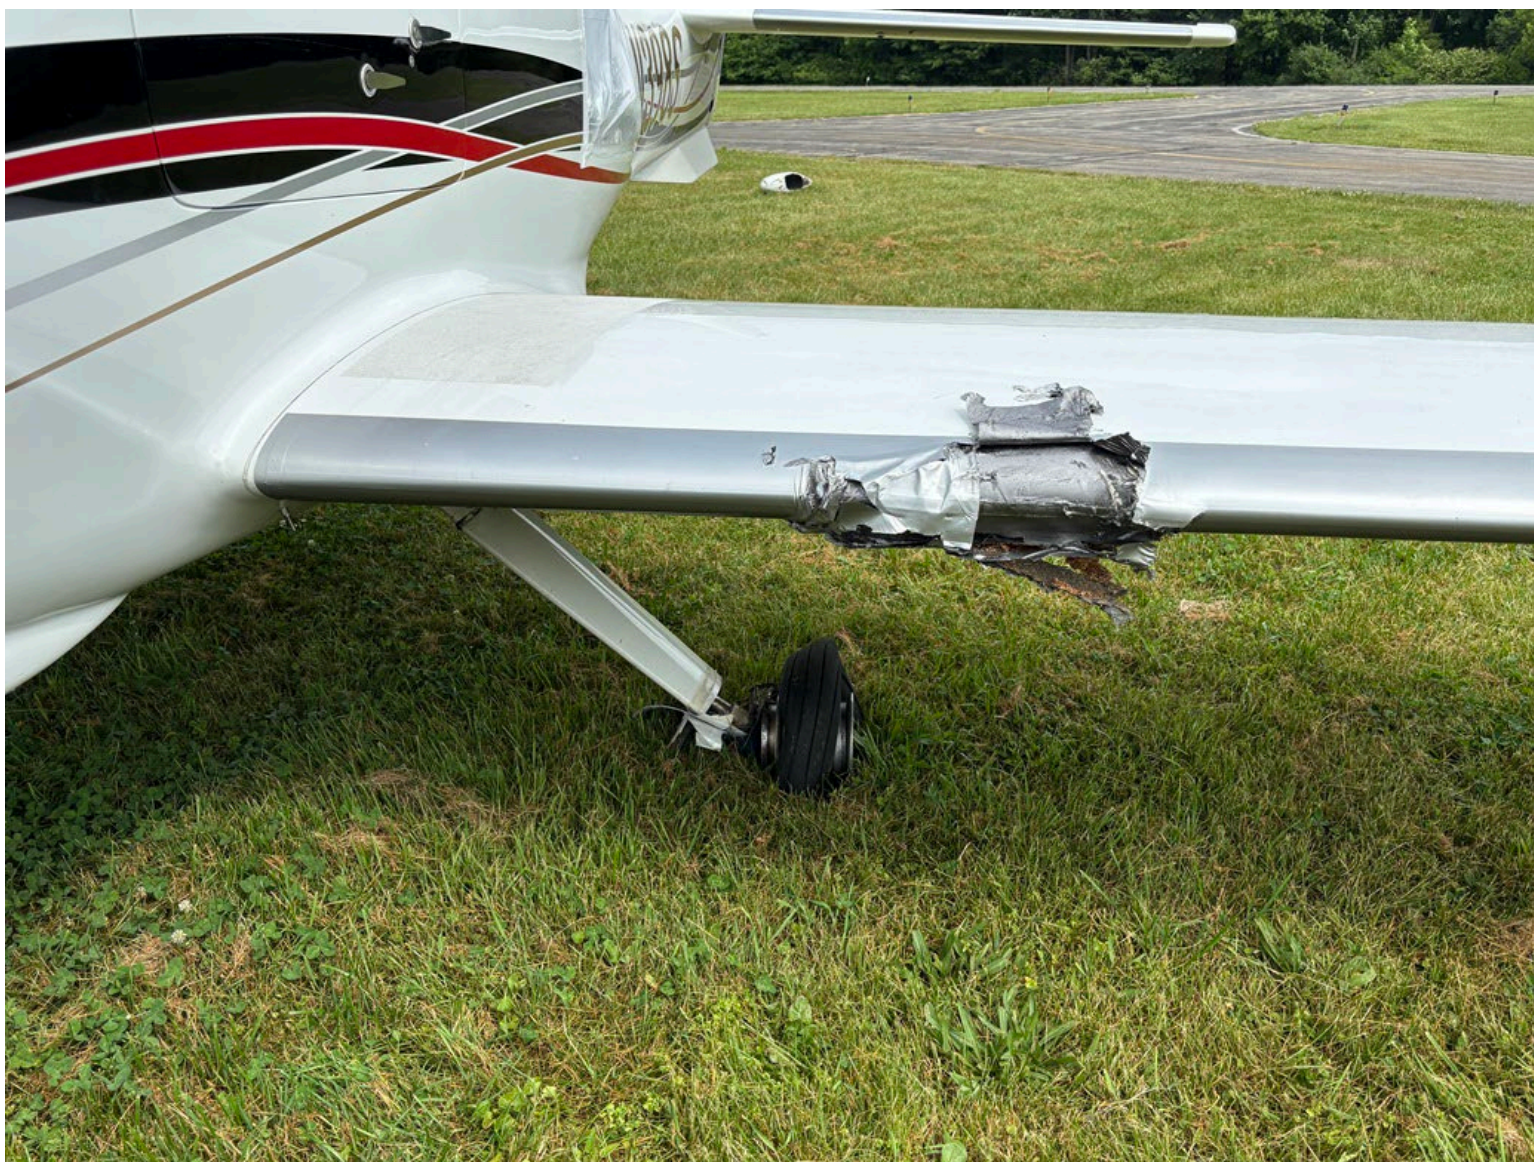
**Photograph 8 - Composite Left Wing Damage (Courtesy of FAA)**

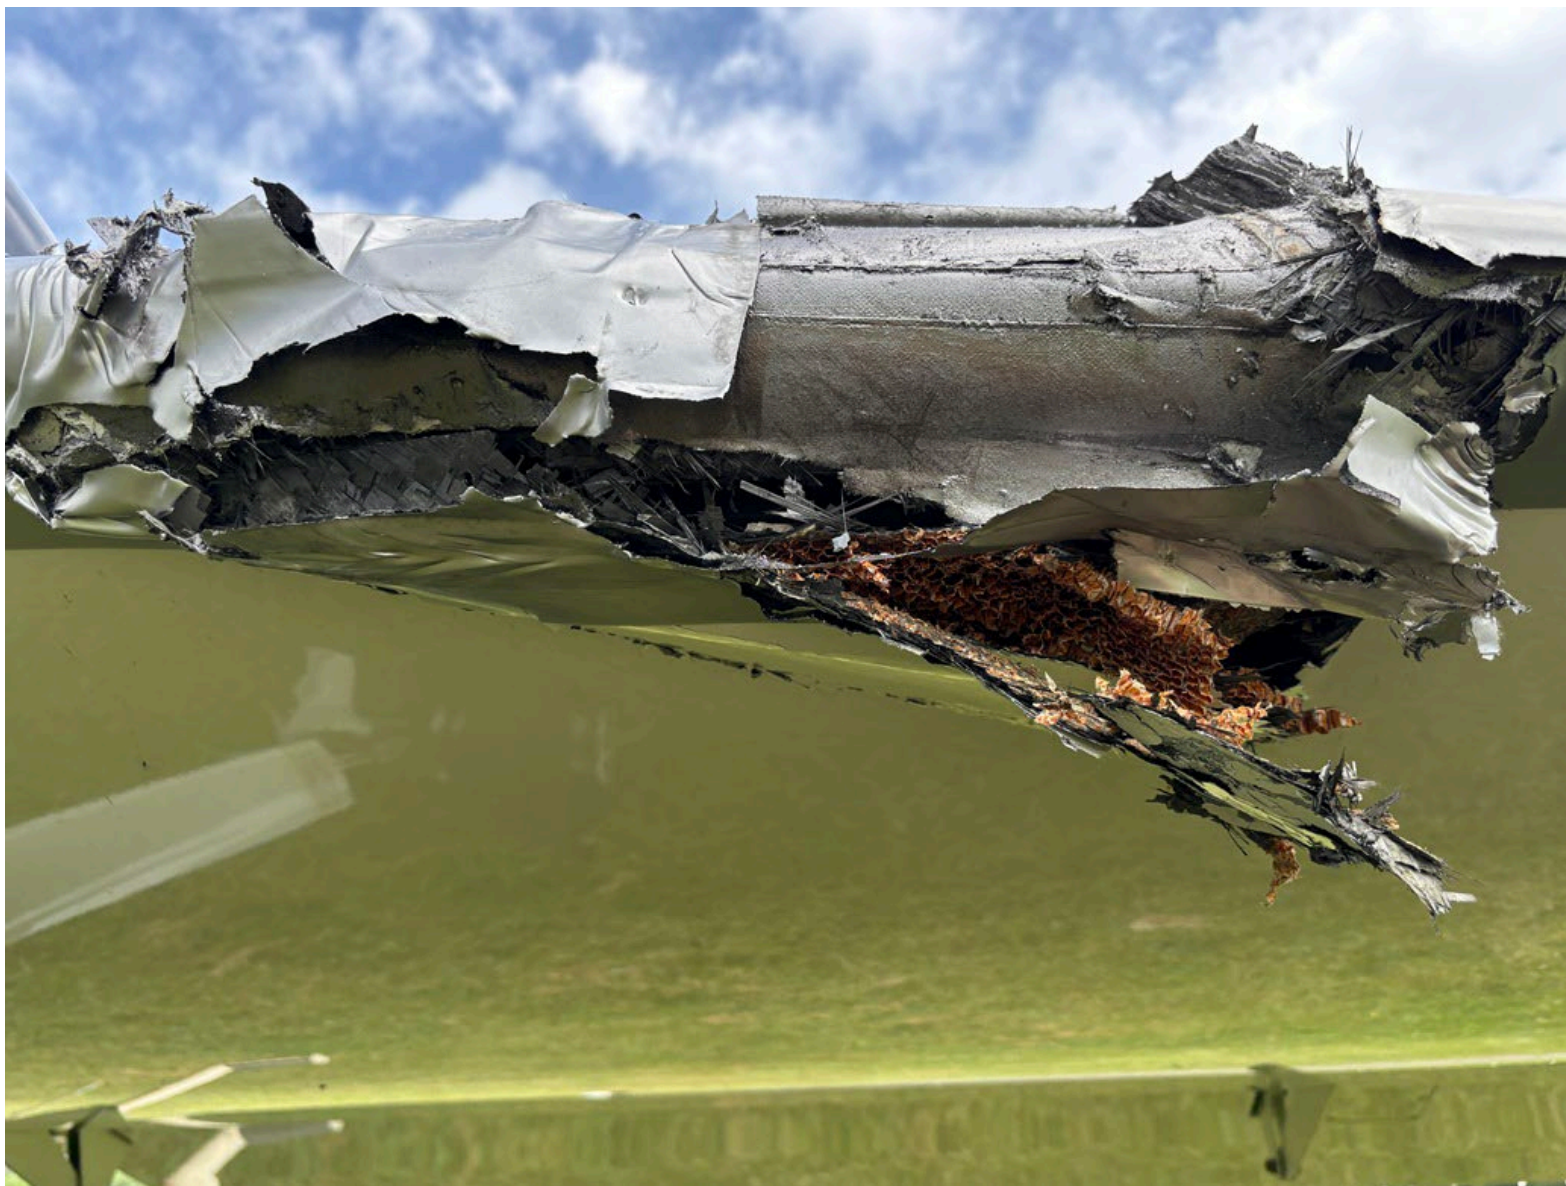
**Photograph 9 - Underside View of Composite Left Wing Damage (Courtesy of FAA)**
