ERA26LA261

## INVESTIGATION PHOTOGRAPHS

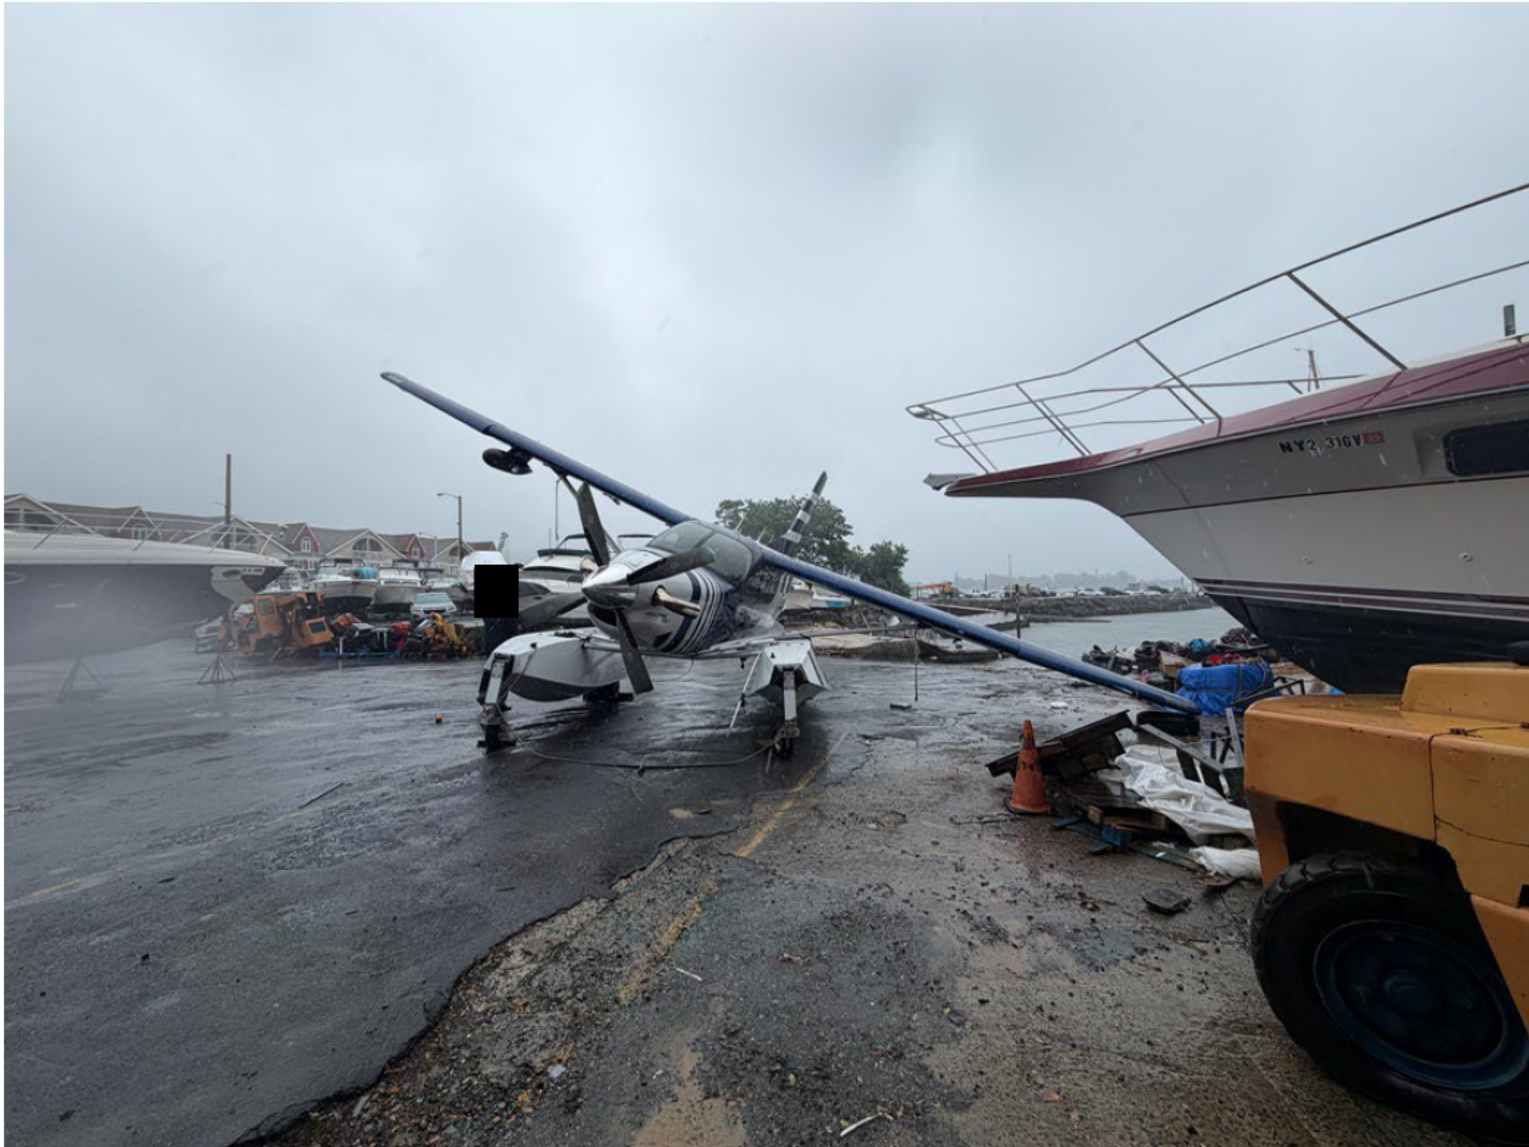
**Photograph 1 - Main Wreckage (Courtesy of FAA)**

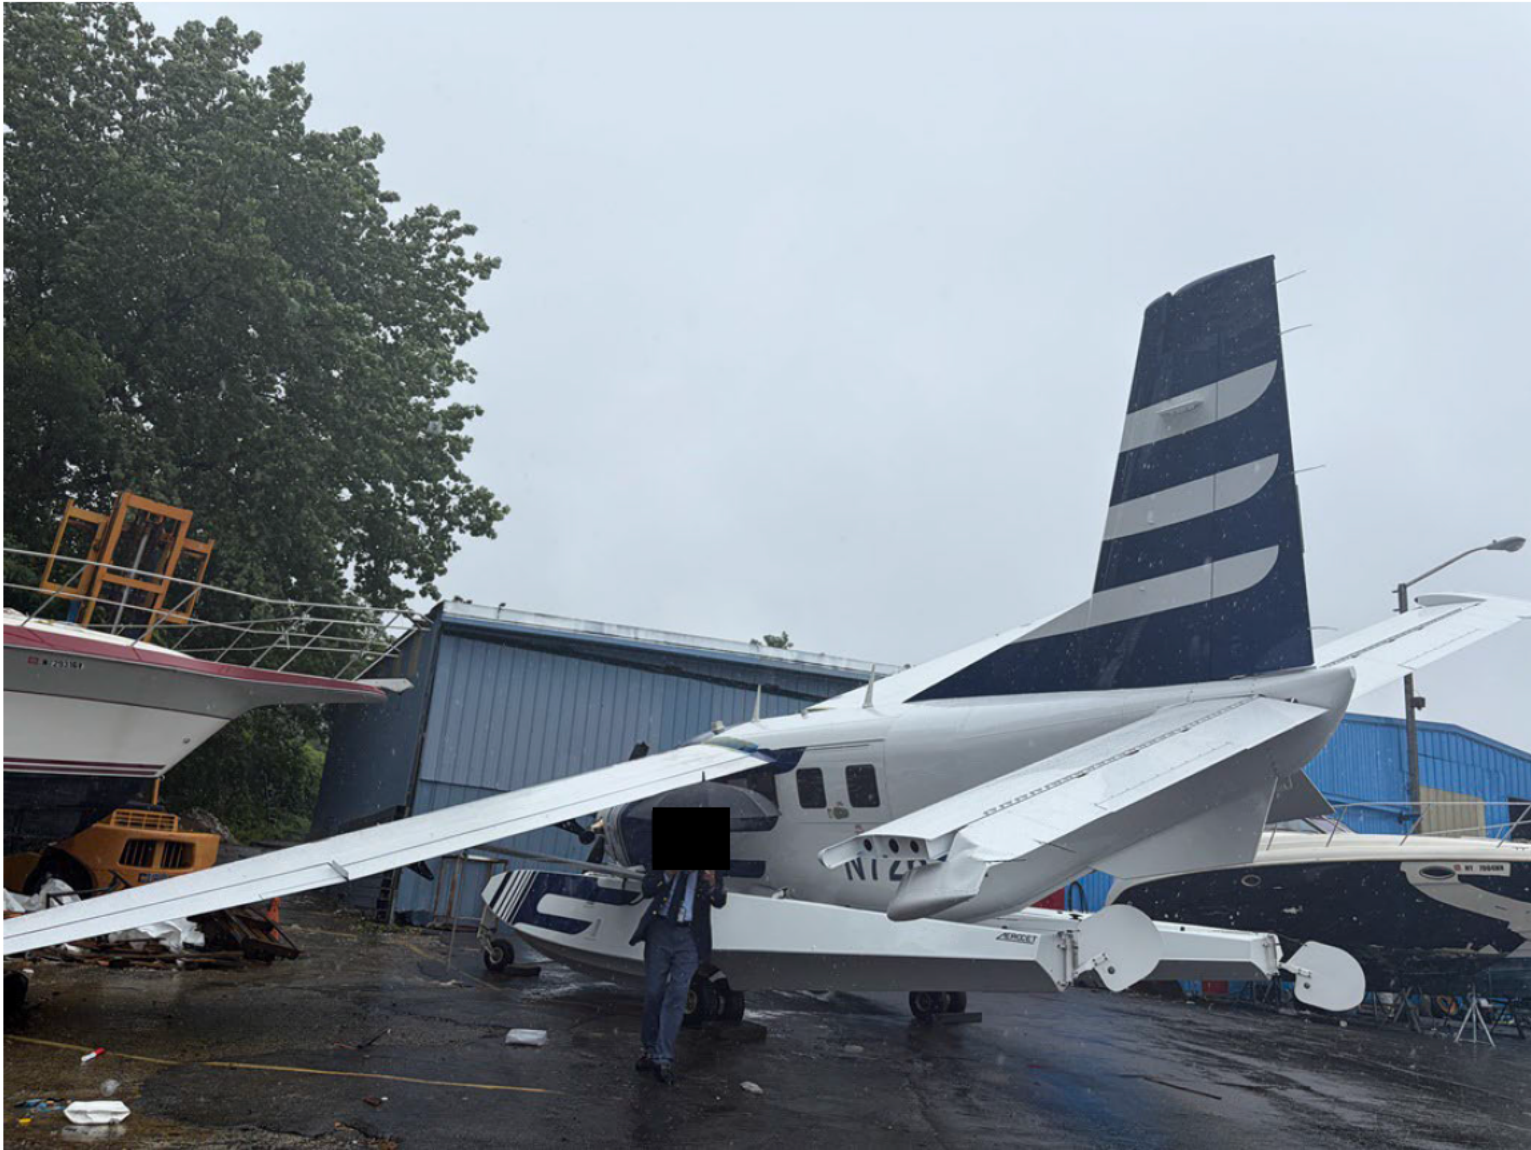
**Photograph 2 - Left Elevator Damage (Courtesy of FAA)**
