ERA26LA264

## INVESTIGATION PHOTOGRAPHS

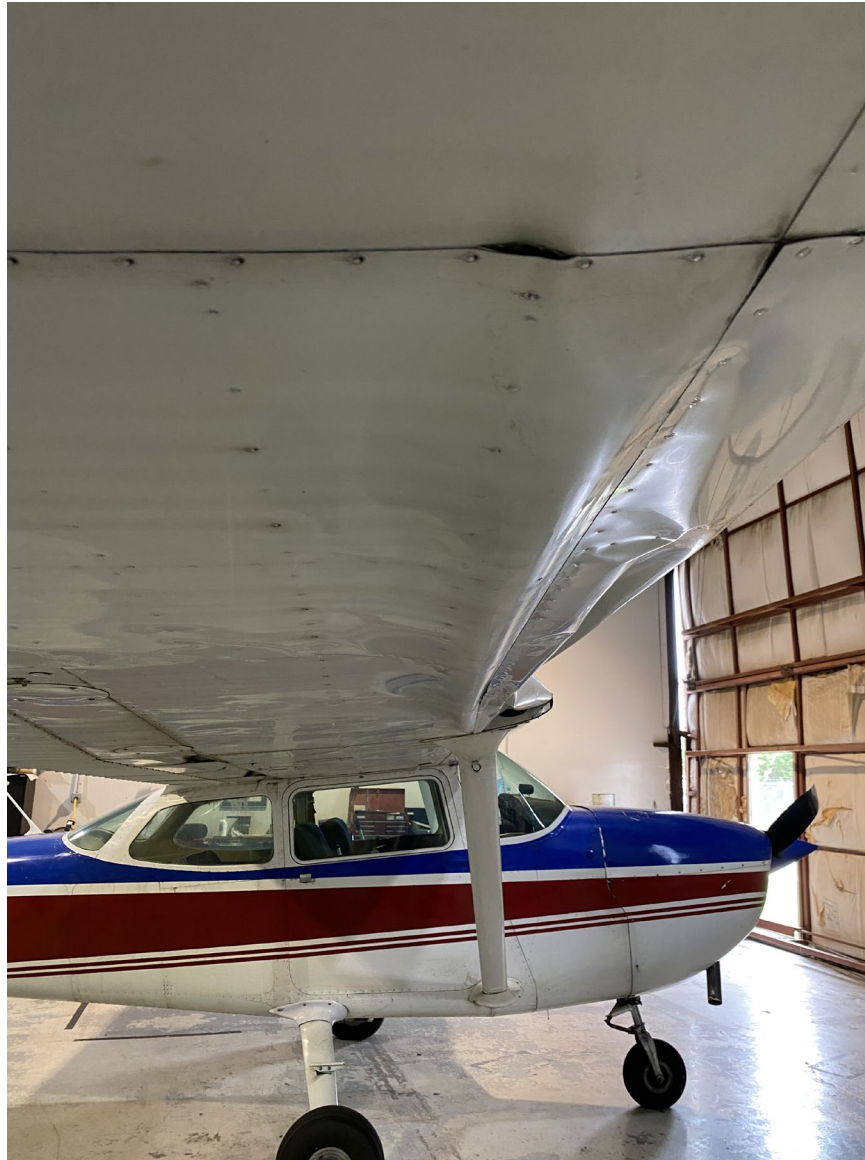
**Photograph 1 - Right wing leading edge damage (Courtesy of FAA)**

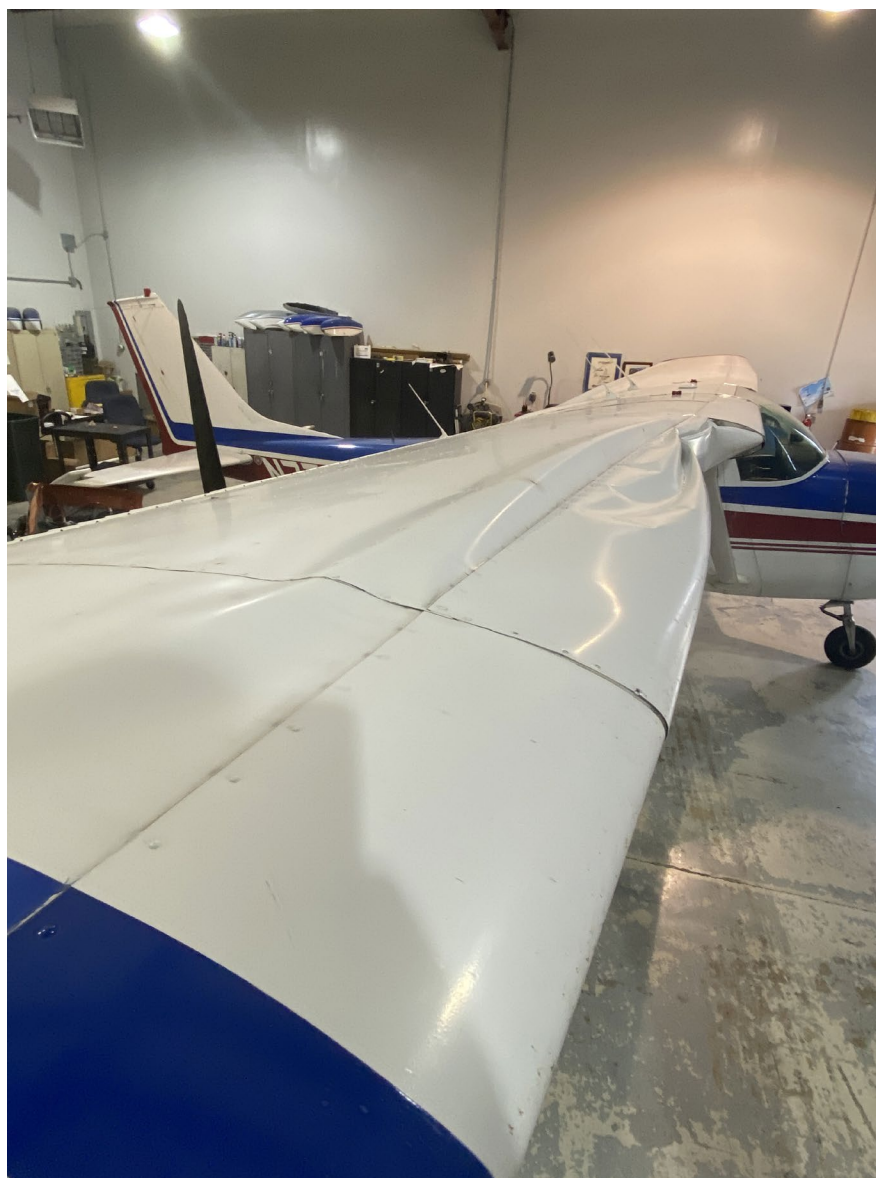
**Photograph 2 -Right wing leading edge damage (Courtesy of FAA)**
