ERA26LA280

## INVESTIGATION PHOTOGRAPHS

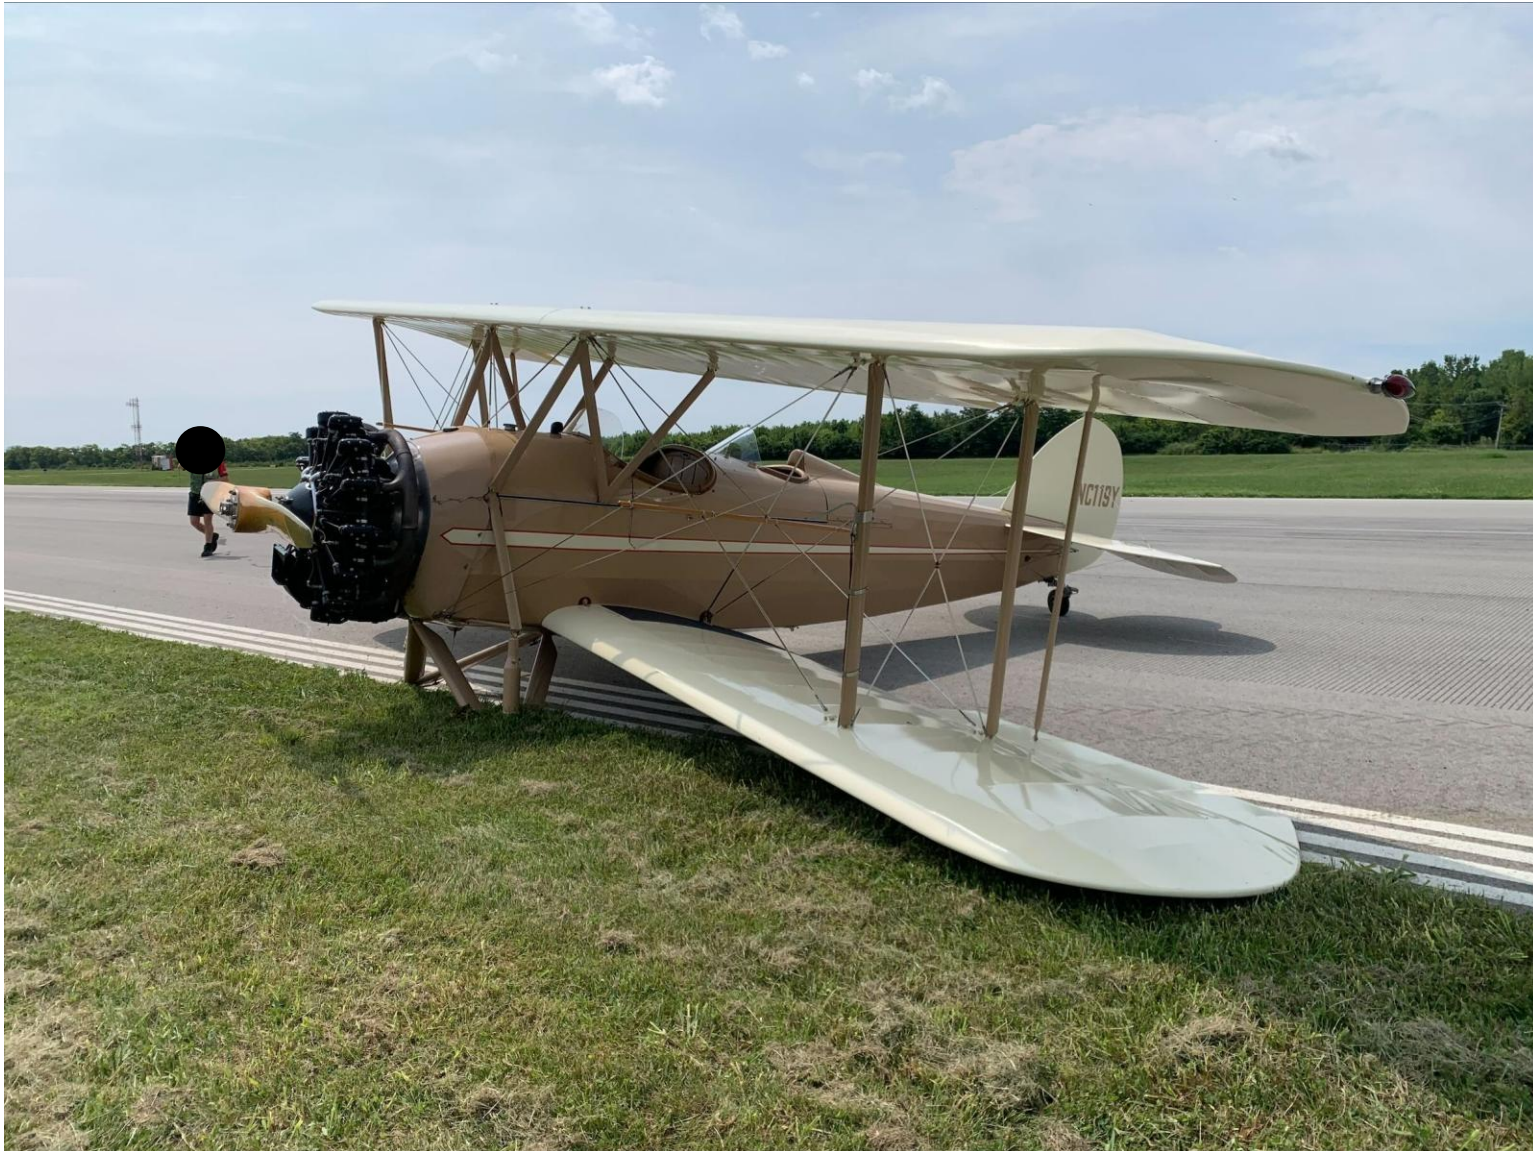
**Photograph 1 - View of the airplane at the accident site. (Courtesy of Airport Manager)**

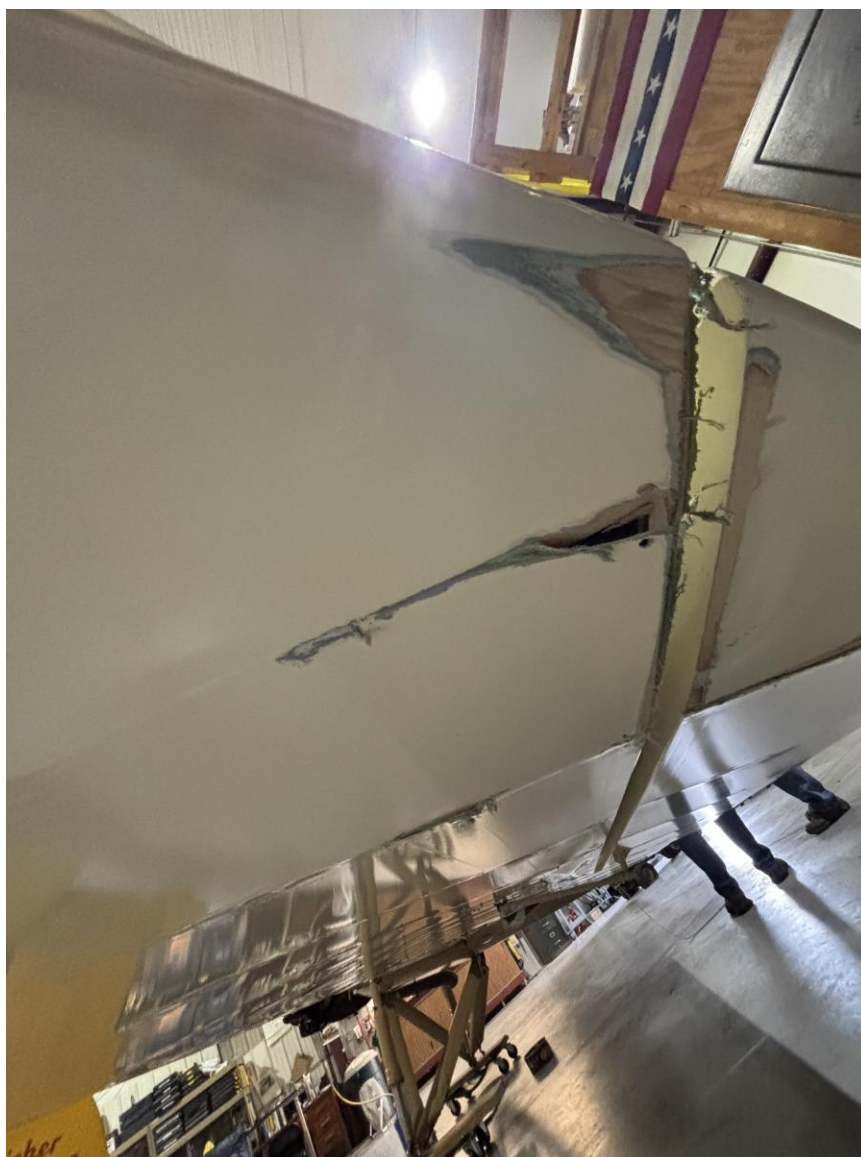
**Photograph 2 - View of damage to the lower left wing and aileron. (Courtesy of FAA)**

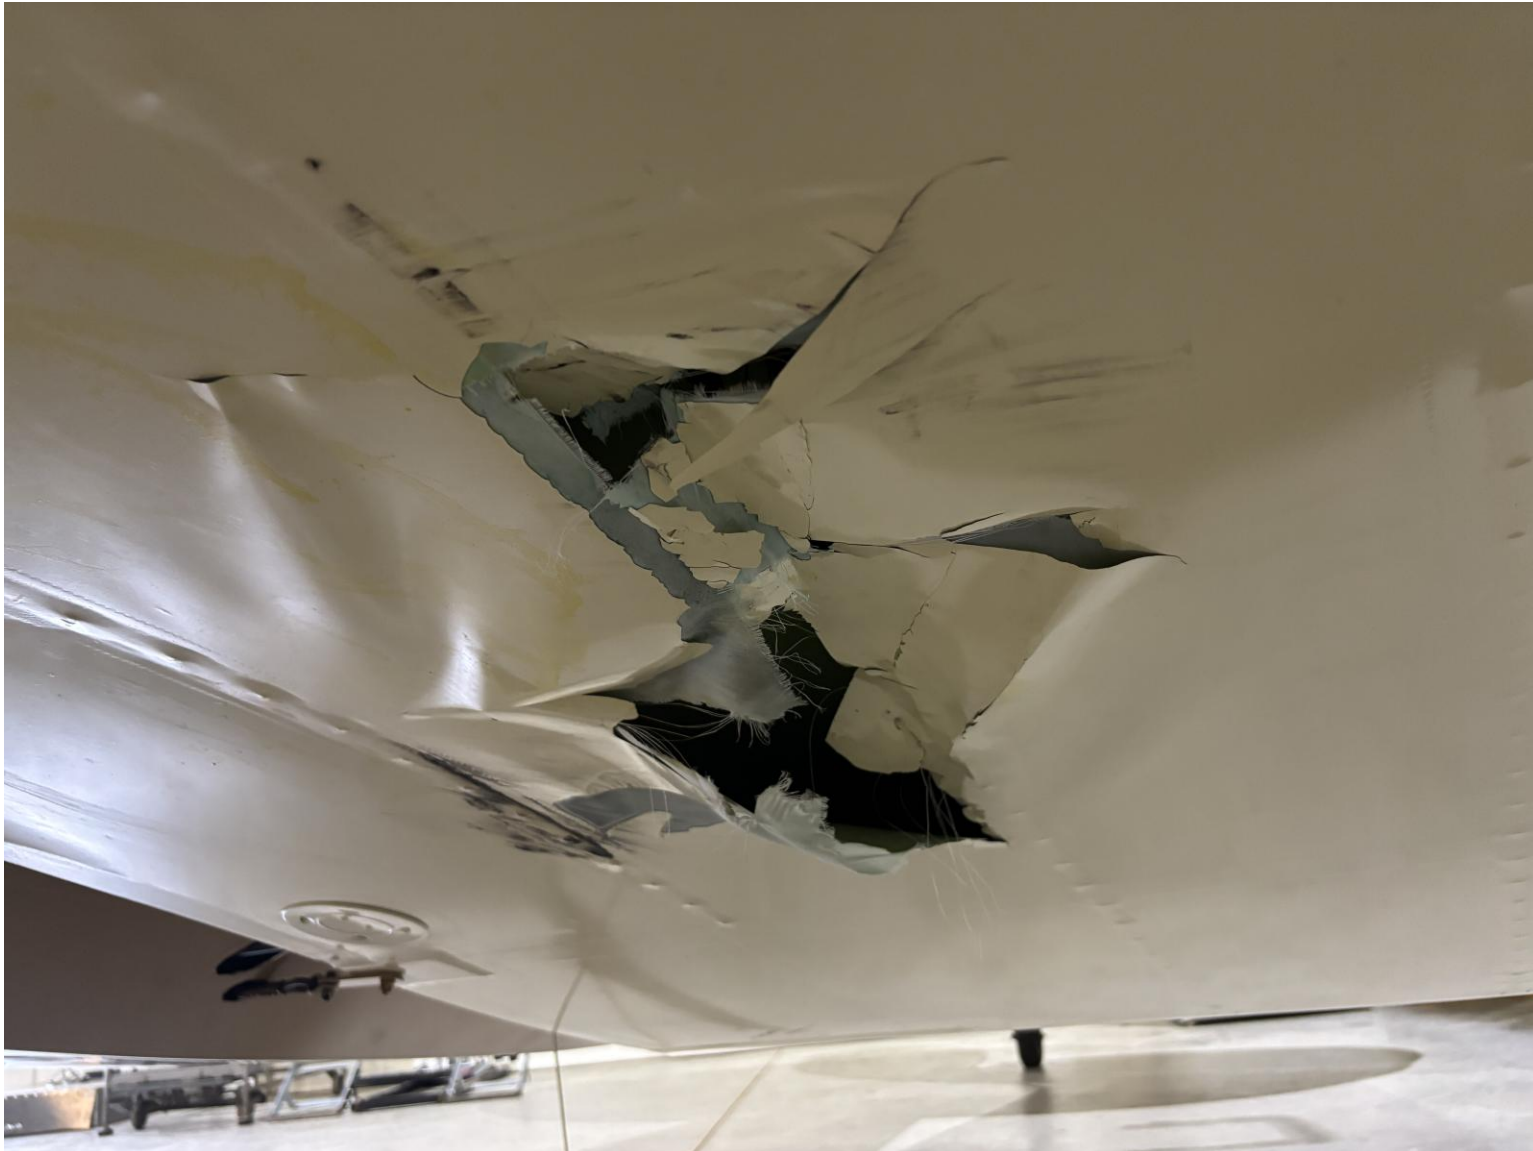
**Photograph 3 - View of damage to the lower left wing. (Courtesy of FAA)**

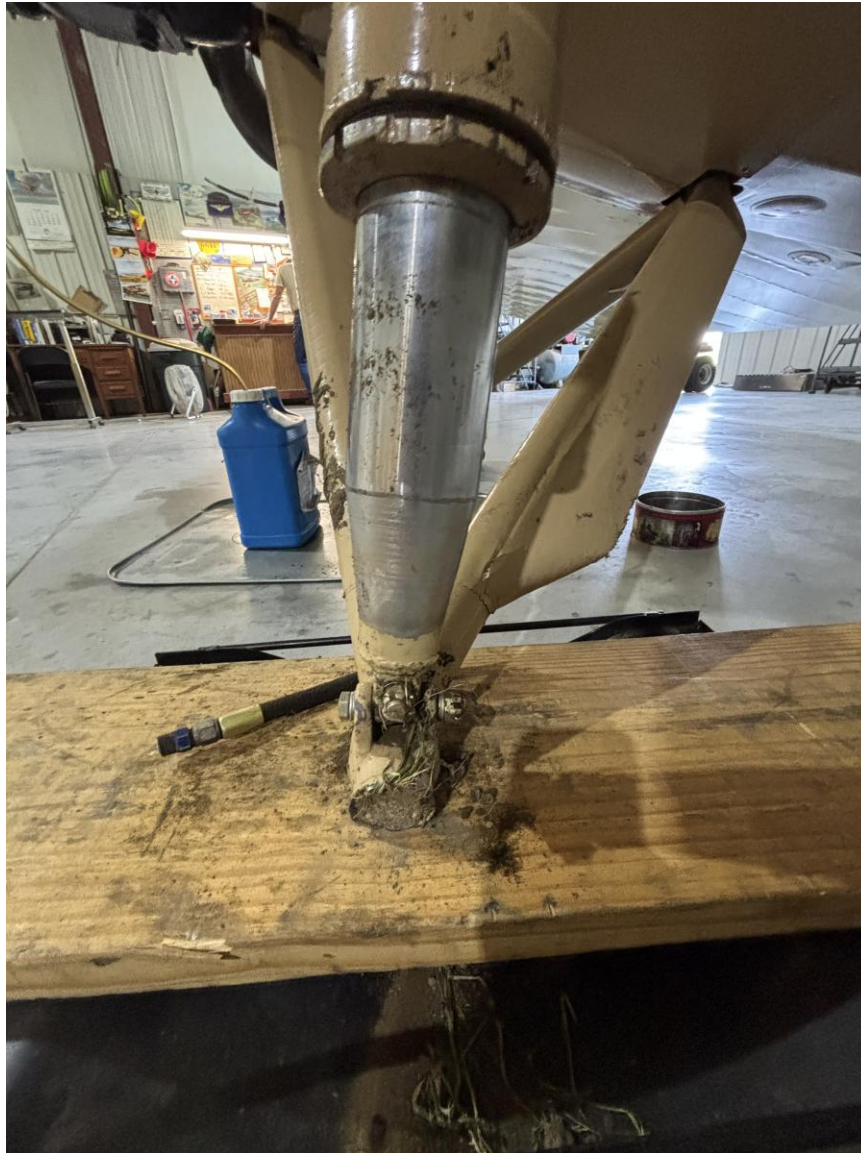
**Photograph 4 - View of the left main landing gear. (Courtesy of FAA)**

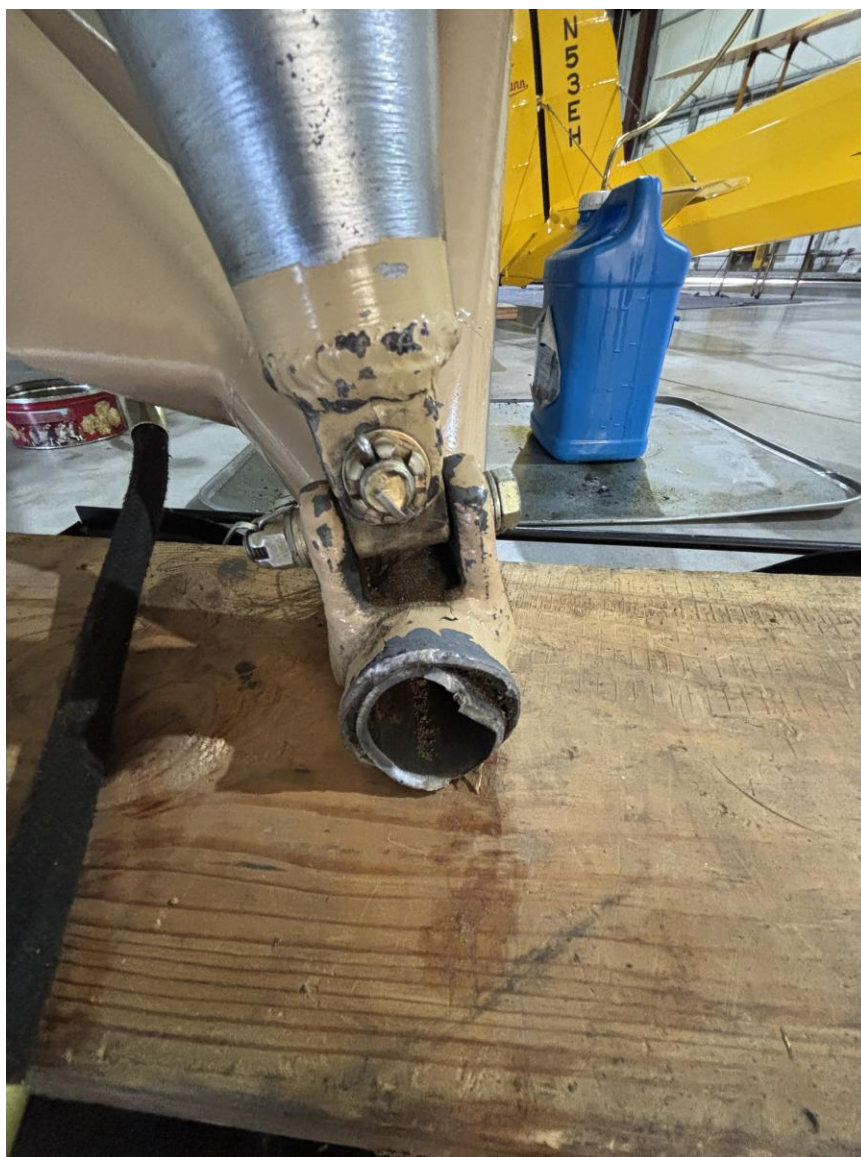
**Photograph 5 - View of the right main landing gear. (Courtesy of FAA)**

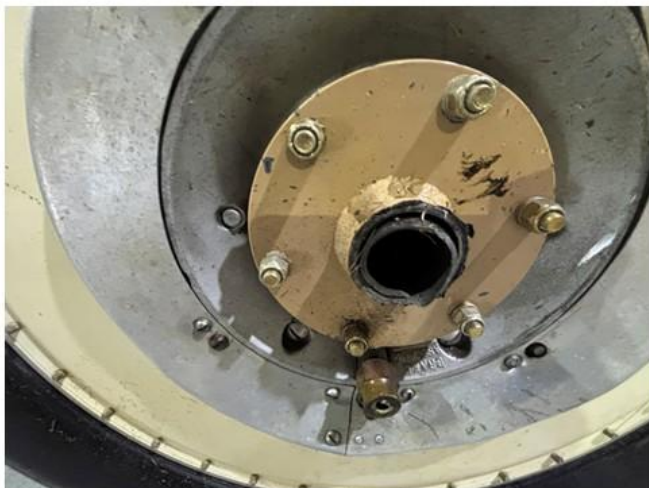
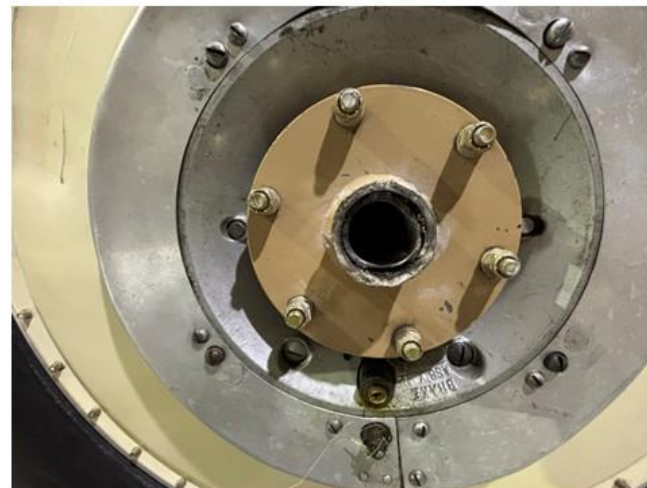
**Photograph 6 - View of the landing gear axles. (Courtesy of FAA)**
