ERA26LA284

## INVESTIGATION PHOTOGRAPHS

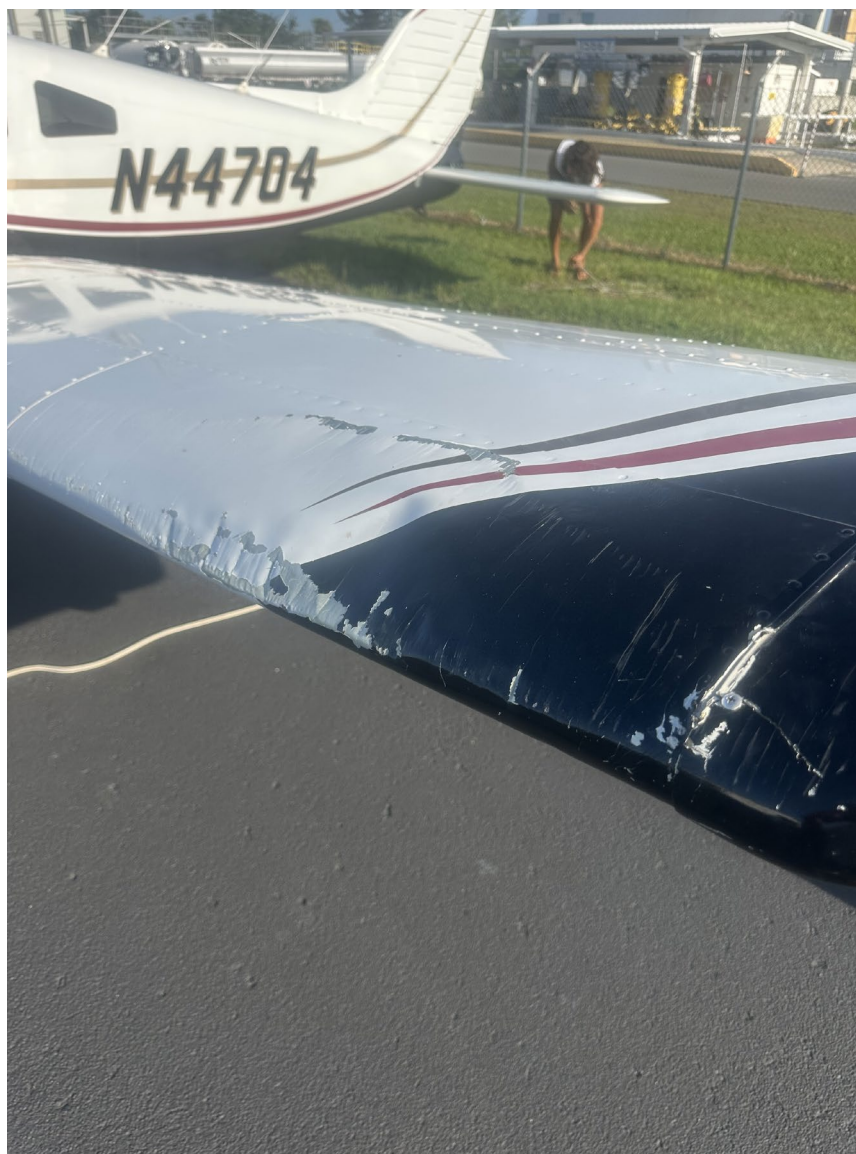
**Photograph 1 - left wing damage (Courtesy of FAA)**

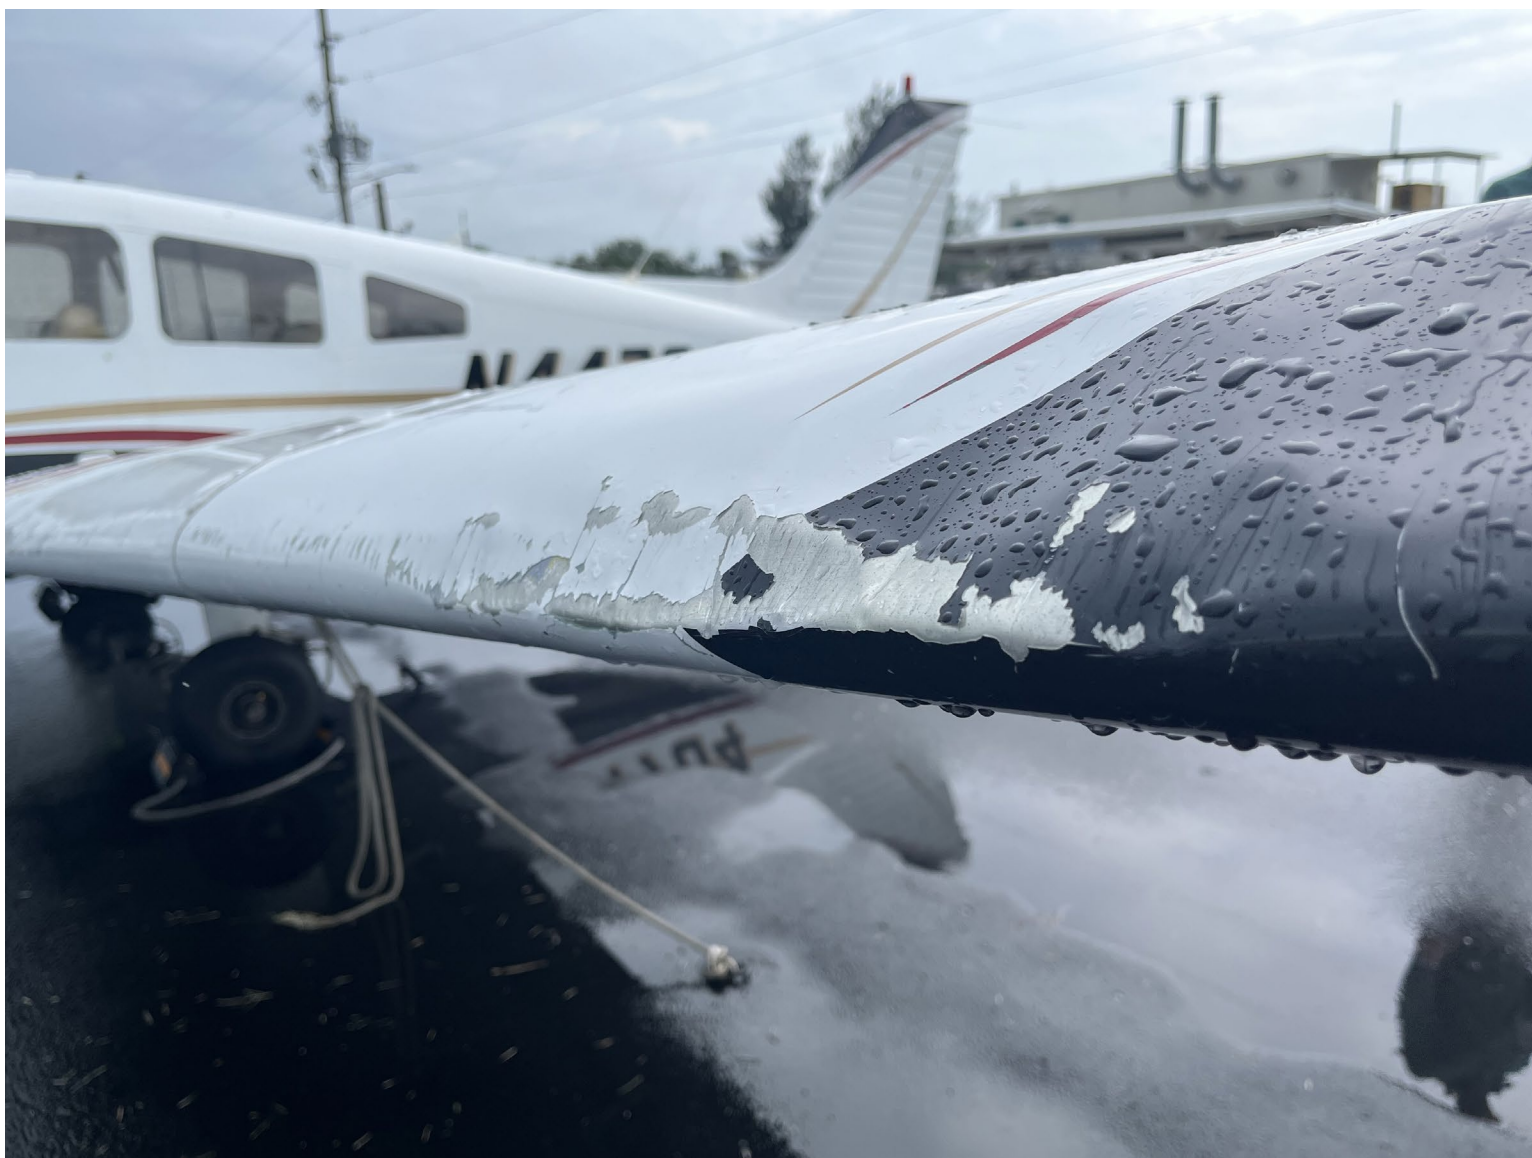
**Photograph 2 - Left wing leading edge (Courtesy of FAA)**

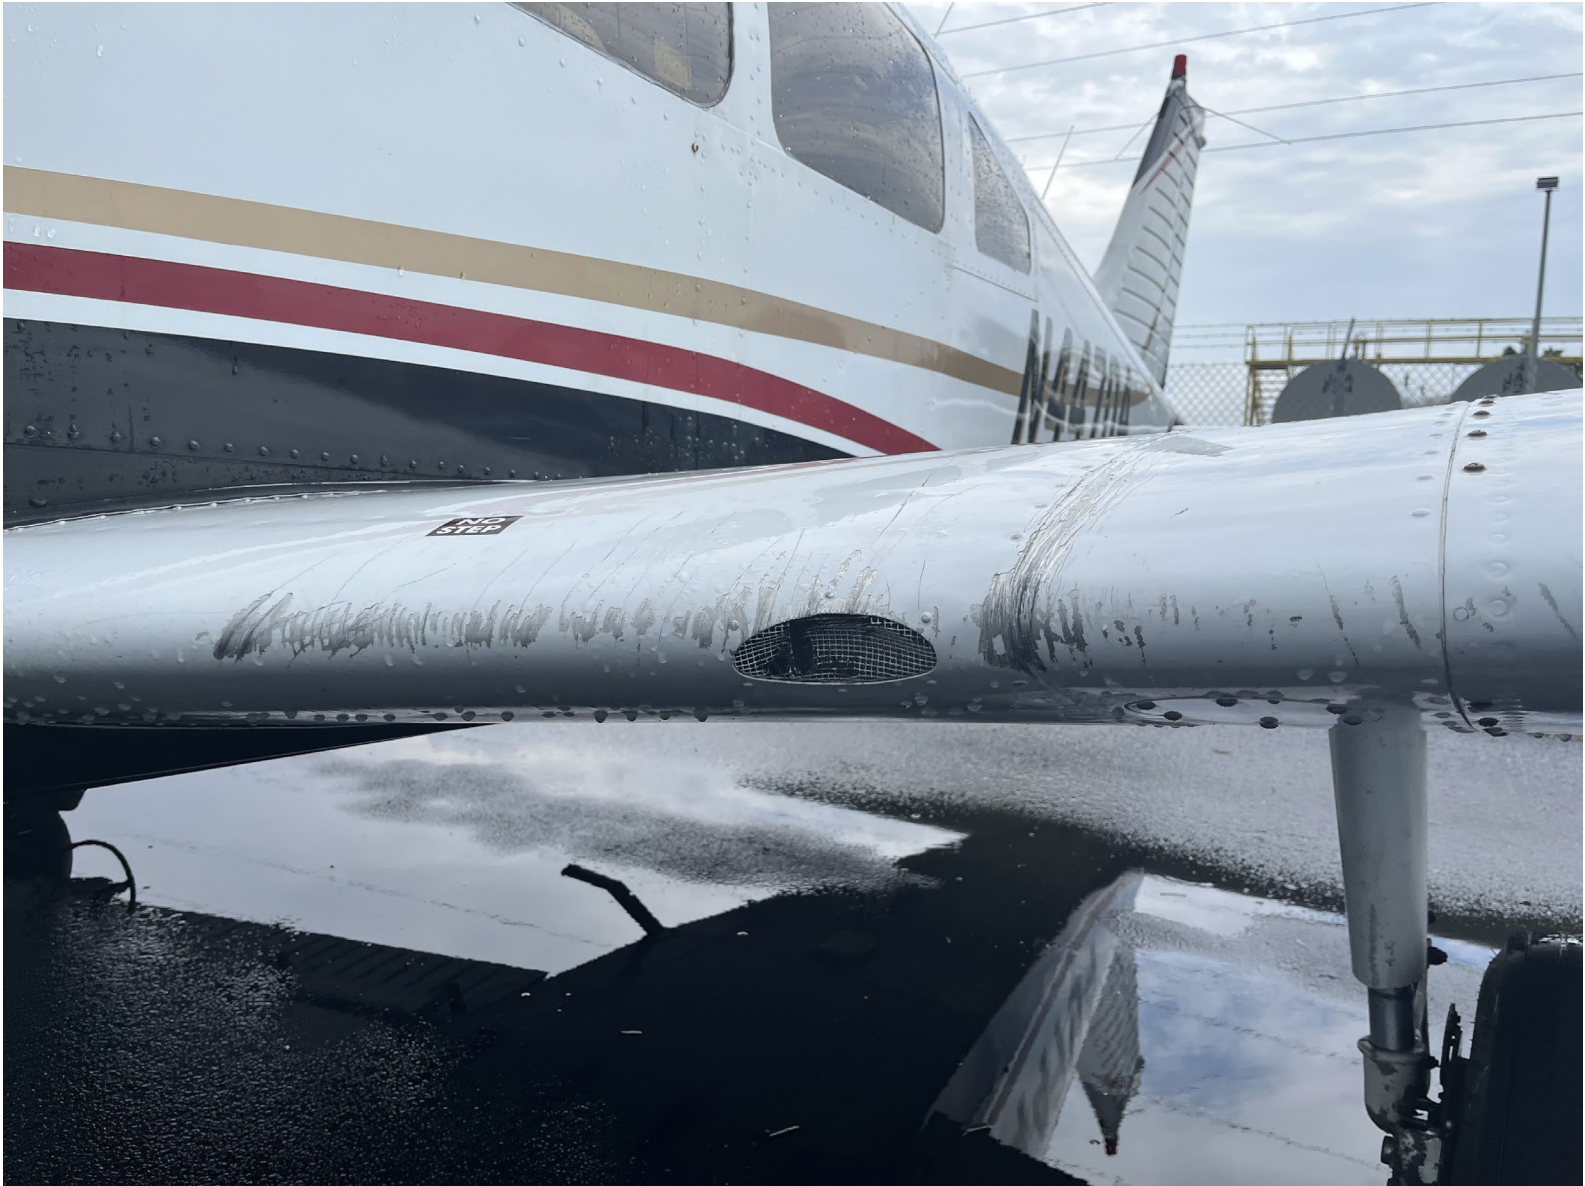
**Photograph 3 - Left wing leading edge (Courtesy of FAA)**
