ERA26LA301

## INVESTIGATION PHOTOGRAPHS

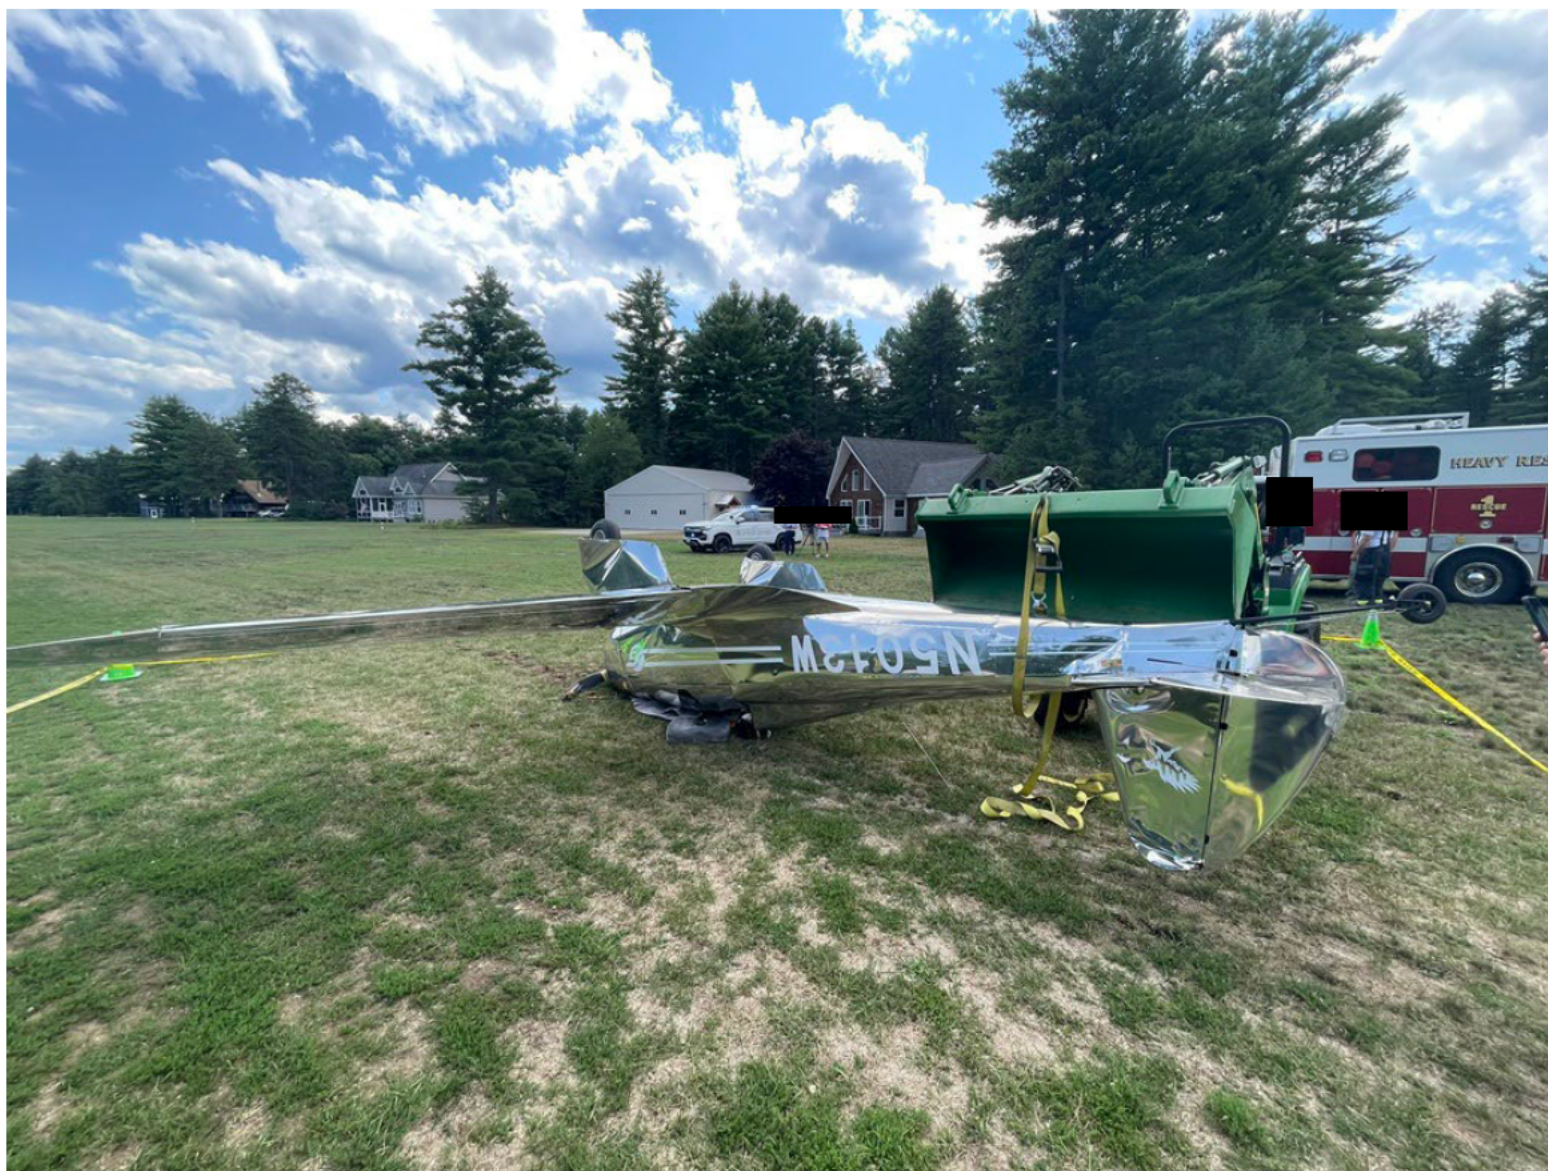
**Photograph 1 - Main Wreckage With Vertical Stabilizer Damage (Courtesy of FAA)**

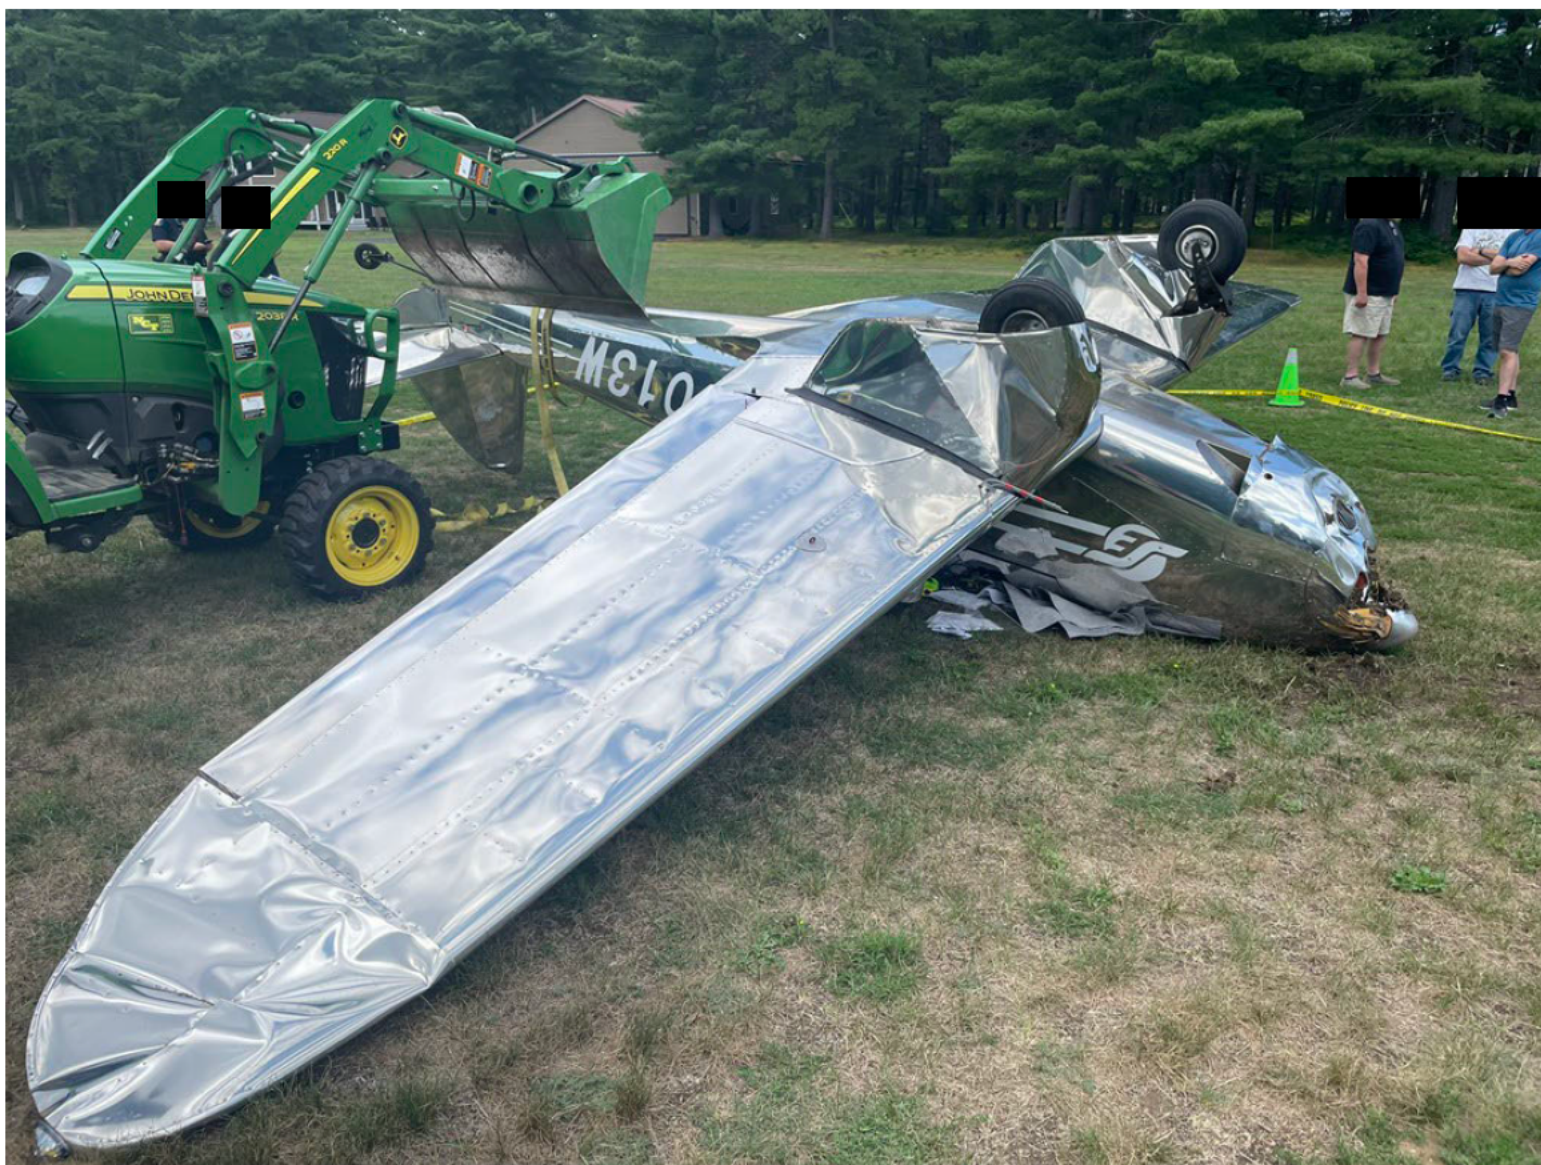
**Photograph 2 - Left Wing Damage (Courtesy of FAA)**
