# Air Safety Investigation Examination Report

| Aircraft Incident/<br>Accident Information | Year: 1959 | Make: Cessna | Model: 180B |
| | Serial number: 50367 | | Registration: N5067E |
| Location: Waterloo, IA | | | Date: 06-06-15 |

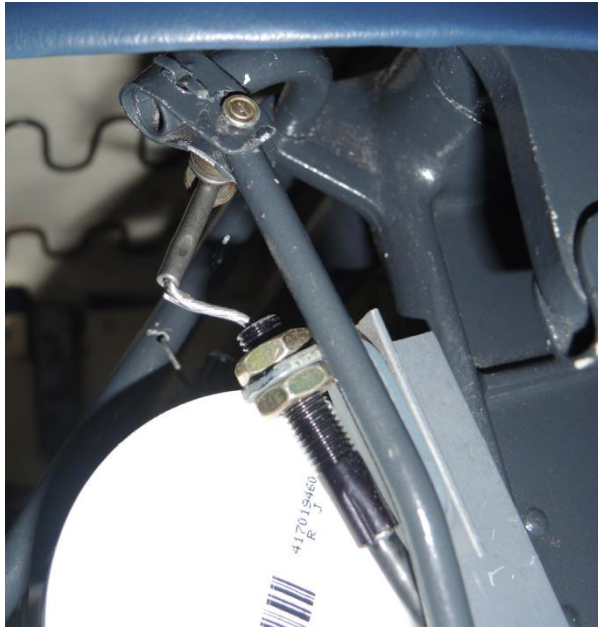
During the NTSB examination it was observed that bracket 1299377-20 was installed with its angled portion facing outboard instead of inboard. In addition, bracket S2300-26 was installed facing forward on 1299377-20 instead of facing outboard. Wear marks were observed on the side of S2300-26 where the seat adjustment pin was rubbing against S2300-26. The position of S2300-26 appeared to cause the seat adjustment pin to be pushed outboard. 1299377-20 exhibited rivet tool marks around the rivets used to attach the bracket to the seat leg.

Textron Aviation photograph "Wreckage exam ASI-15-BQ-020.jpg" showing installation of 1299377-20 and S2300-26. Camera is looking inboard and left side of photograph is forward.

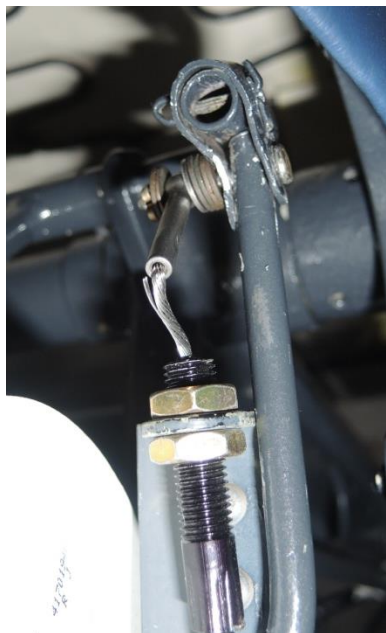
Textron Aviation photograph "Wreckage exam ASI-15-BQ-021.jpg" showing seat adjustment pin sitting against S2300-26. Camera is looking aft and right side of photograph is outboard.

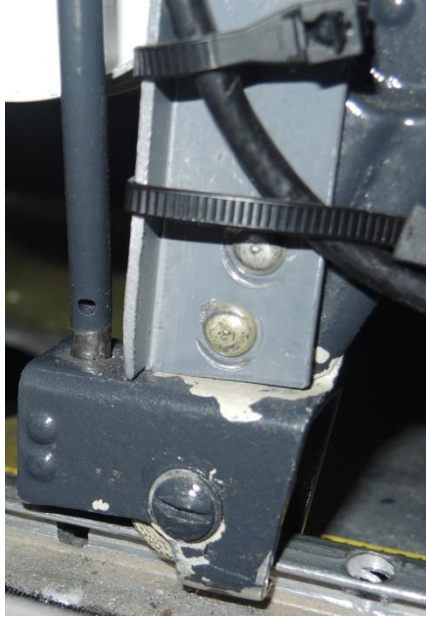
Textron Aviation photograph "Wreckage exam ASI-15-BQ-027.jpg" showing rivet tool marks on 1299377-20.

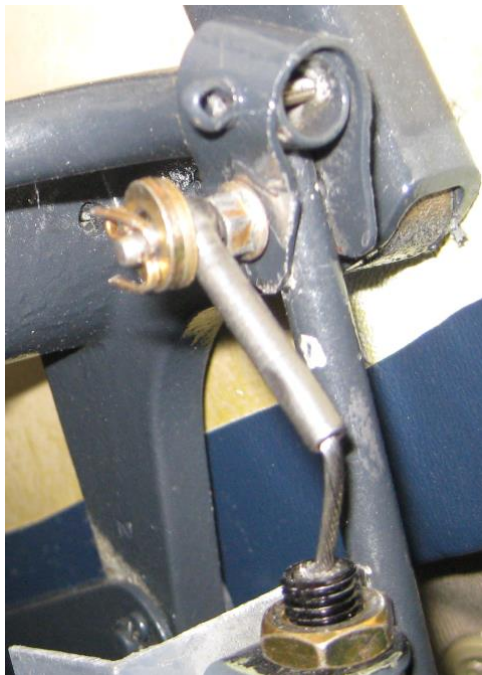
FAA provided photograph showing two washers and nut installed on pin.

In the FAA provided photograph, two thick washers are located on the cotter pin side of the terminal end and a nut is located on the other side of the terminal end. The service kit does not detail the installation of a nut on the pin which the cable assembly is attached to. The FAA inspector stated during his examination that he found the terminal end of the secondary seat stop reel to be unmovable

due to the tightness of the assembly. The mechanic at A&M Aircraft also stated he found that the terminal end was binding on its pin and that he subsequently removed the cotter pin, washers, and nut that were installed. He stated that when he removed the cotter pin one of the washers “shot” across the room due to the tension it was under. He reported he then installed the “correct” washers.

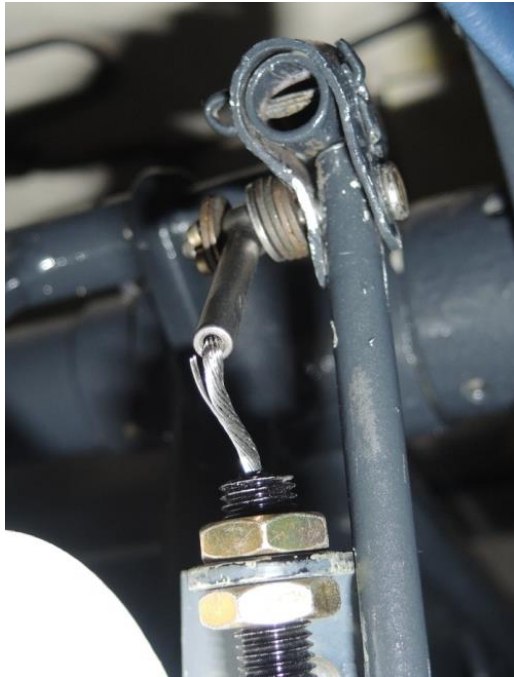
During the NTSB examination, two thin washers were found located on the cotter pin side of the terminal end and five thin washers were located on the other side of the terminal end. The terminal could be rotated by hand.

Textron Aviation photograph “Wreckage exam ASI-15-BQ-021.JPG” showing washer stack.

The service kit limits the number of washers to a total of 3 NAS1149FN432P washers. The washers installed during the NTSB examination appeared to be thinner than a NAS1149FN432P washer.

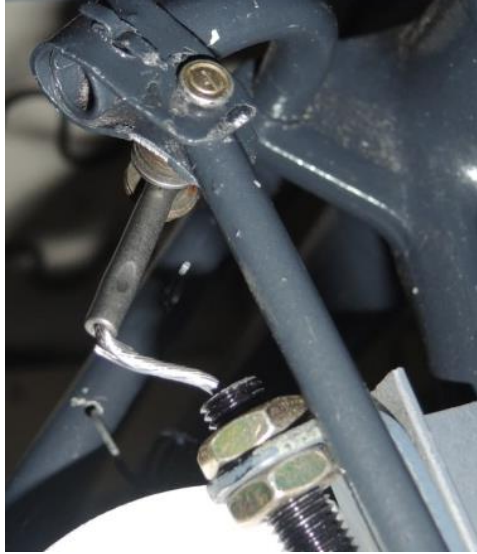
During the NTSB examination it was observed that the secondary seat stop reel cable assembly was bent in two places, once at the base of the terminal end and again approximately 1 inch along the cable where it exited the cable sheath. The bends were “set” and the cable would not return to an unbent condition. Two broken strands were observed at the bend at the base of the terminal end.

Textron Aviation photograph "Wreckage exam ASI-15-BQ-020.jpg" showing double bend in cable and two separated cable strands at base of terminal end. Camera is looking inboard and left side of photograph is forward.

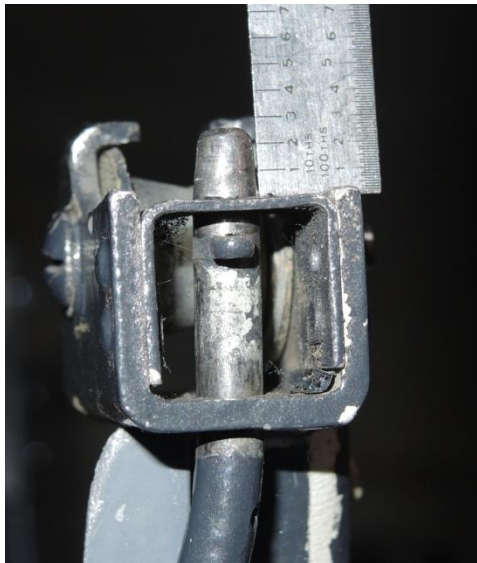
It was also noted that the seat adjustment pin was not fully extending into the seat rail. The seat adjustment handle could be push down and the adjustment pin would fully extend. If the adjustment handle was pulled up the pin would not return to the fully extended position. This appeared to be caused by the bends in the secondary seat stop cable. The bends caused the cable to function like a spring and apply upward pressure to the adjustment pin thus preventing it from fully extending down into the seat rail. The adjustment pin would extend approximately 0.35 inches from the housing when the handle was pushed down. Without pressing the handle down the adjustment pin would extend approximately 0.20 to 0.25 inches from the housing.

Textron Aviation photograph "Wreckage exam ASI-15-BQ-024.jpg" showing adjustment pin position.

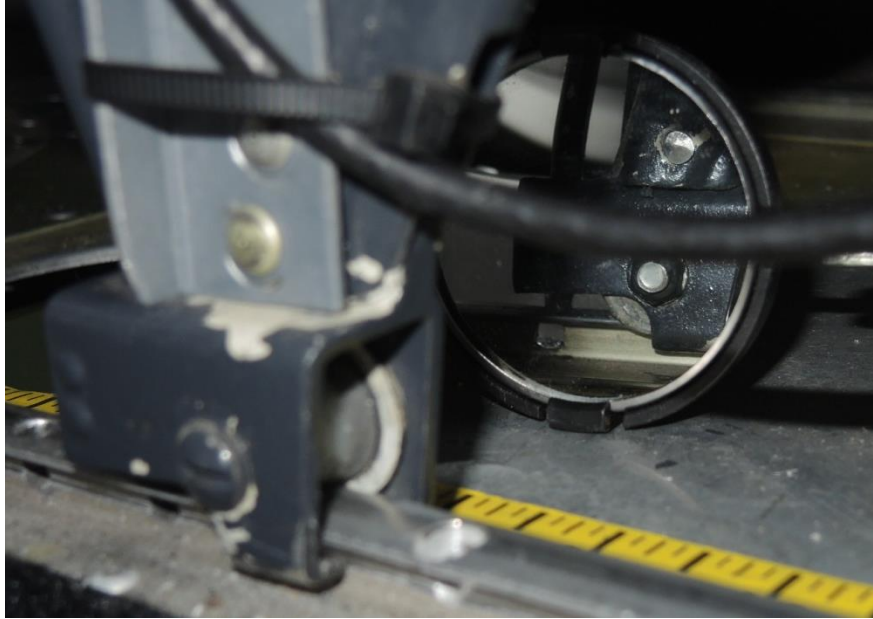
Textron Aviation photograph "Wreckage exam ASI-15-BQ-028.jpg" showing adjustment pin not engaging in seat rail.

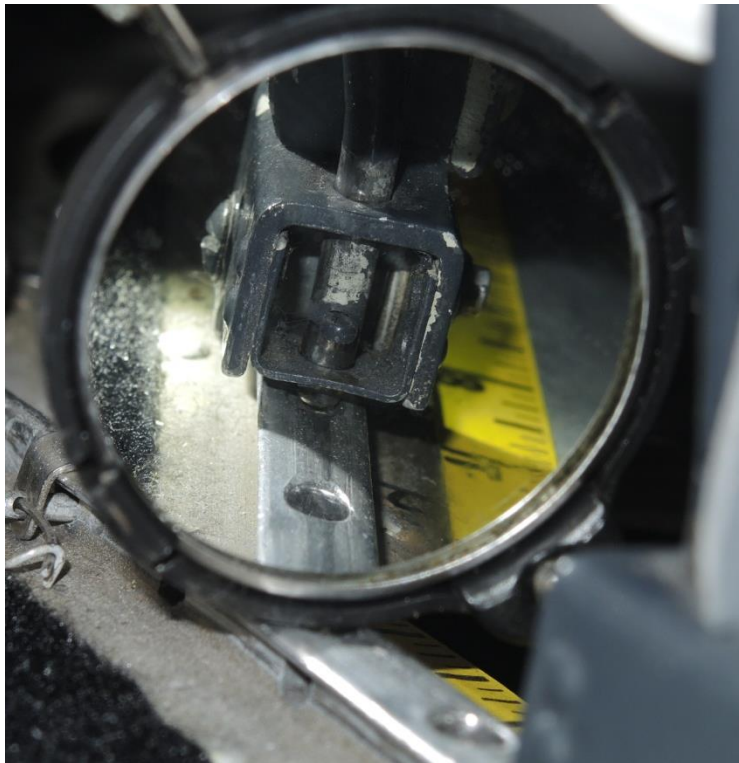
Textron Aviation photograph "Wreckage exam ASI-15-BQ-029.jpg" showing adjustment pin not engaging in seat rail.

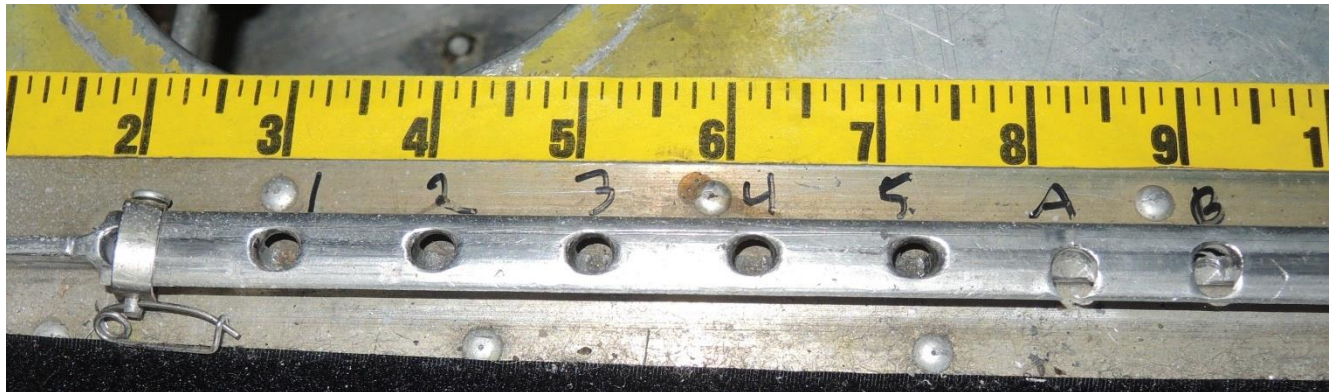
labeled 1 through 5, forward to aft, by the investigators. The seventh hole appeared to be drilled off center and was labeled "A" by the investigators. Hole "A" was elongated laterally and the outboard edge of the seat rail was missing along the circumference of the hole. The bottom of the hole exhibited drill marks not observed in holes 1 through 5. The eighth hole was labeled "B" by the investigators. The hole was also elongated laterally and what appeared to be a crack was observed where the hole meet the outboard edge of the seat rail. The bottom of the hole exhibited drill marks similar to the bottom of hole "A".

Textron Aviation photograph "Wreckage exam ASI-15-BQ-018.jpg" showing Seat 1 outboard seat rail.

Holes 1 through 5 were examined using a using a McFarlane Seat Rail Wear Gauge. All of the holes exhibited wear less than 0.42 inches. FAA Airworthiness Directive (AD) 2011-10-09 requires seat rails to be replaced if they exhibit wear greater than 0.42 inches.
