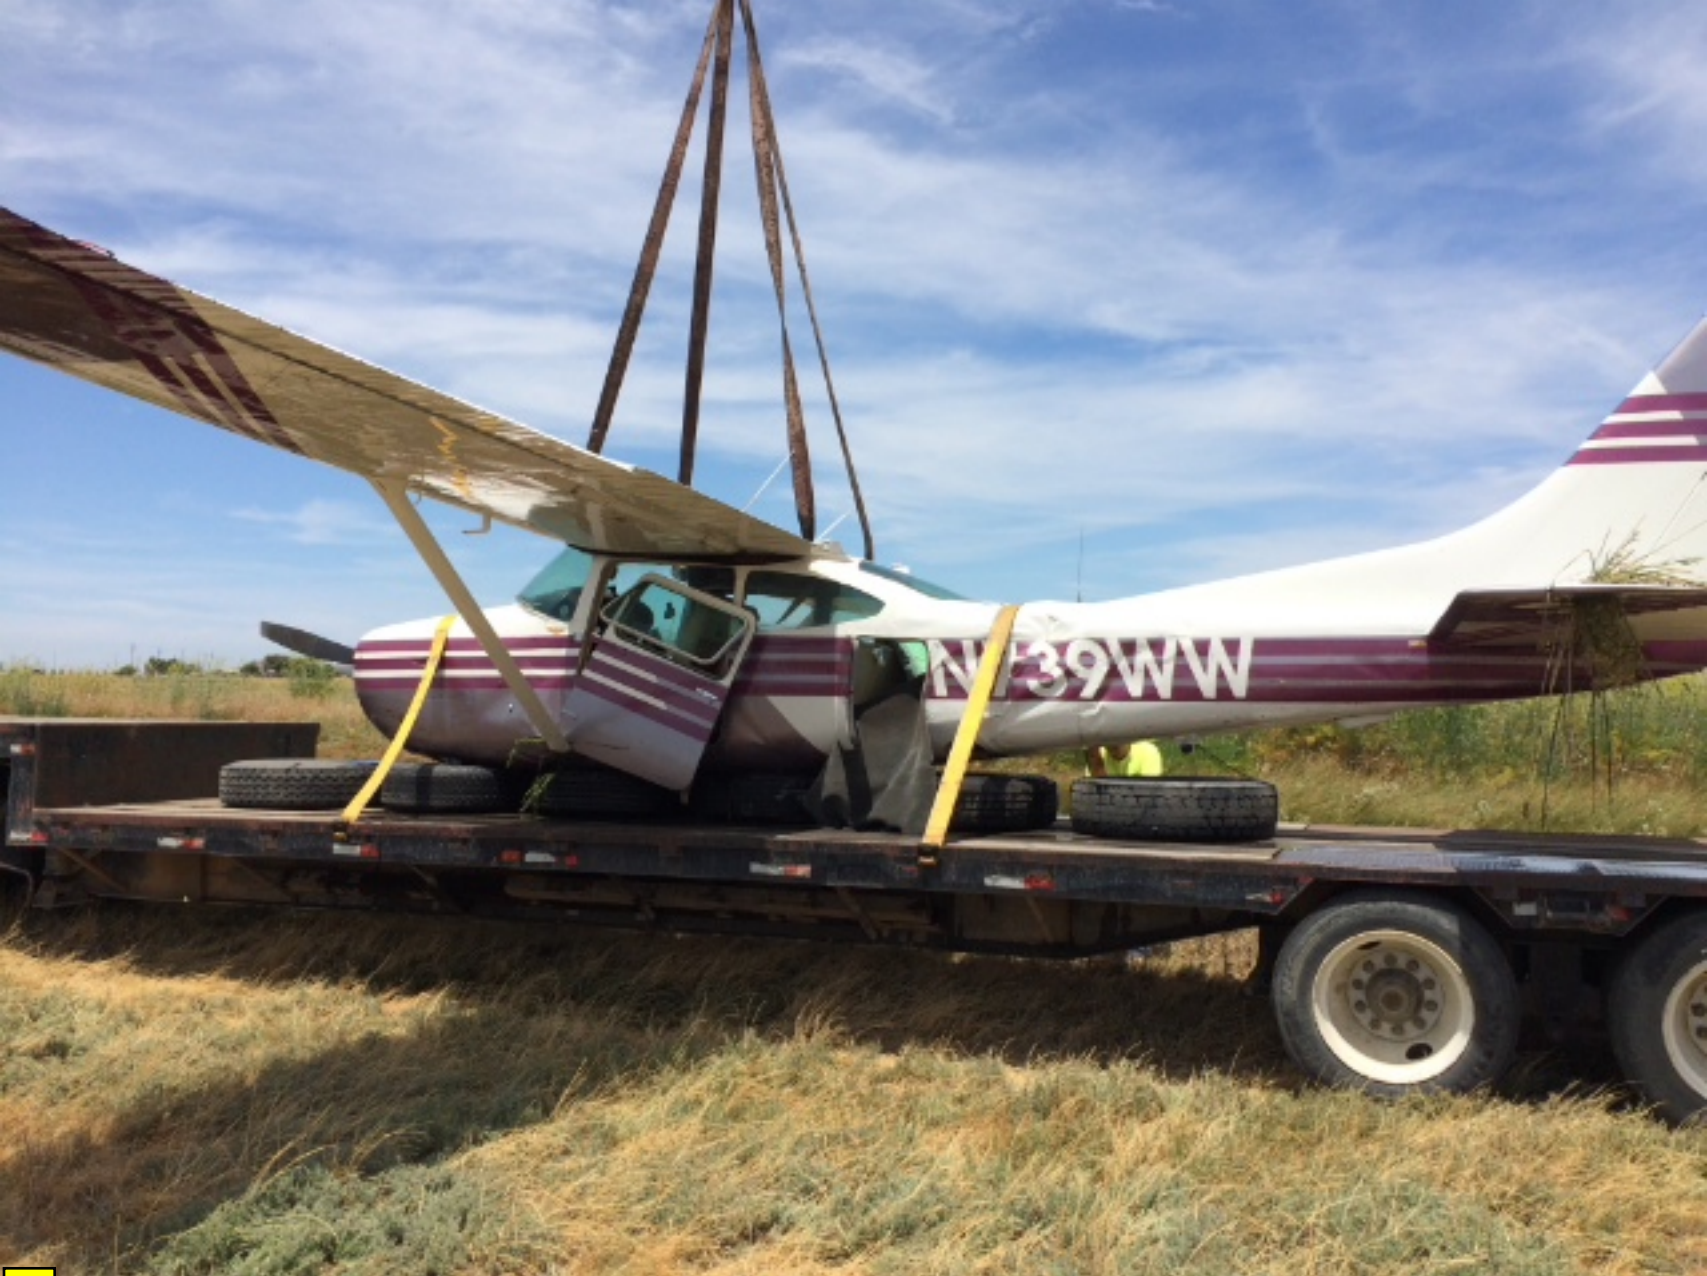
Photo 2 – Fuselage Damage from Left Aft (photo courtesy of owner)
