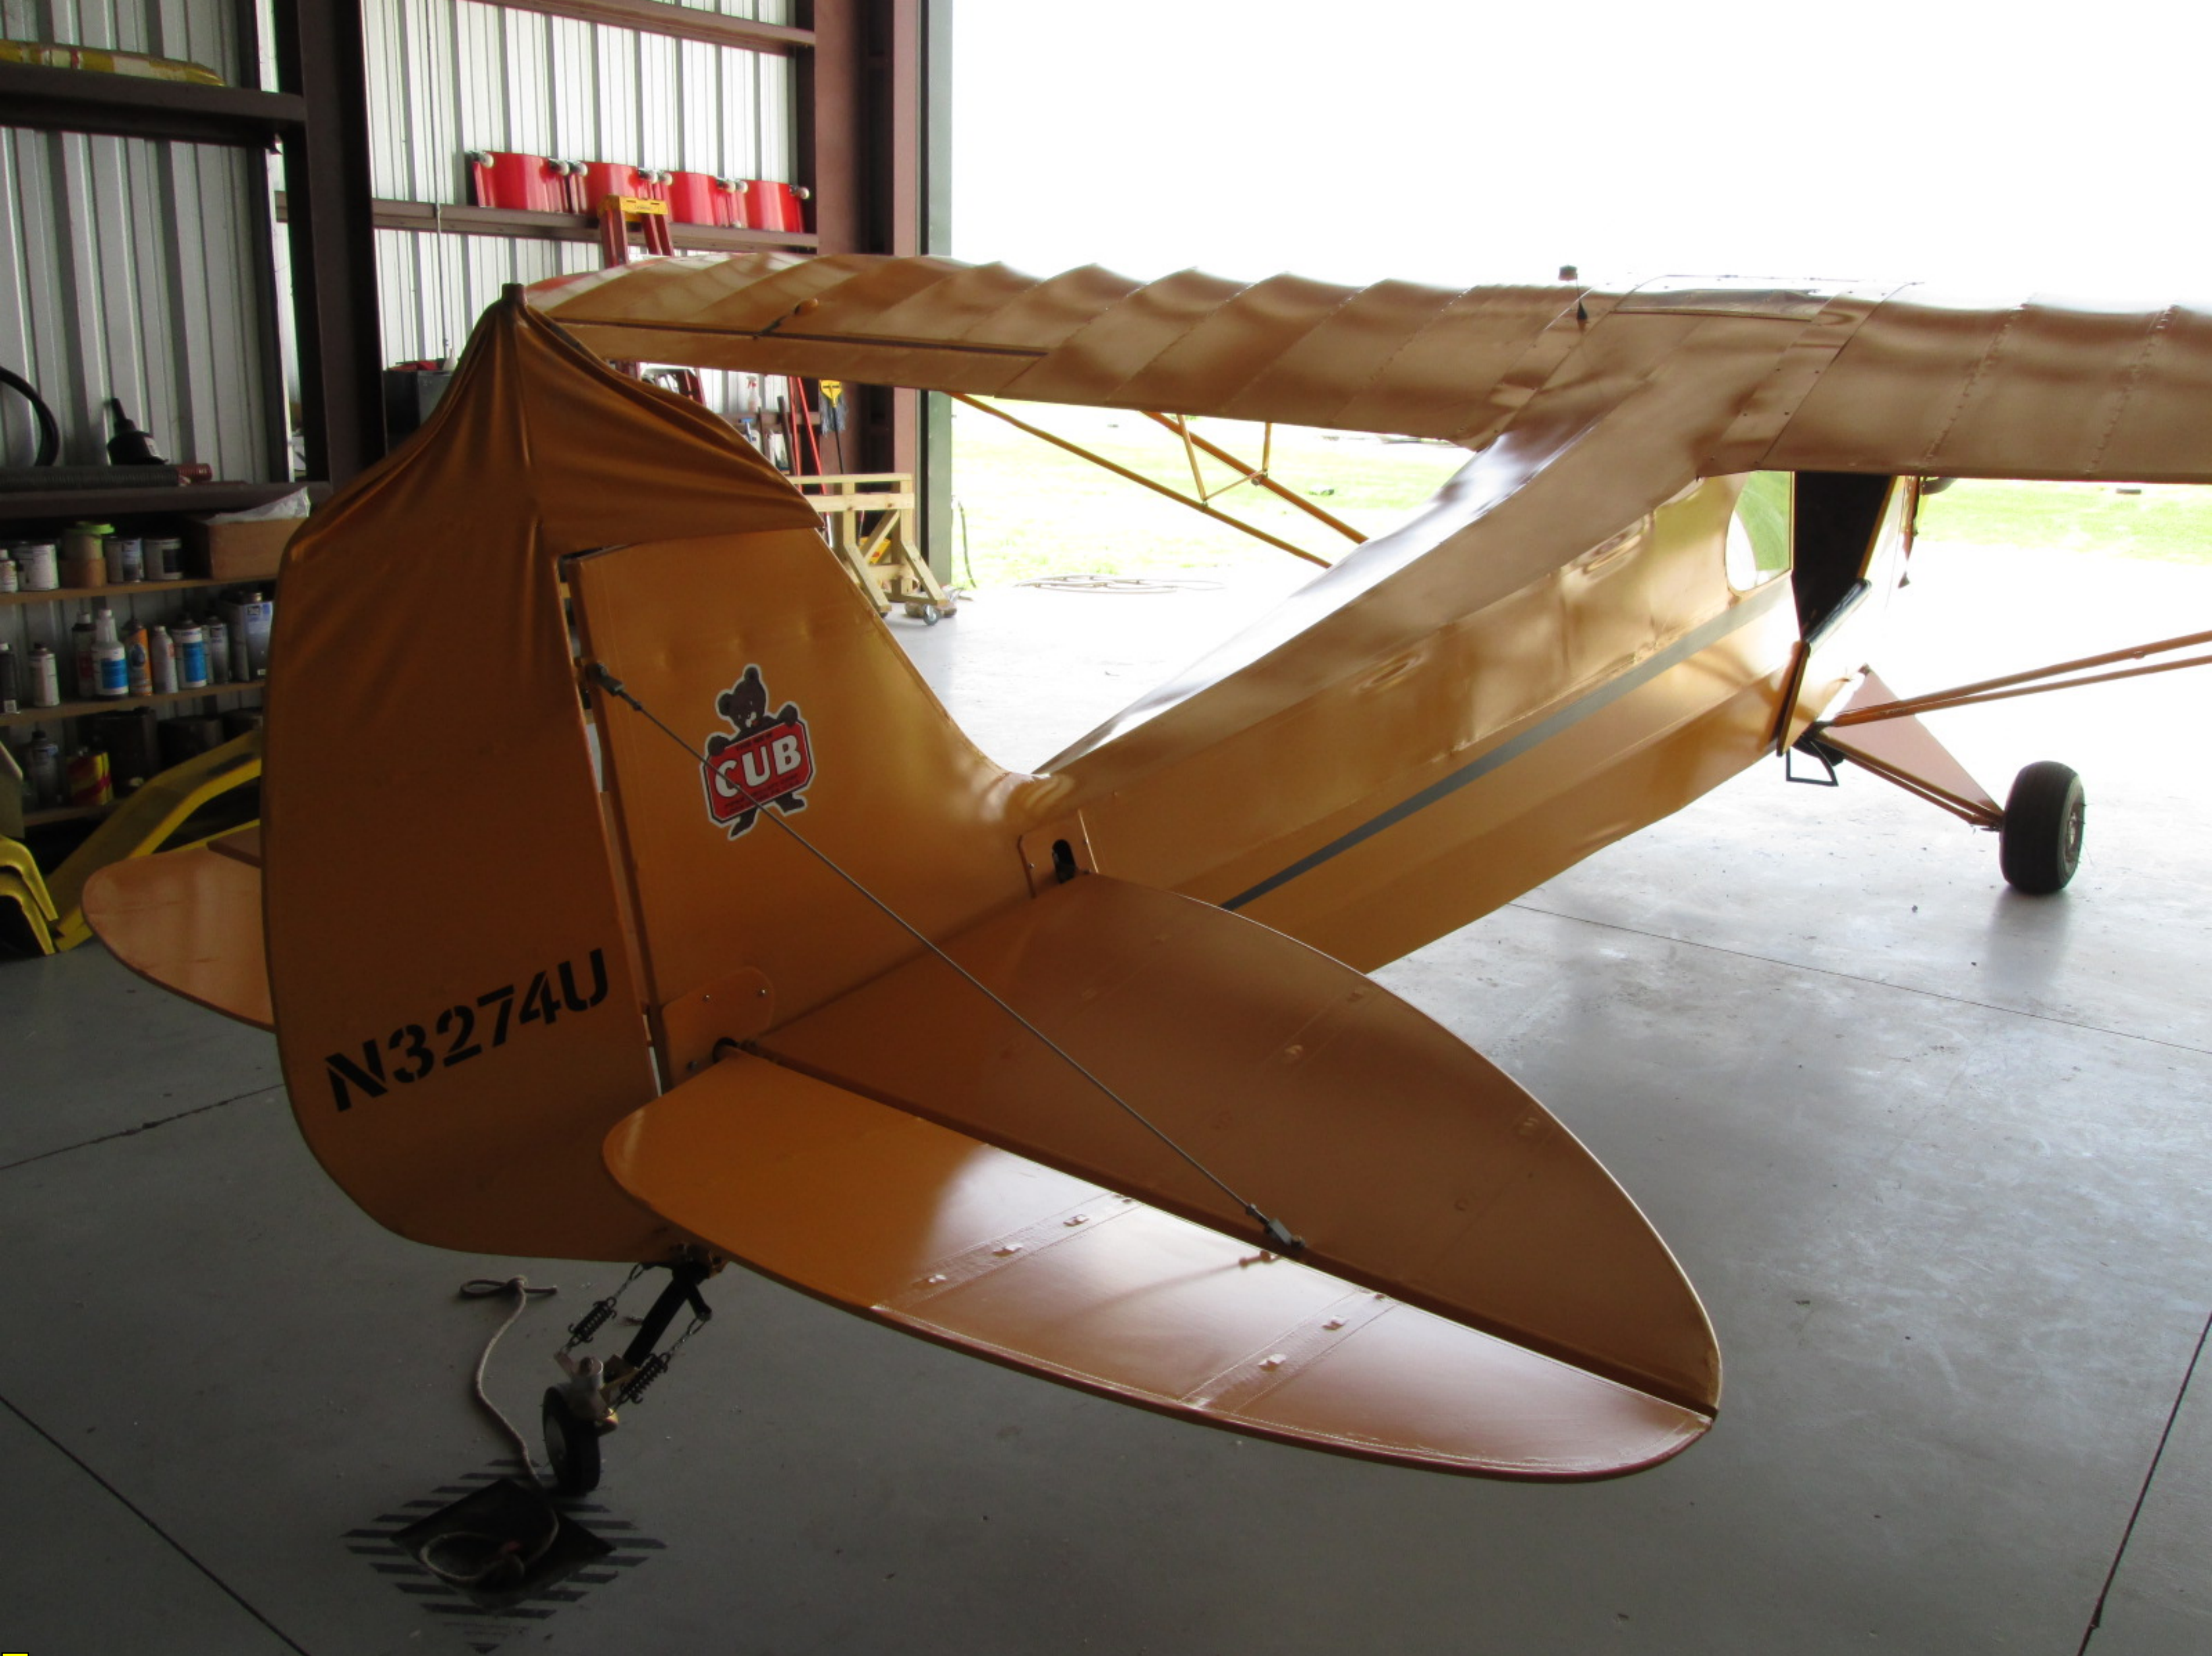
Photograph 1: Substantial damage to empennage (Courtesy of FAA)
