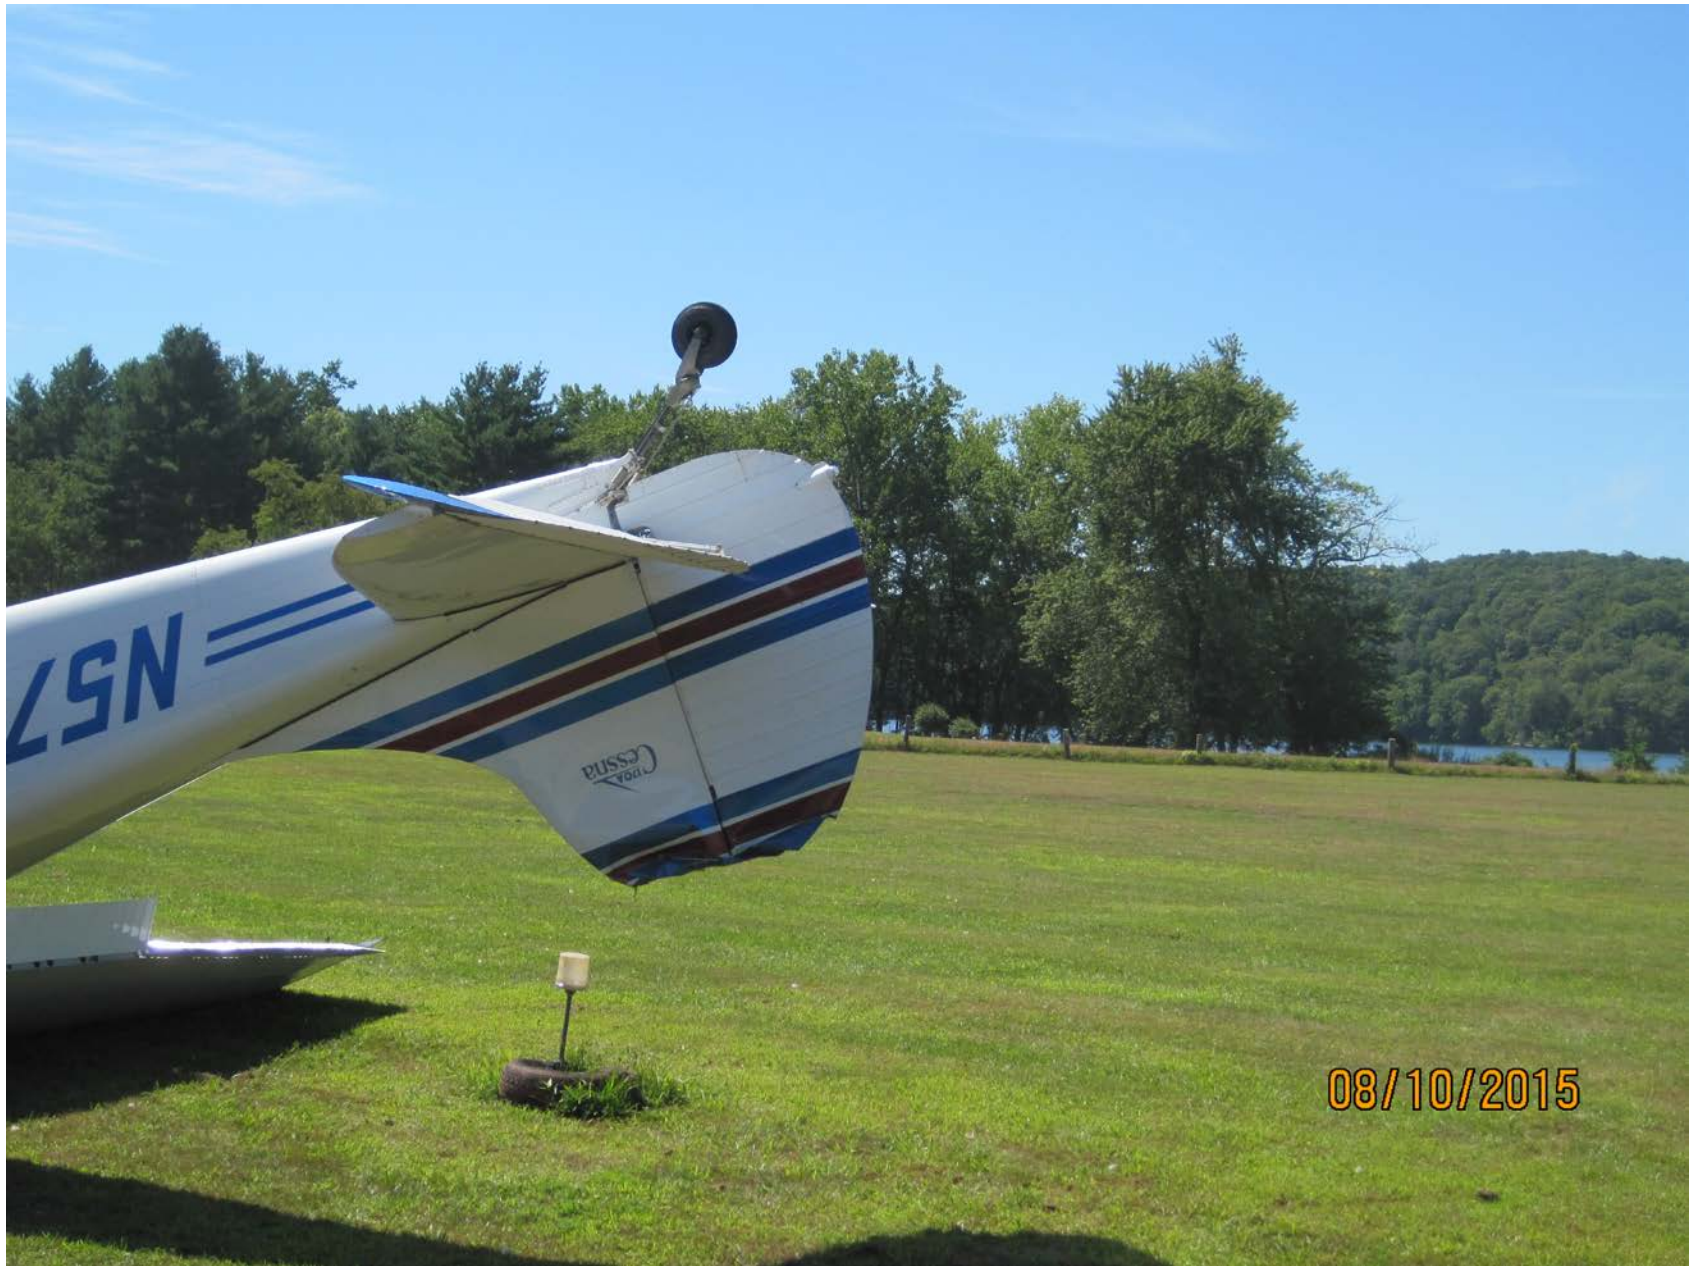
**Photo 1 – -View of empennage damage (photo courtesy of the FAA)**
