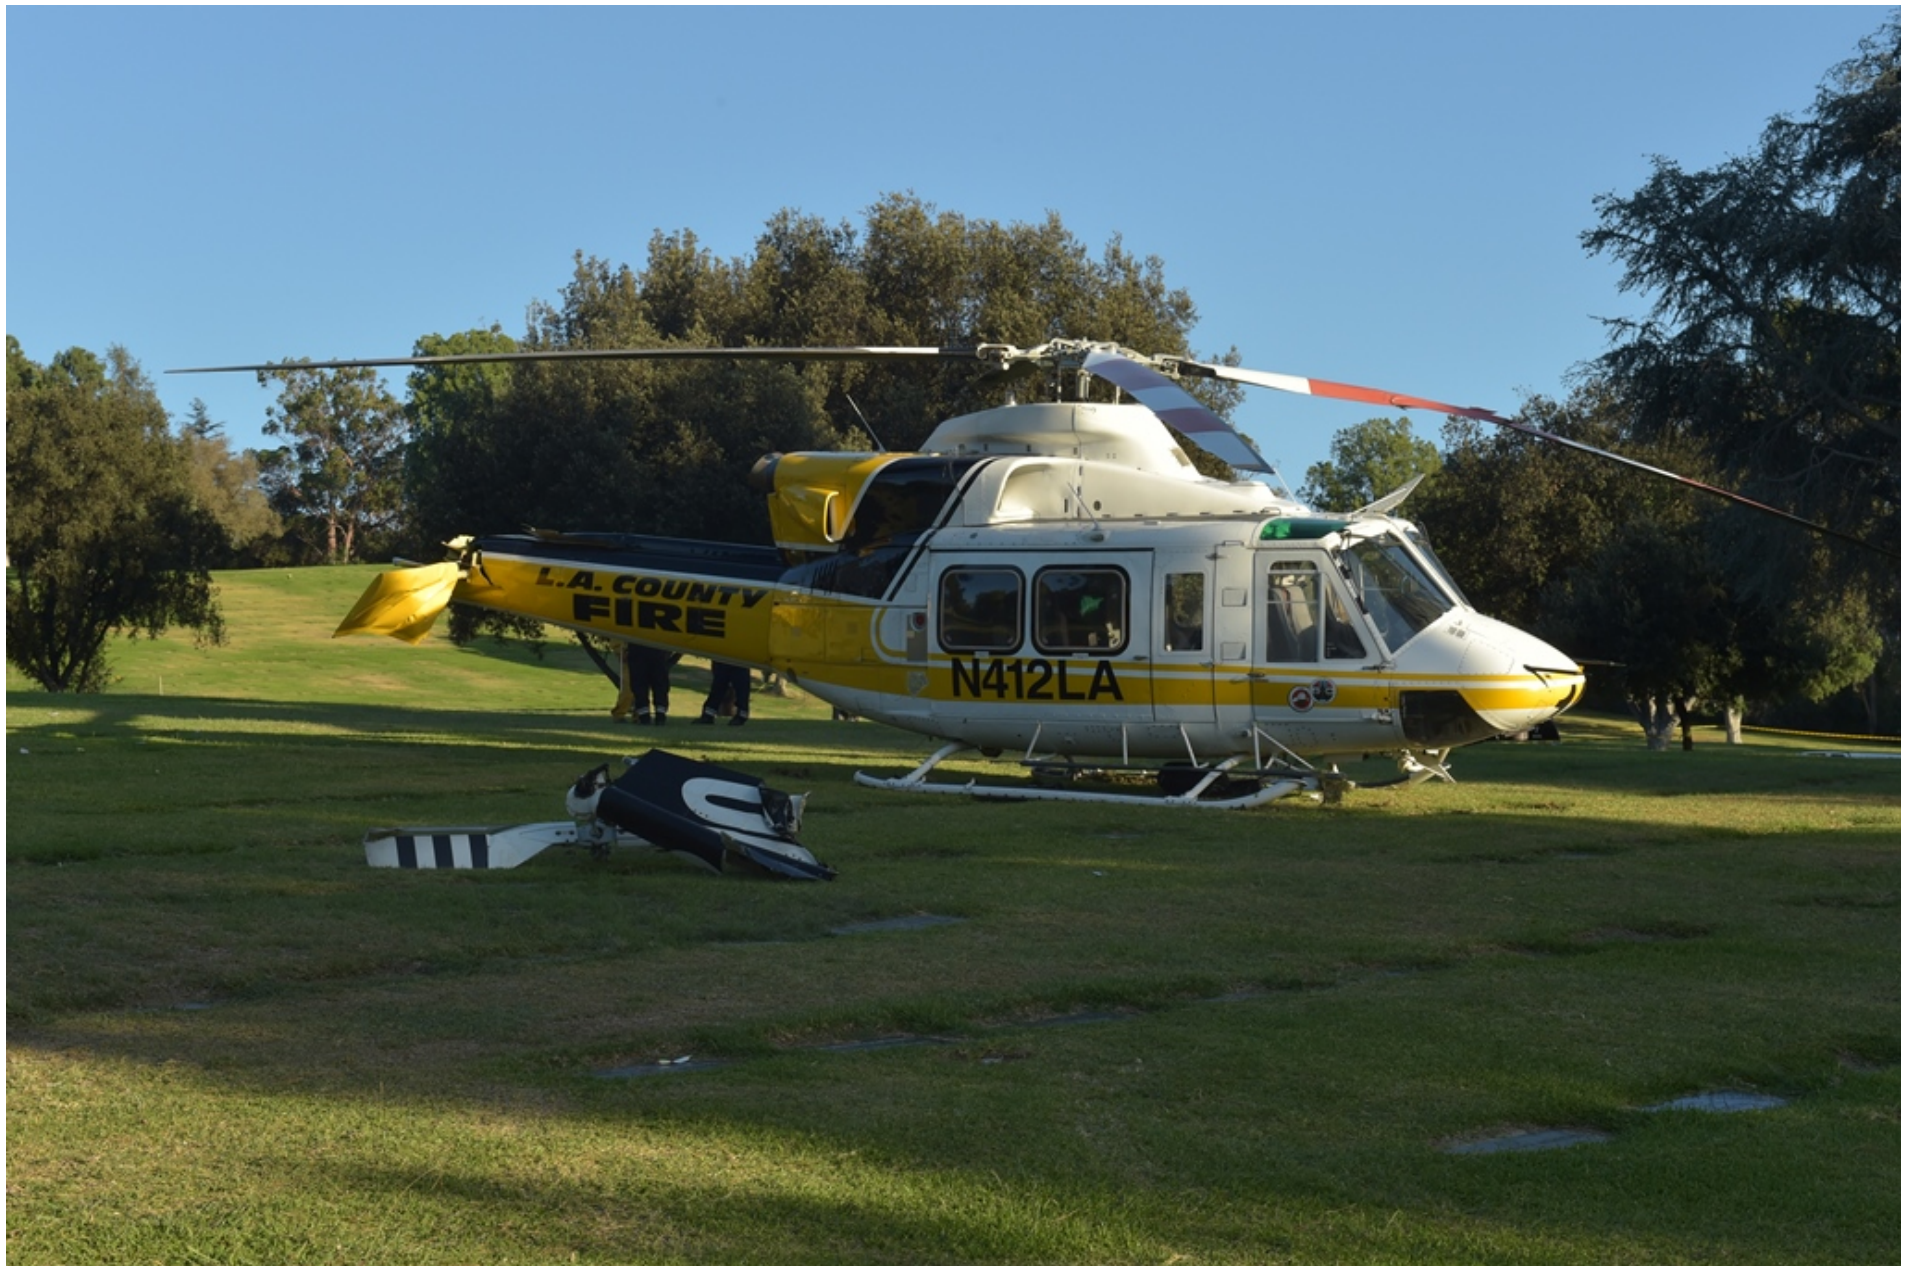
**Photo 1 – View of substantial damage to tail pylon, main rotor and tail rotor blades**
