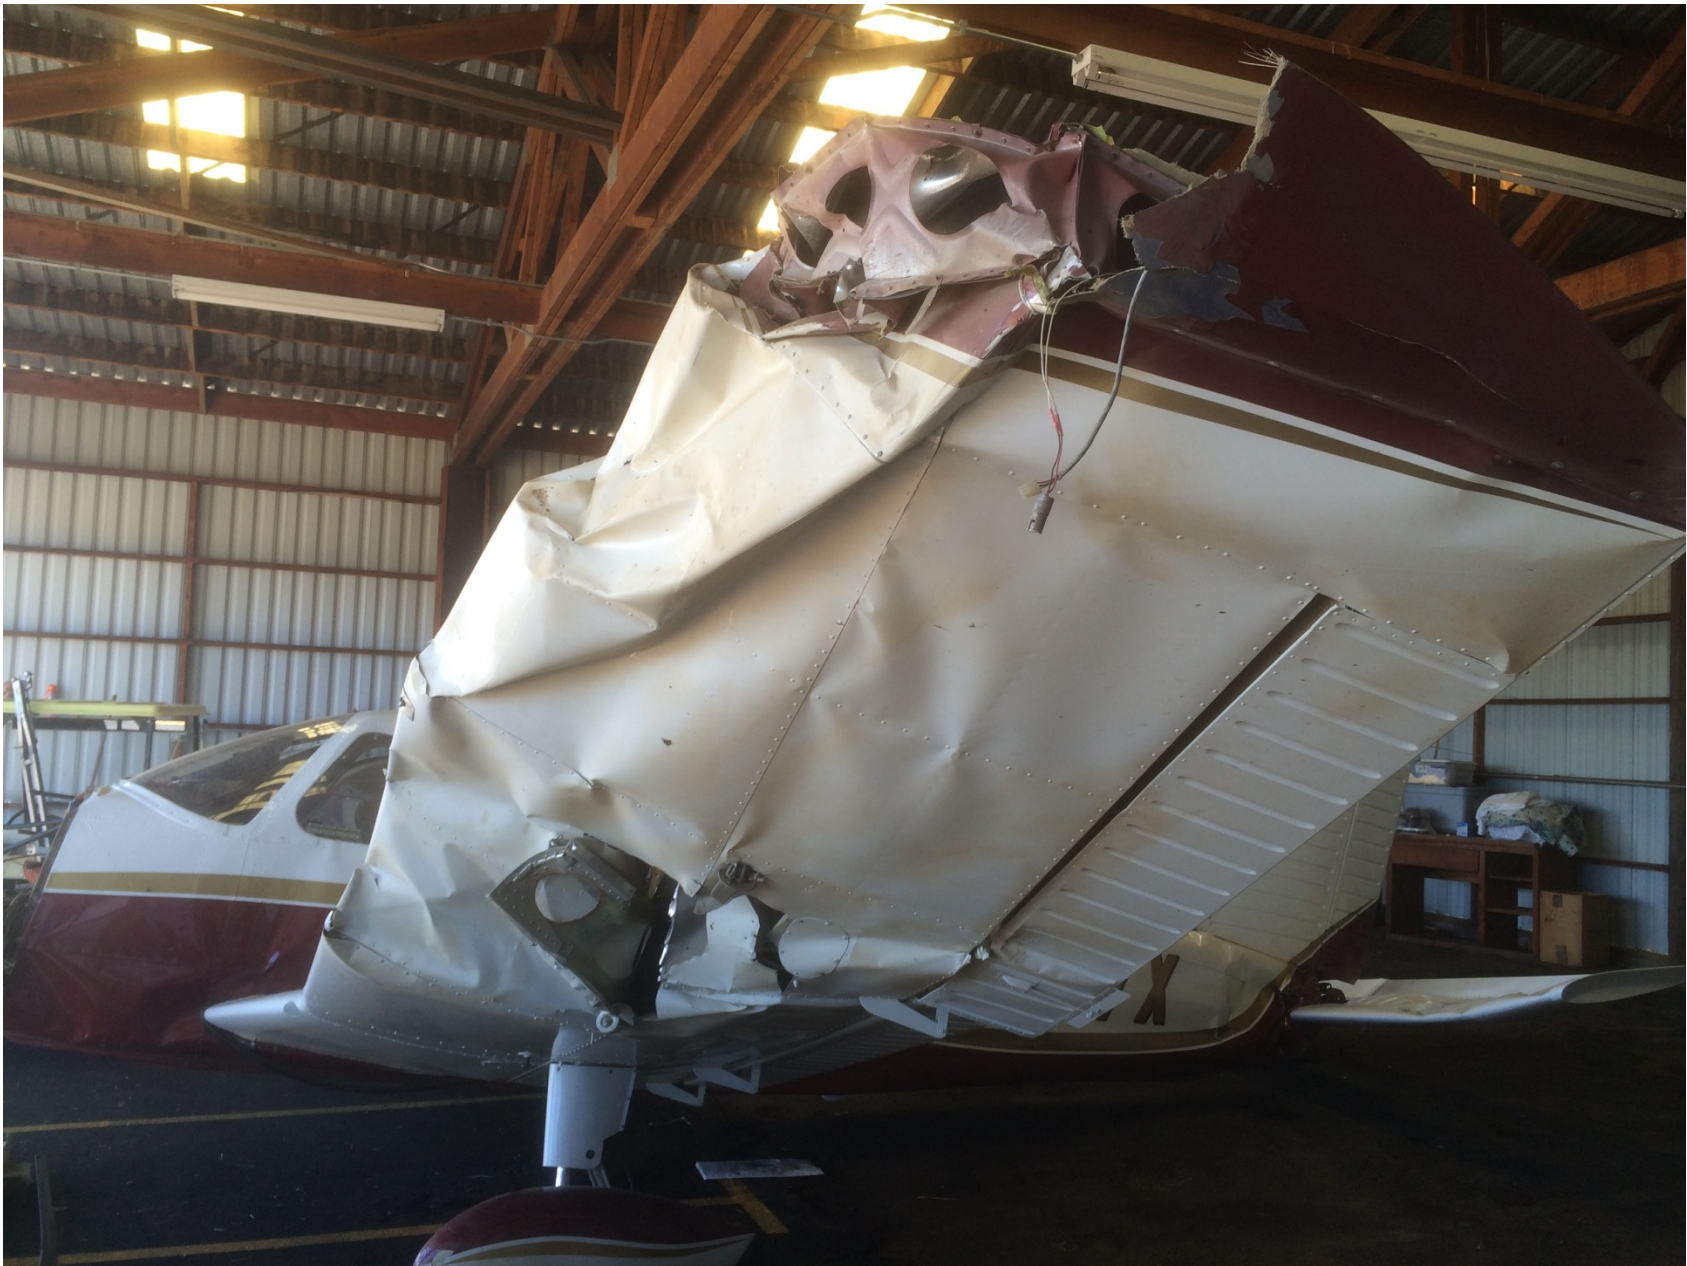
**Photo 1 –View of left wing damage (photo courtesy of the FAA)**

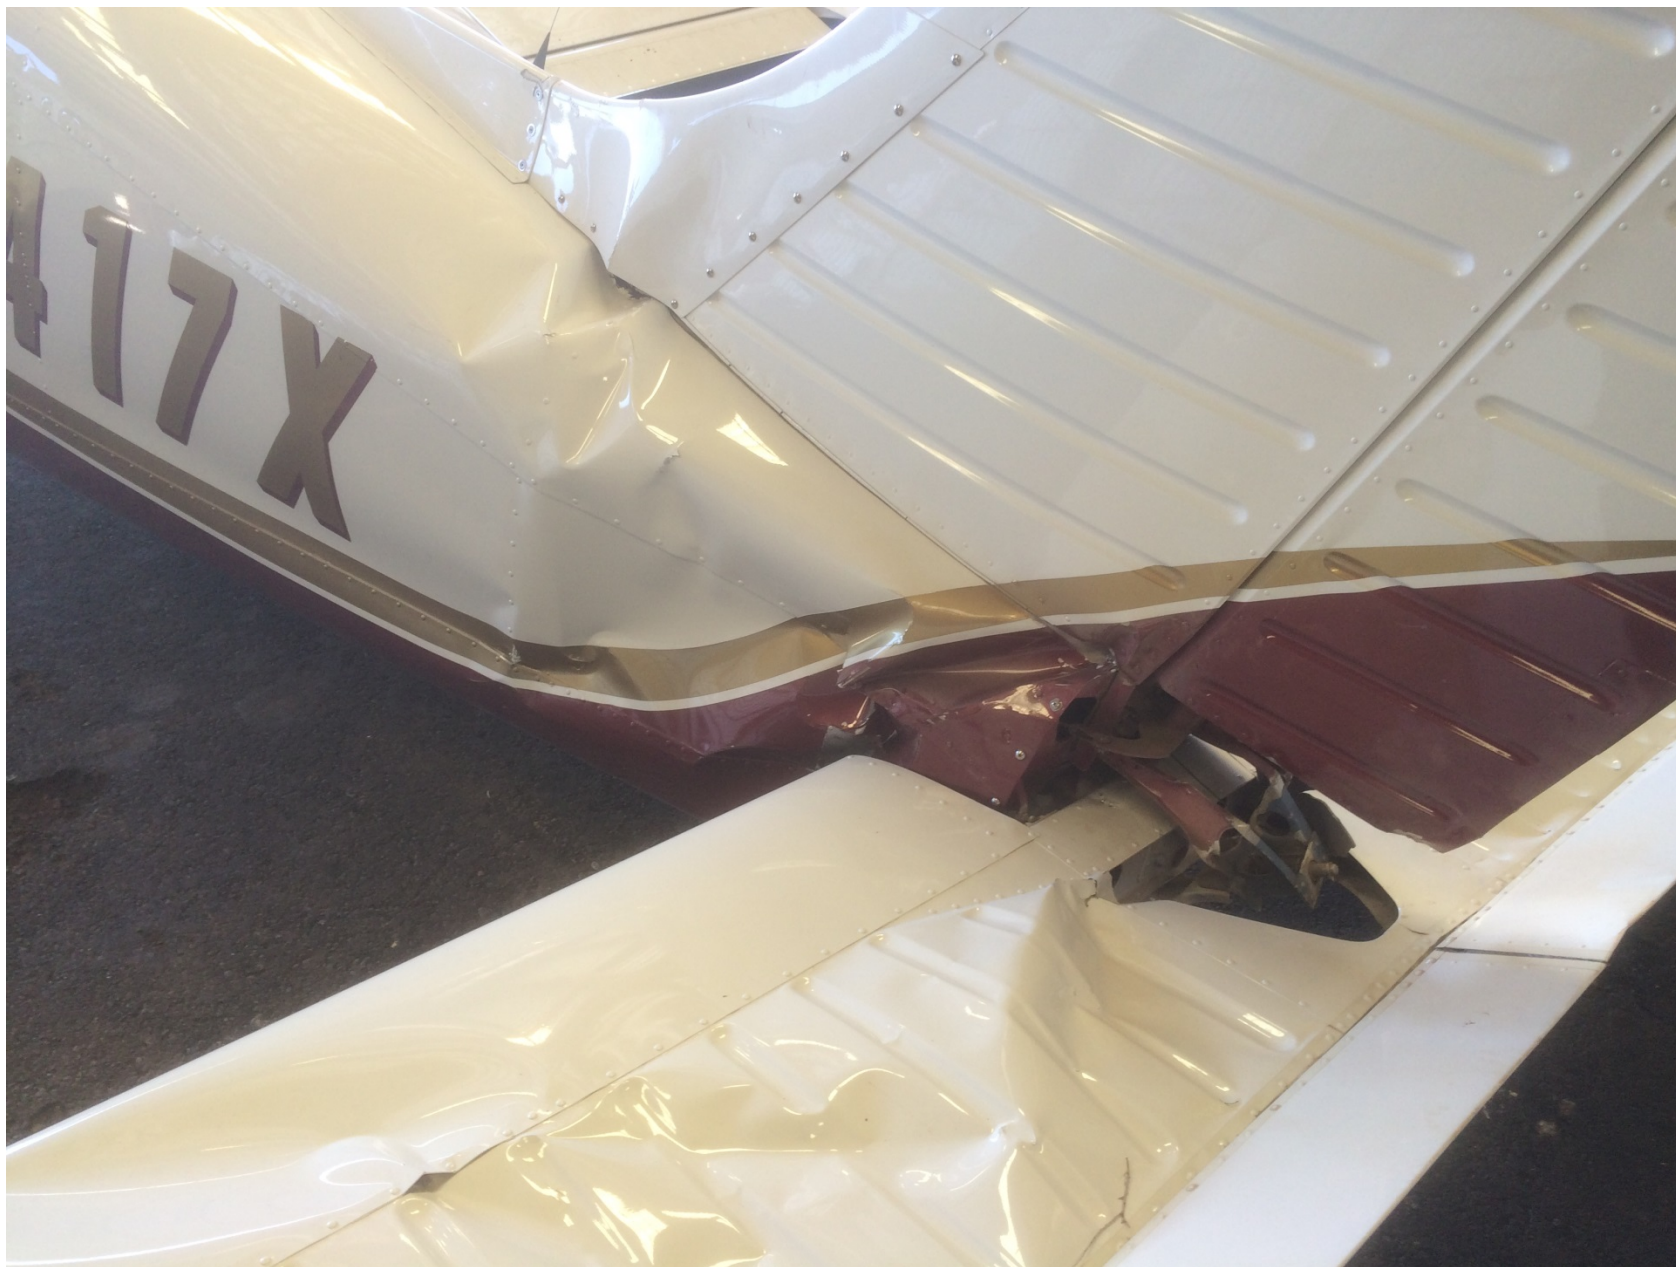
**Photo 2 -View of empennage damage (photo courtesy of the FAA)**
