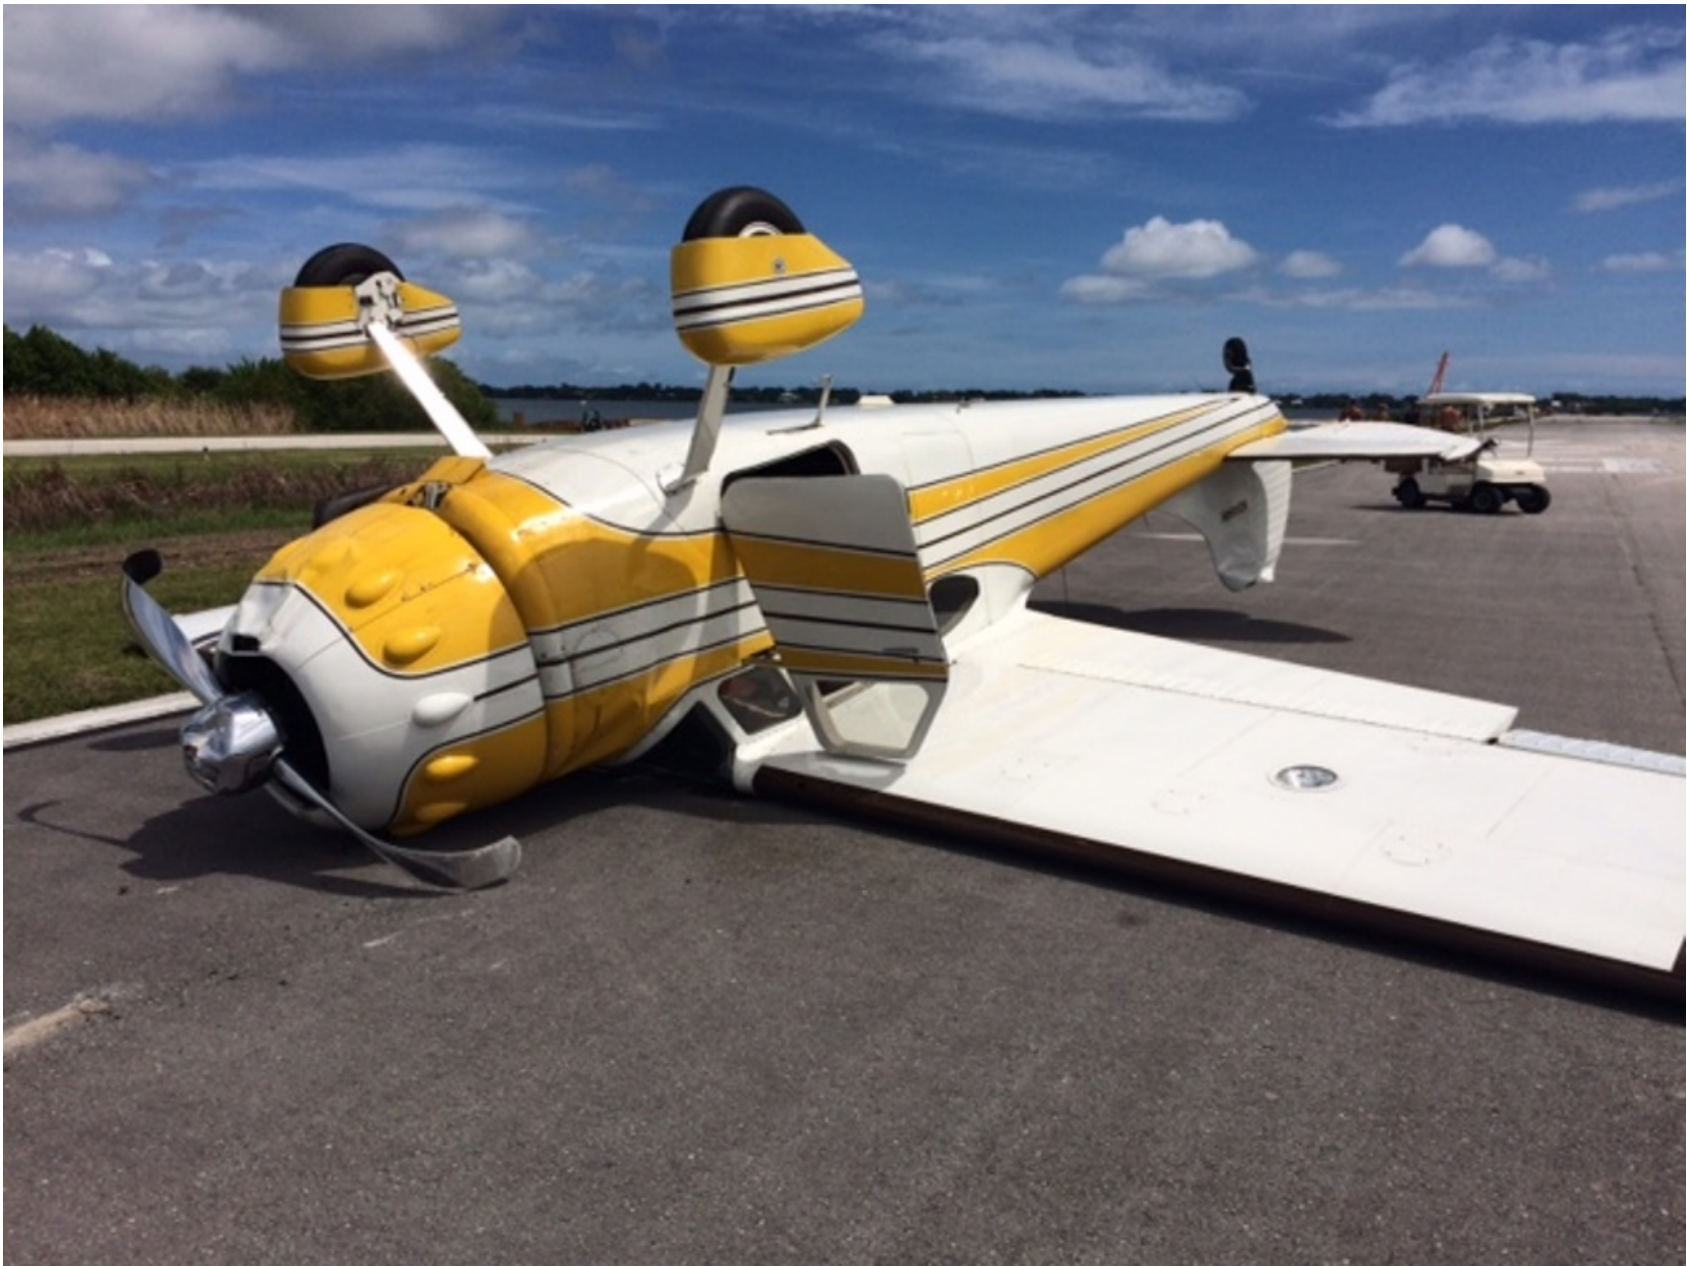
**Photo 1 – View of substantial damage to vertical stabilizer and rudder (Courtesy of FAA)**

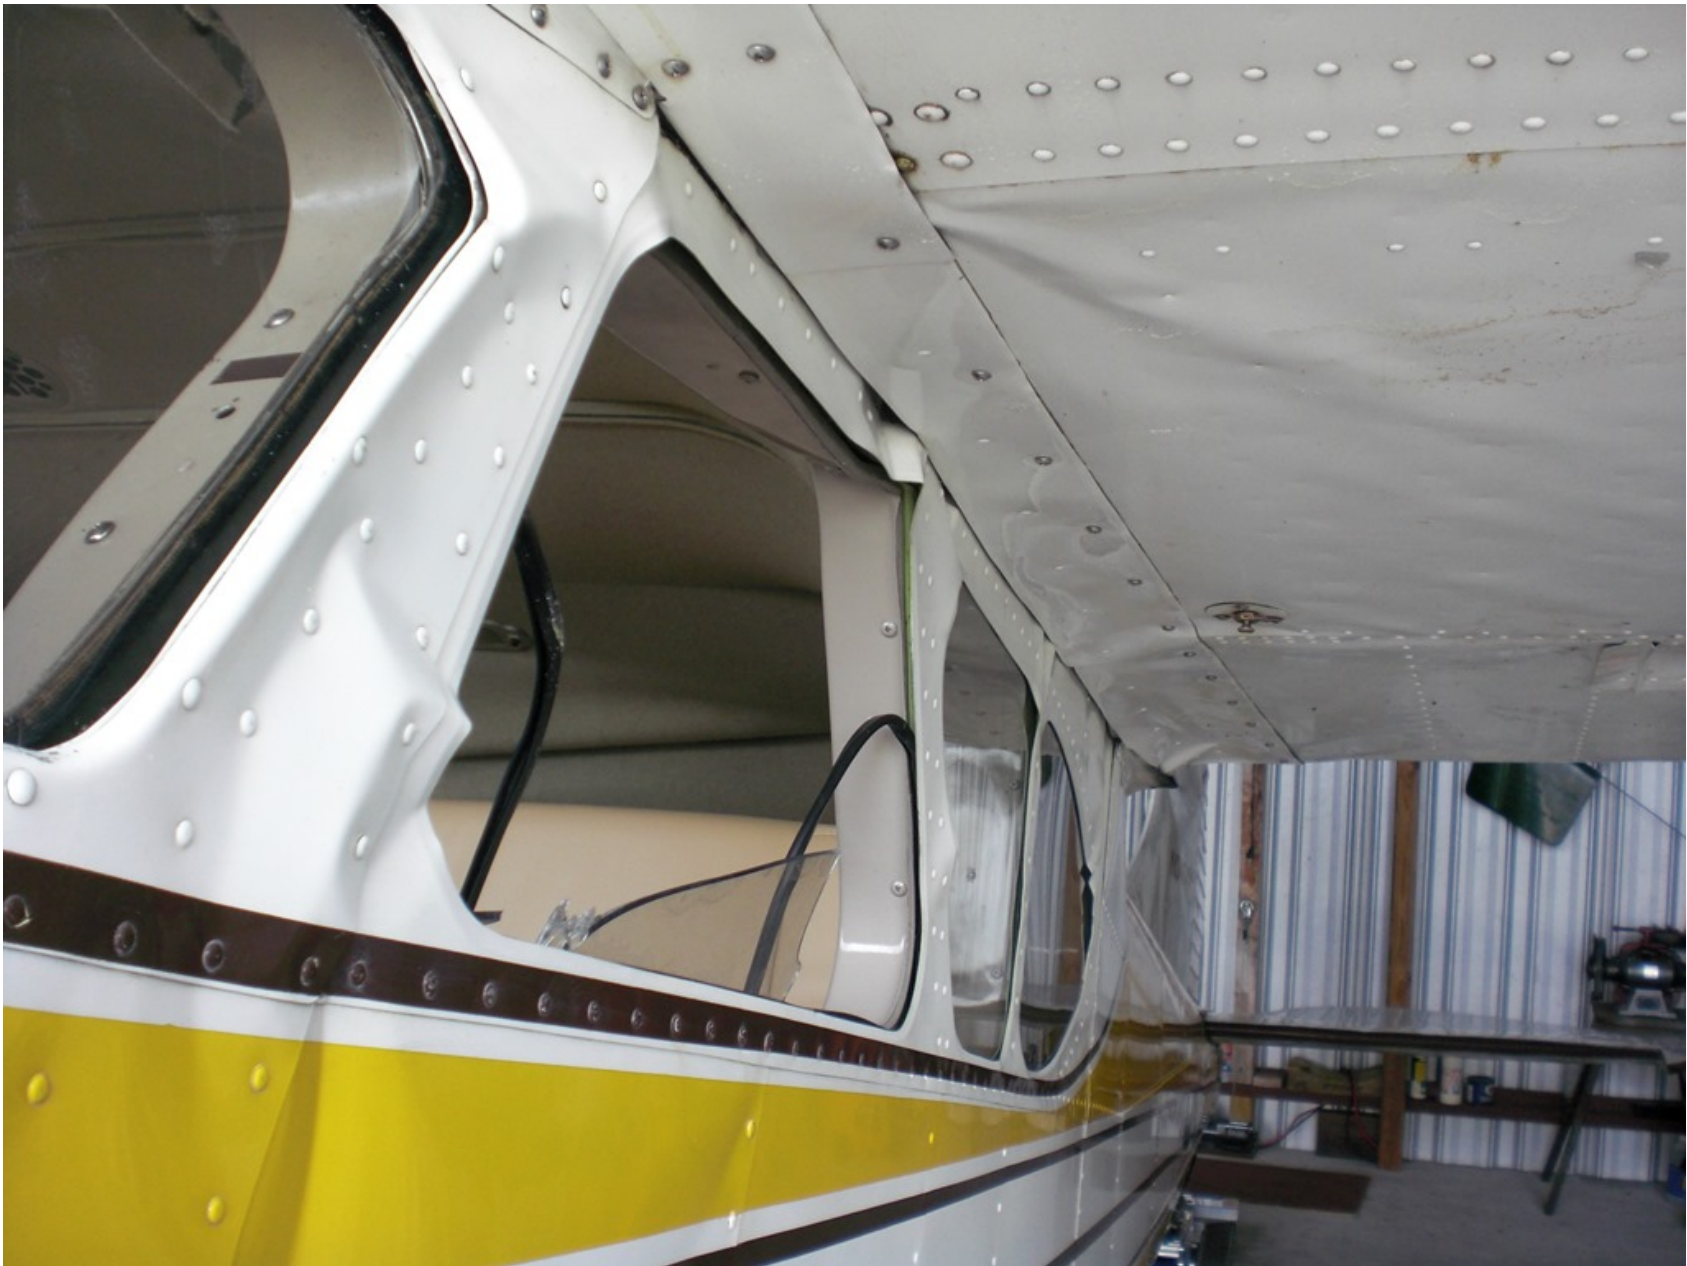
**Photo 2 – View of substantial damage to fuselage and left inboard wing (Courtesy of FAA)**

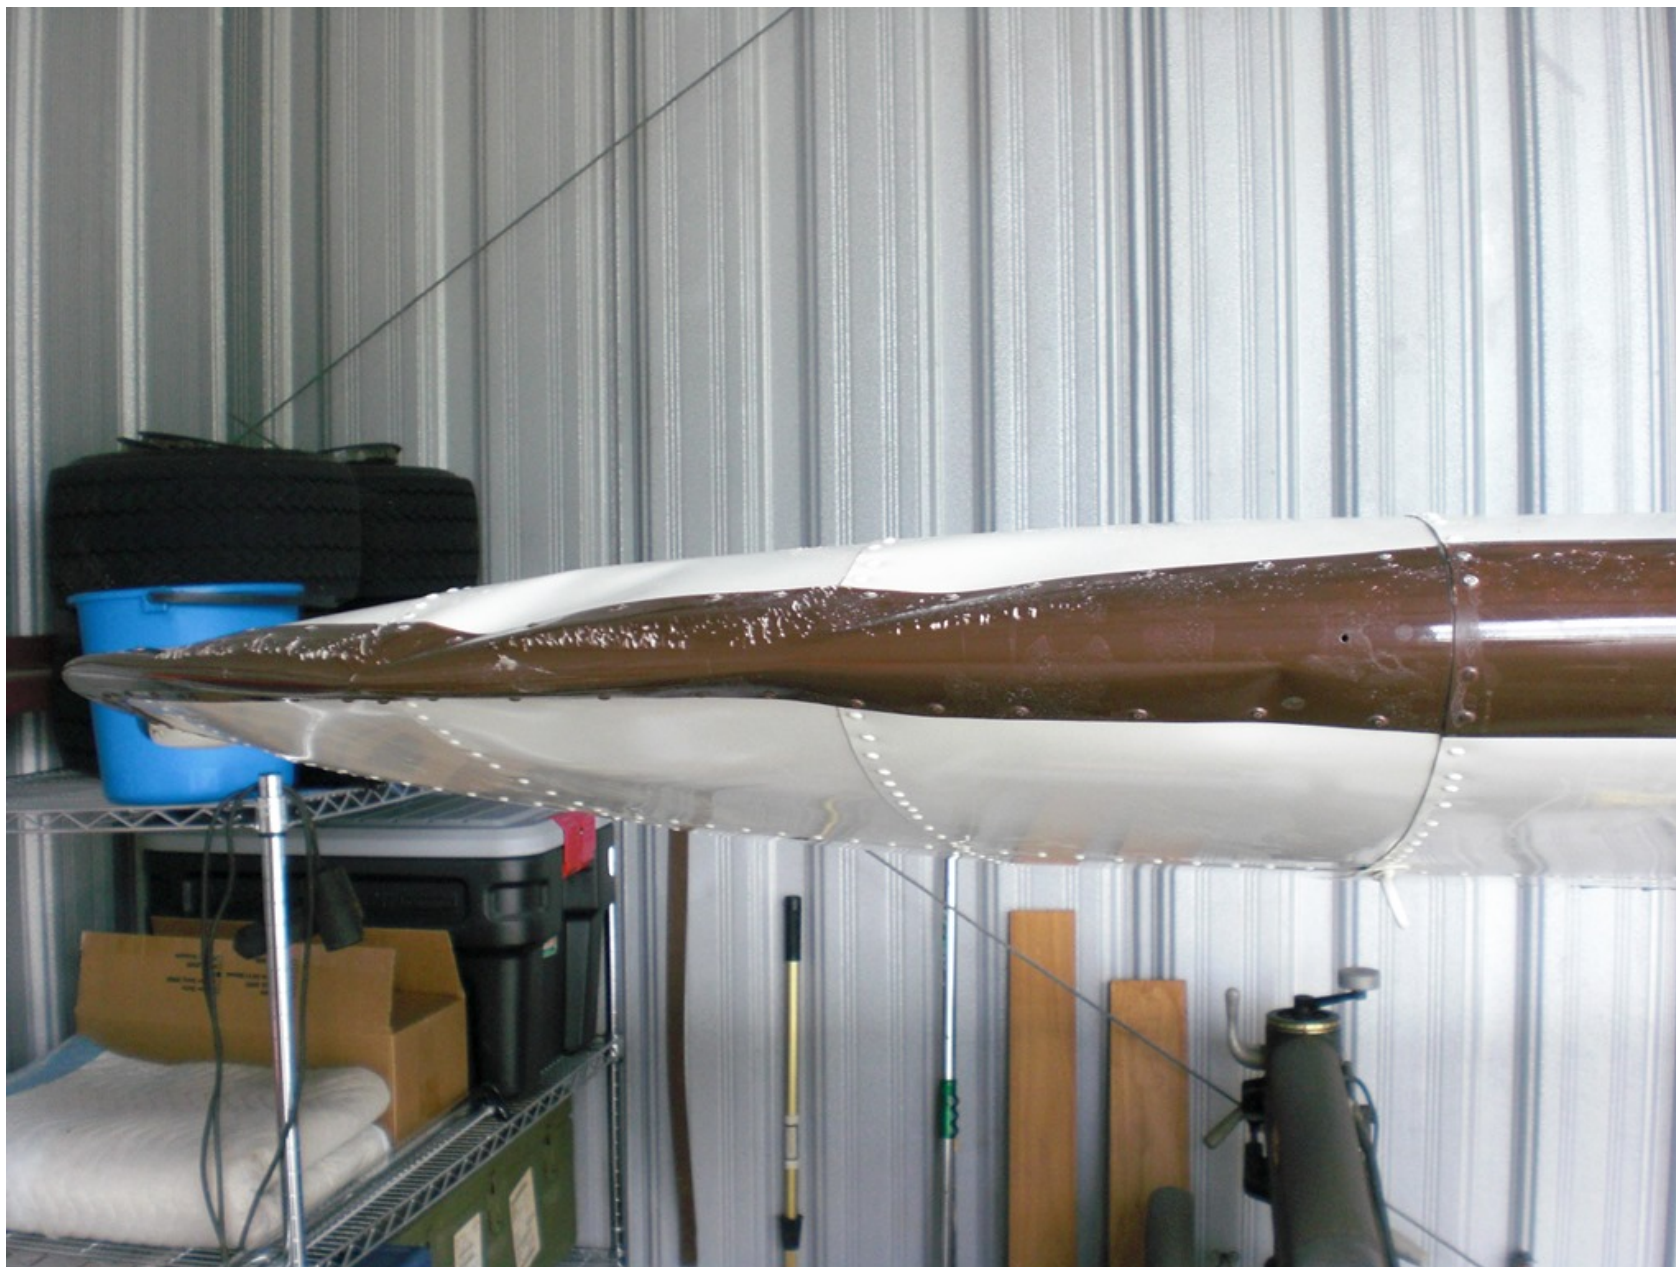
**Photo 3 – View of damage to outboard right wing (Courtesy of FAA)**

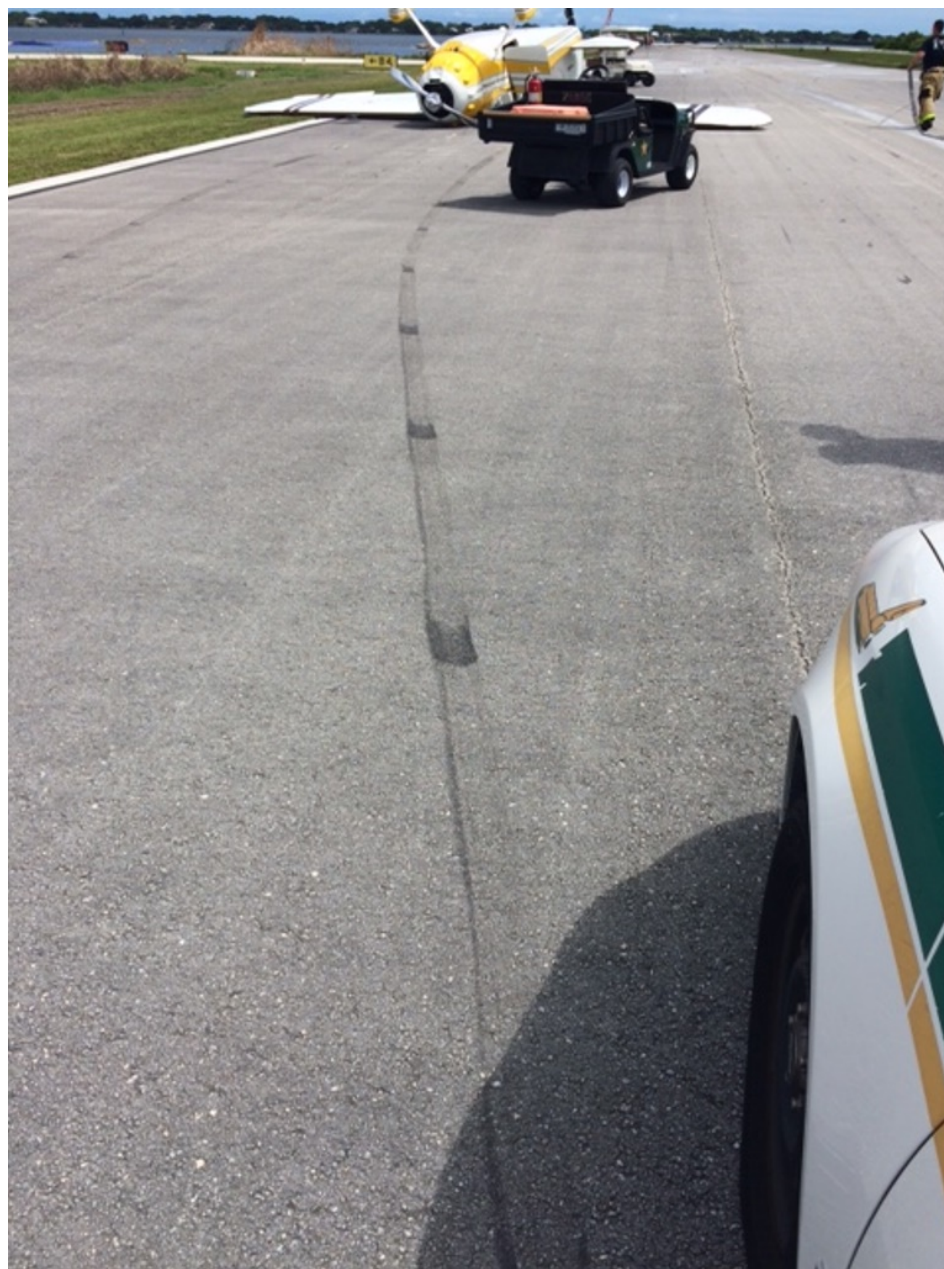
**Photo 4 - View of right tire skid marks (Courtesy of FAA)**

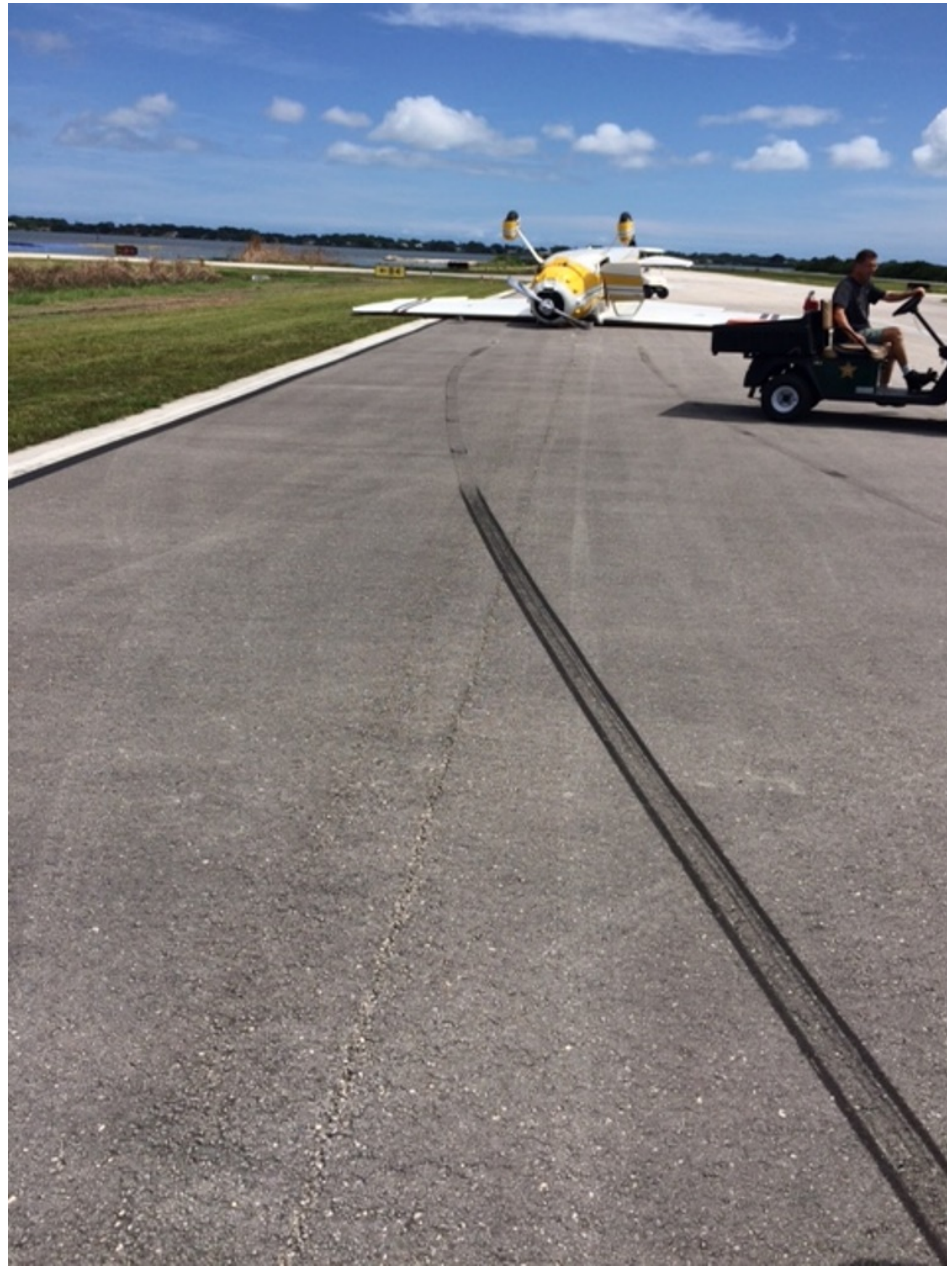
**Photo 5 - View of left tire skid marks (Courtesy of FAA)**
