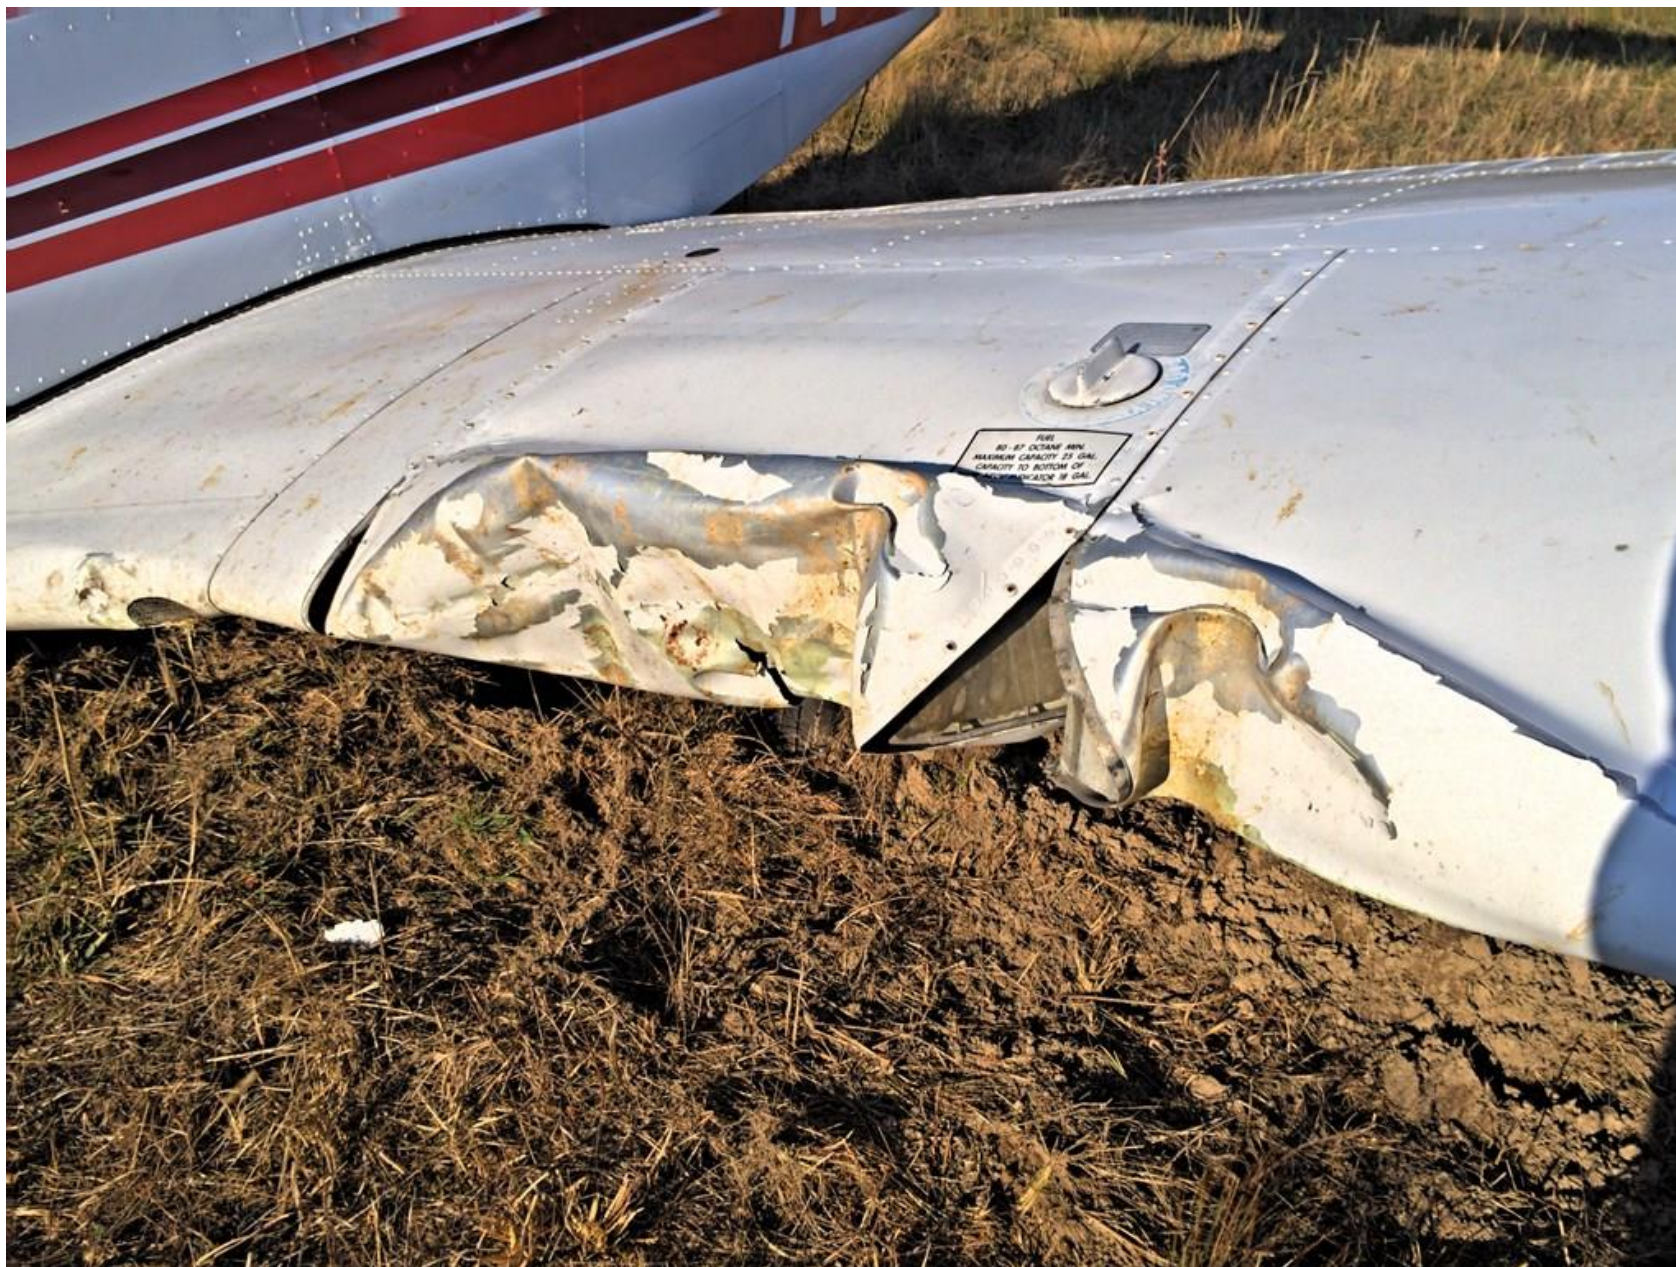
**Photo 1 – Left wing leading edge impact damage after colliding with trees (Courtesy of FAA)**
