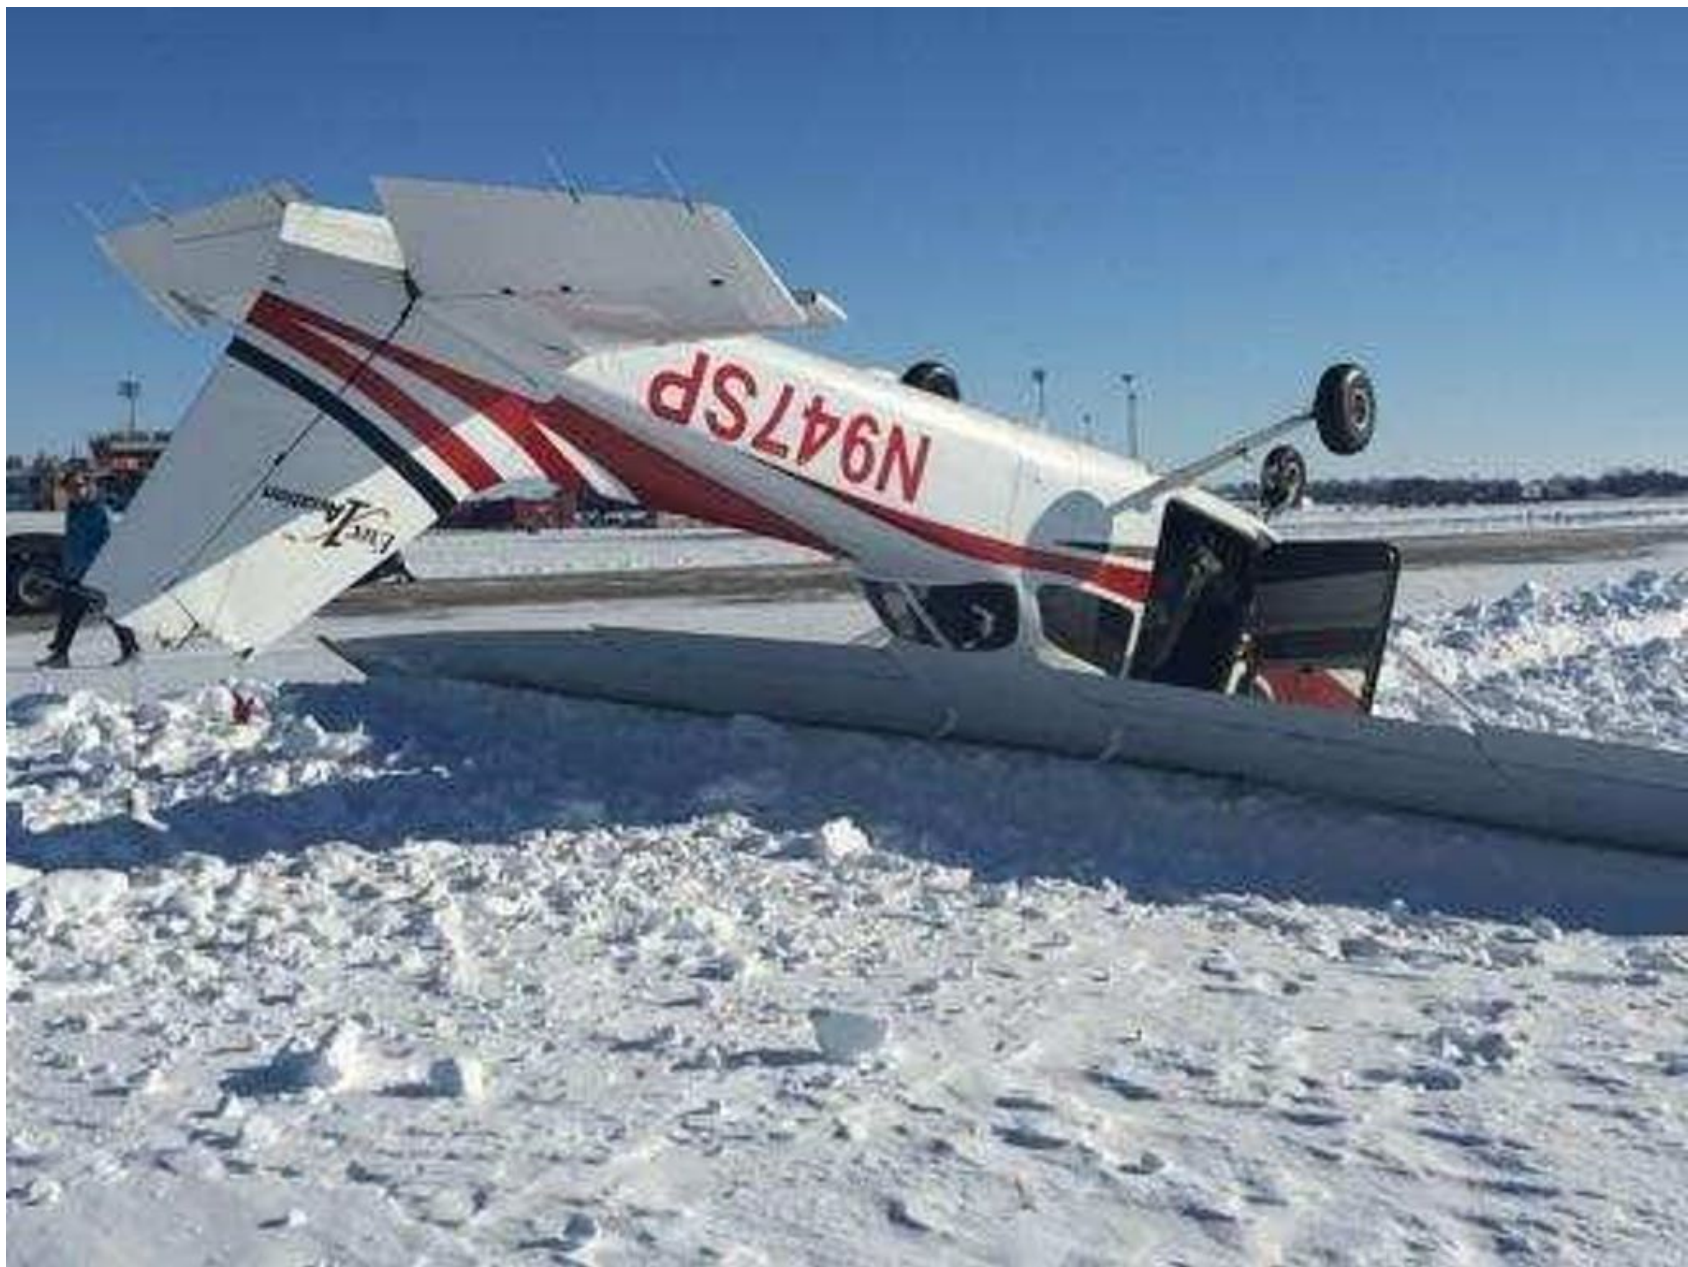
**Photo 1 – View of damage to vertical stabilizer and rudder (Courtesy of FAA)**

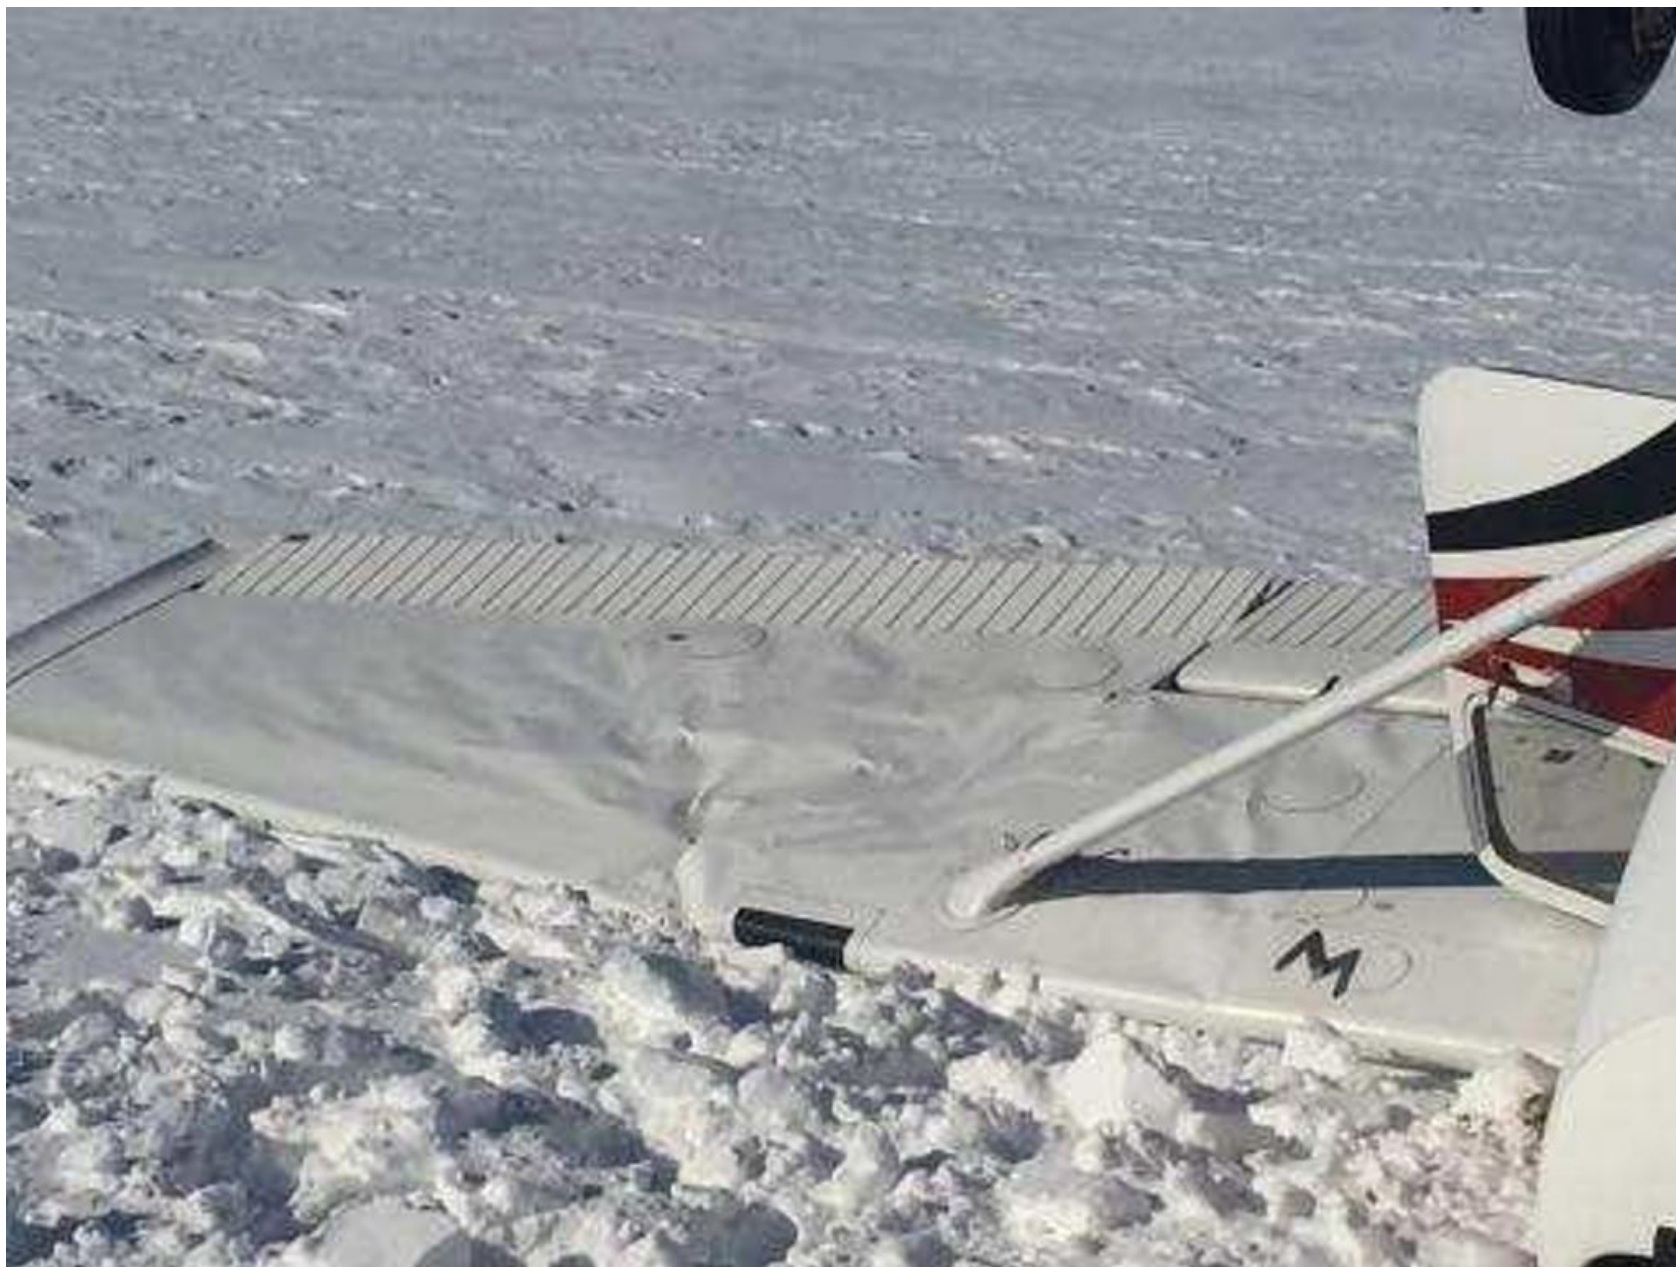
**Photo 2 – View of damage to left wing spar (Courtesy of FAA)**

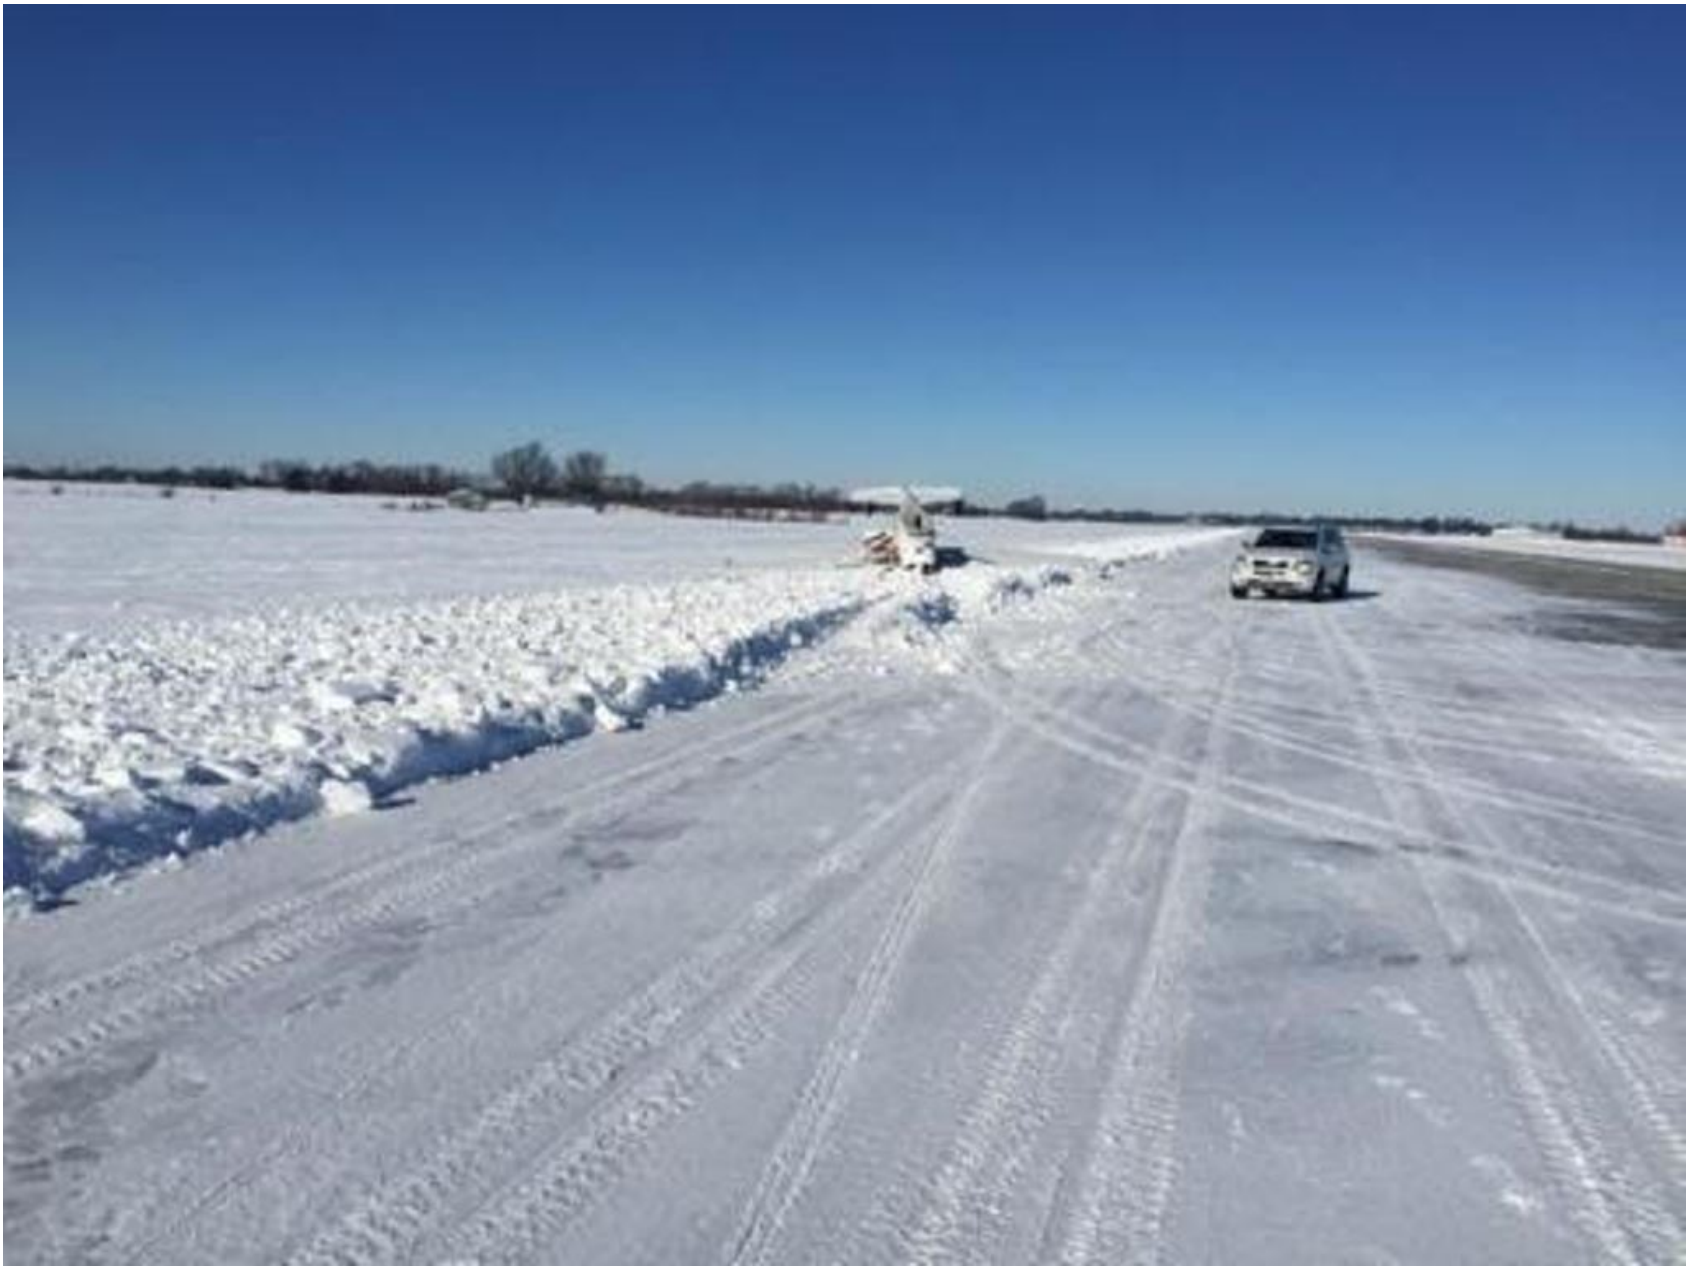
**Photo 3 – View of initial impact point (Courtesy of FAA)**
