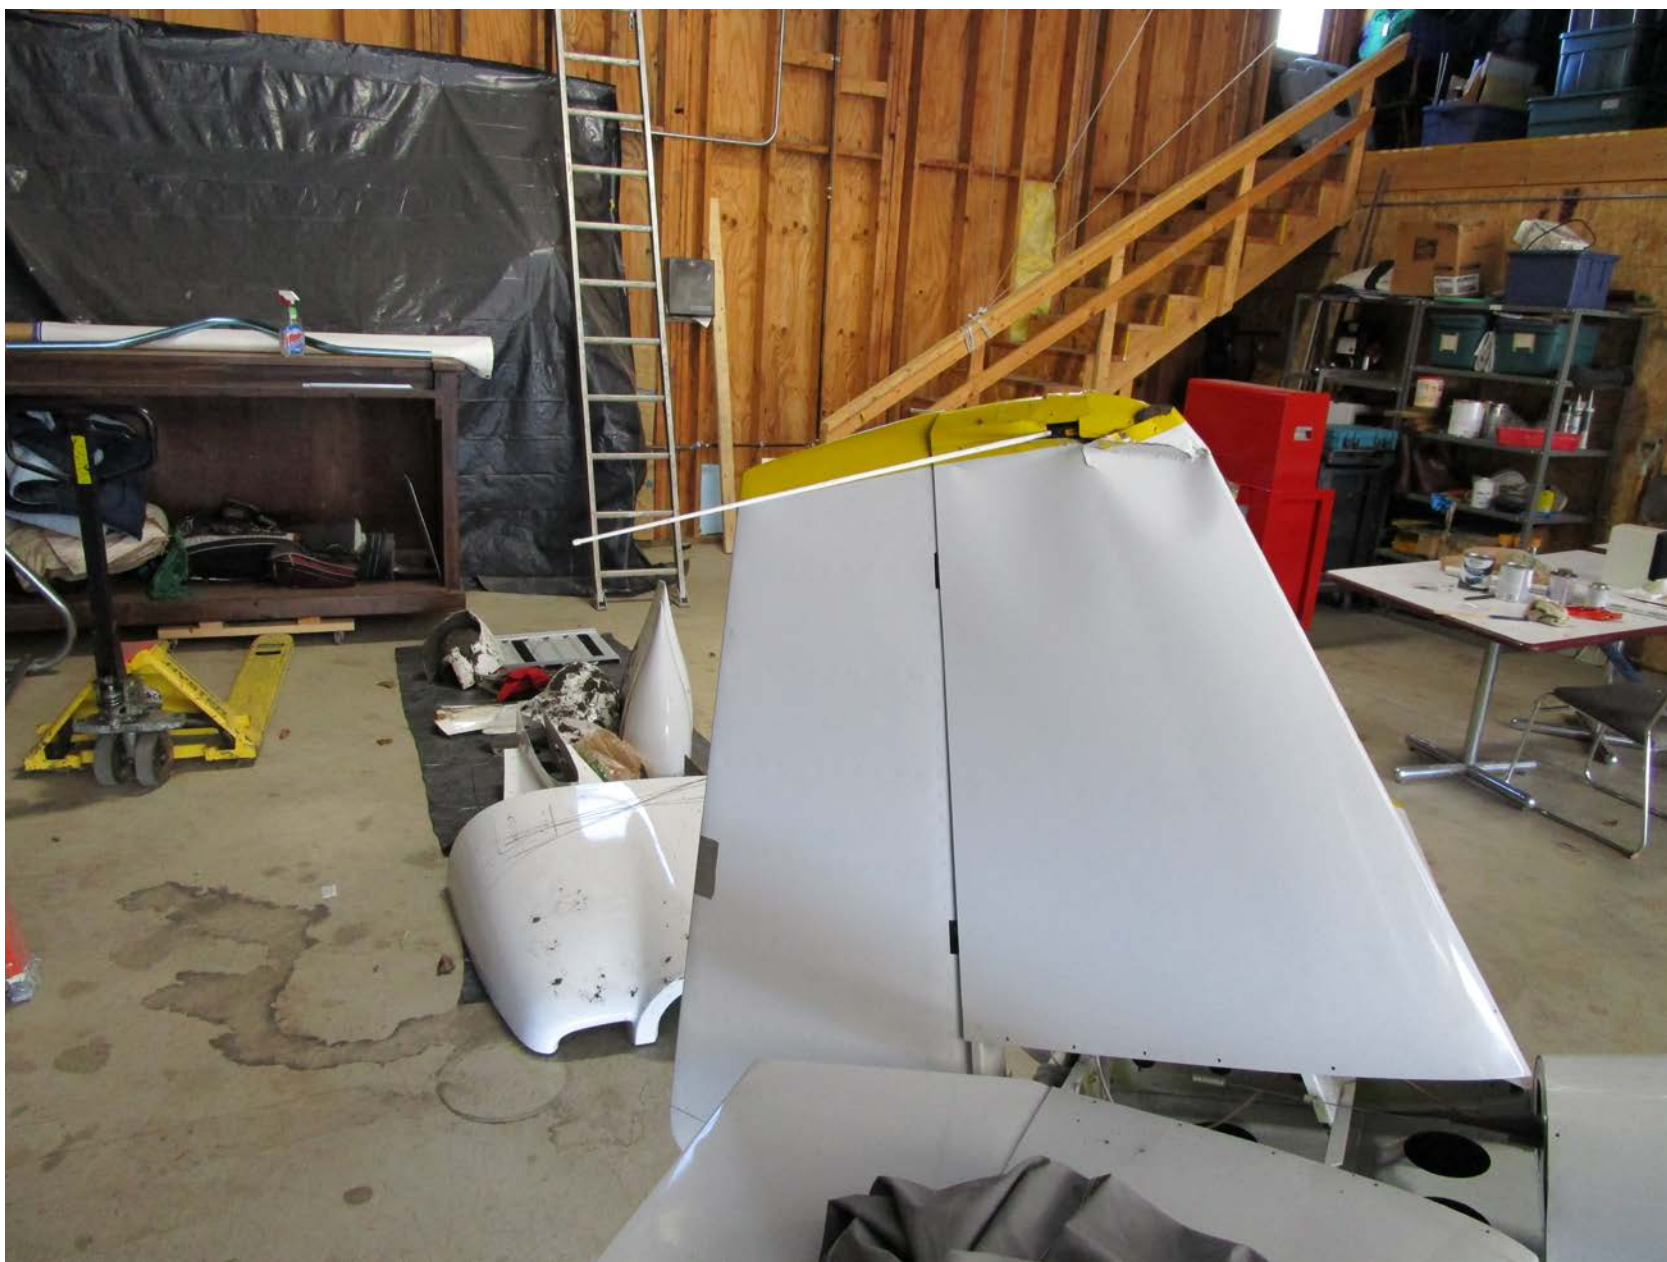
**Photo 1 – View of empennage damage (photo courtesy of the pilot)**
