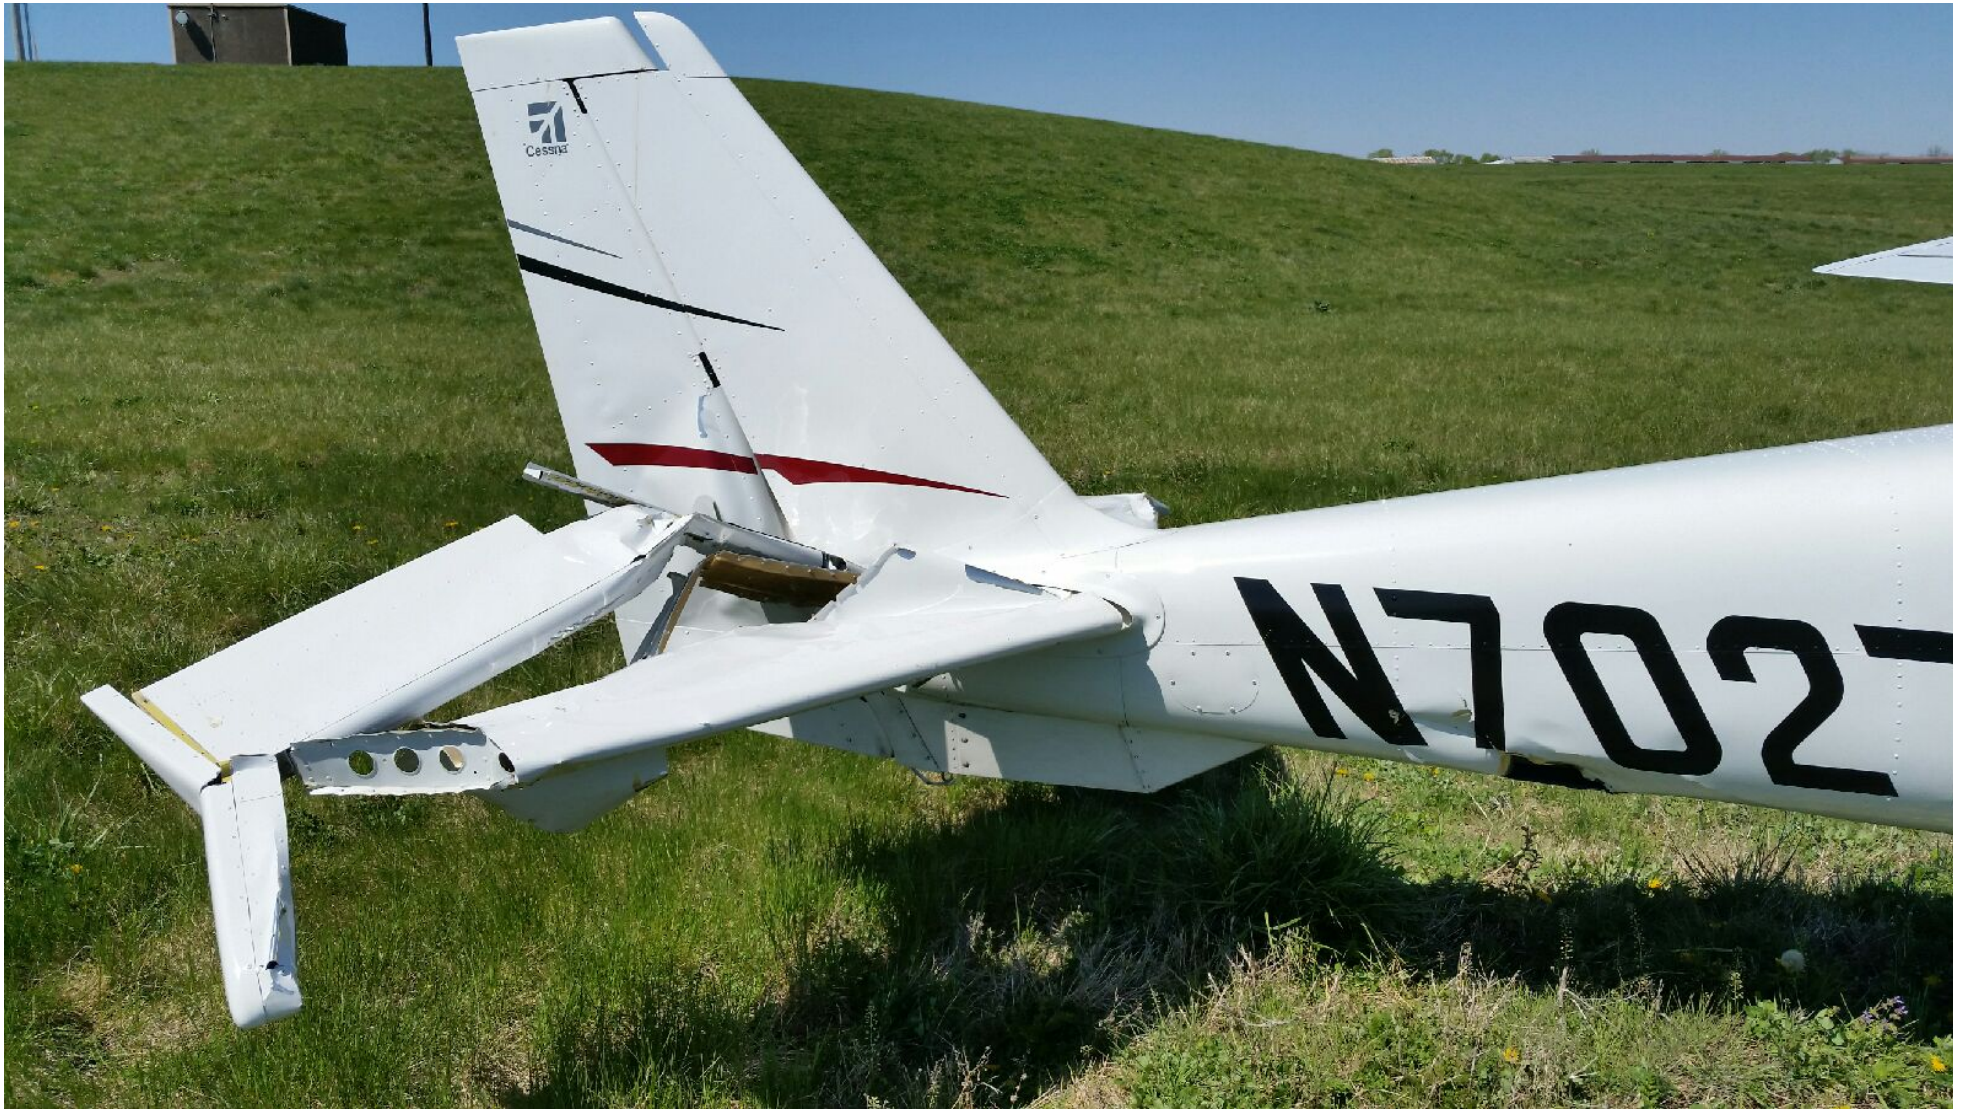
**Photo 1 – View of the empennage and substantial damage (Photo courtesy of FAA)**
