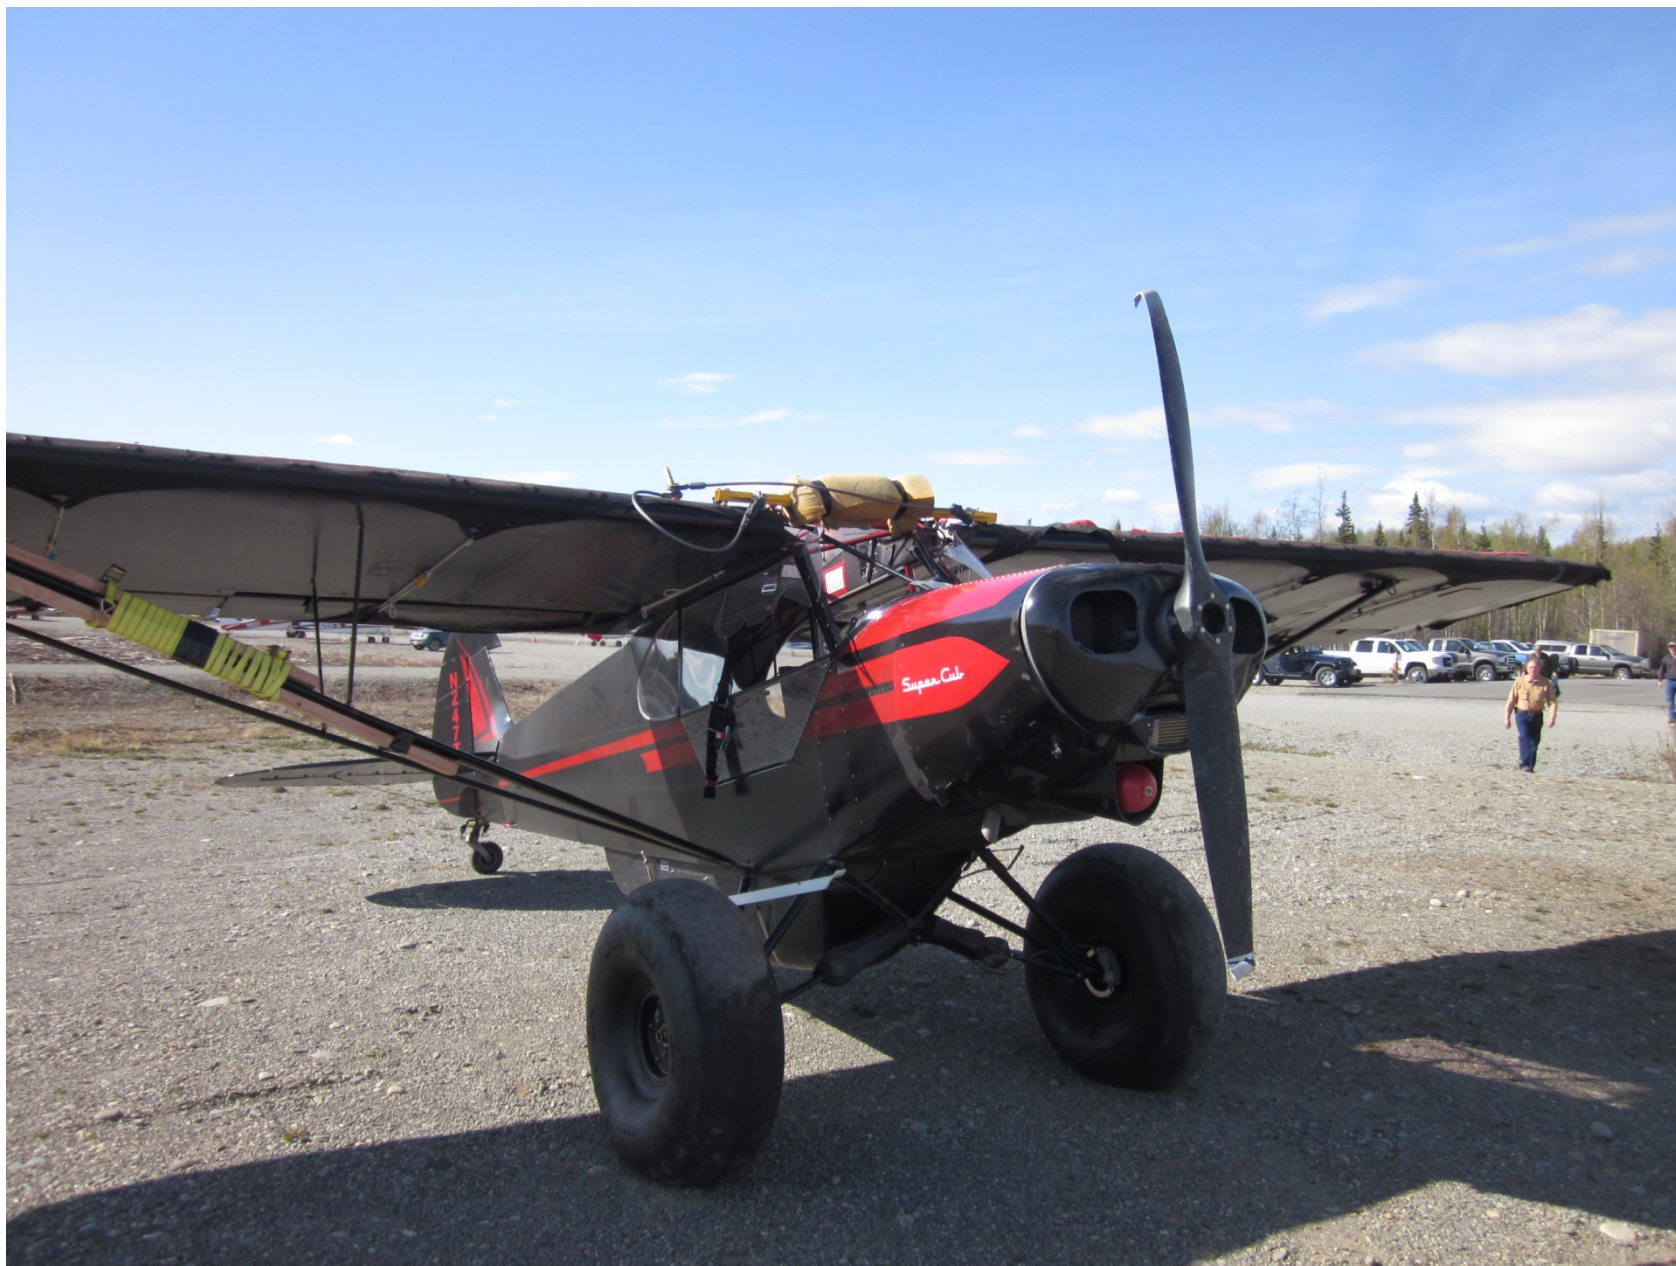
**Photo 1 – View of substantially damaged windscreen and right wing lift strut (photo courtesy of FAA)**
