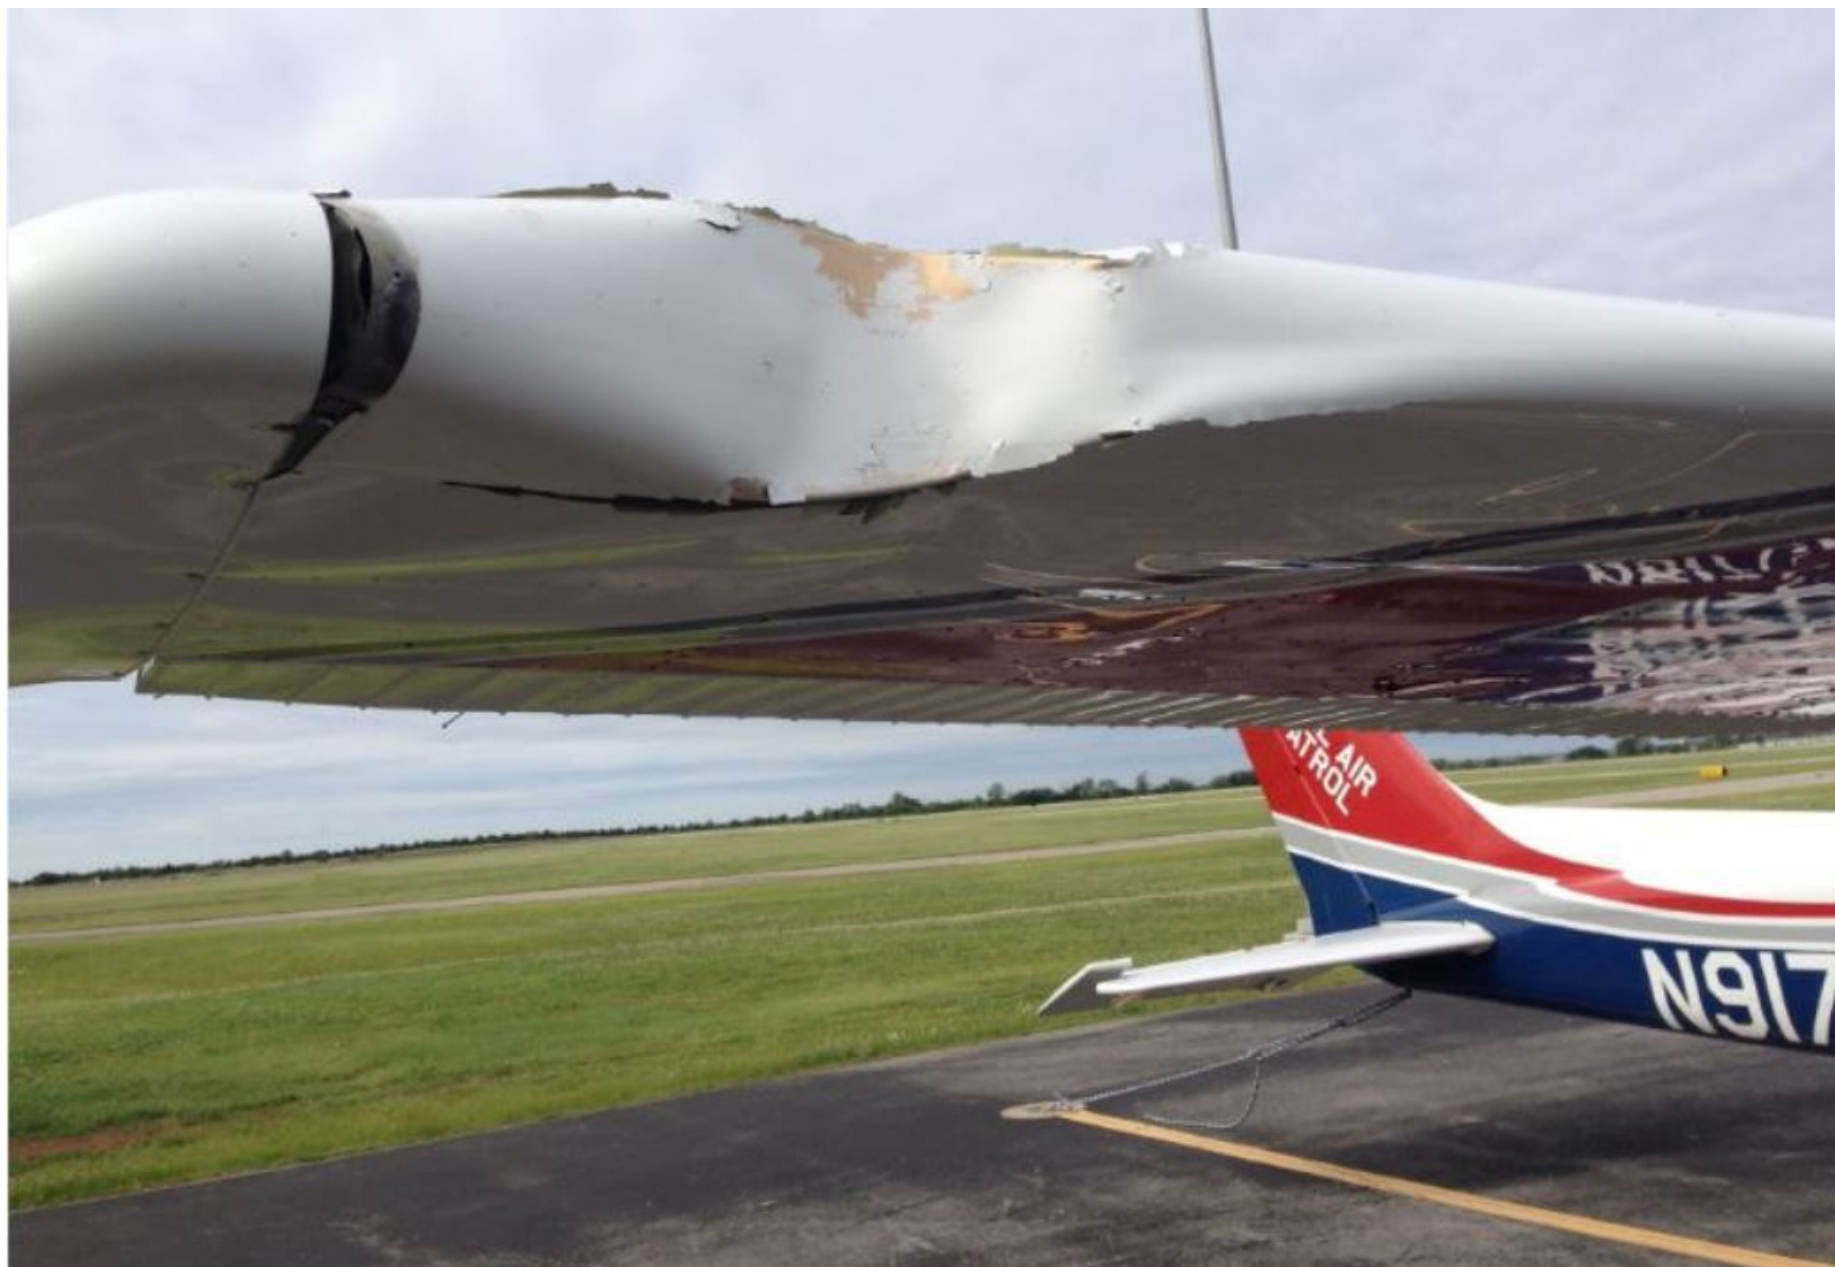
**Photo 1 – View of damage to right wing rib and spar (Courtesy of FAA)**

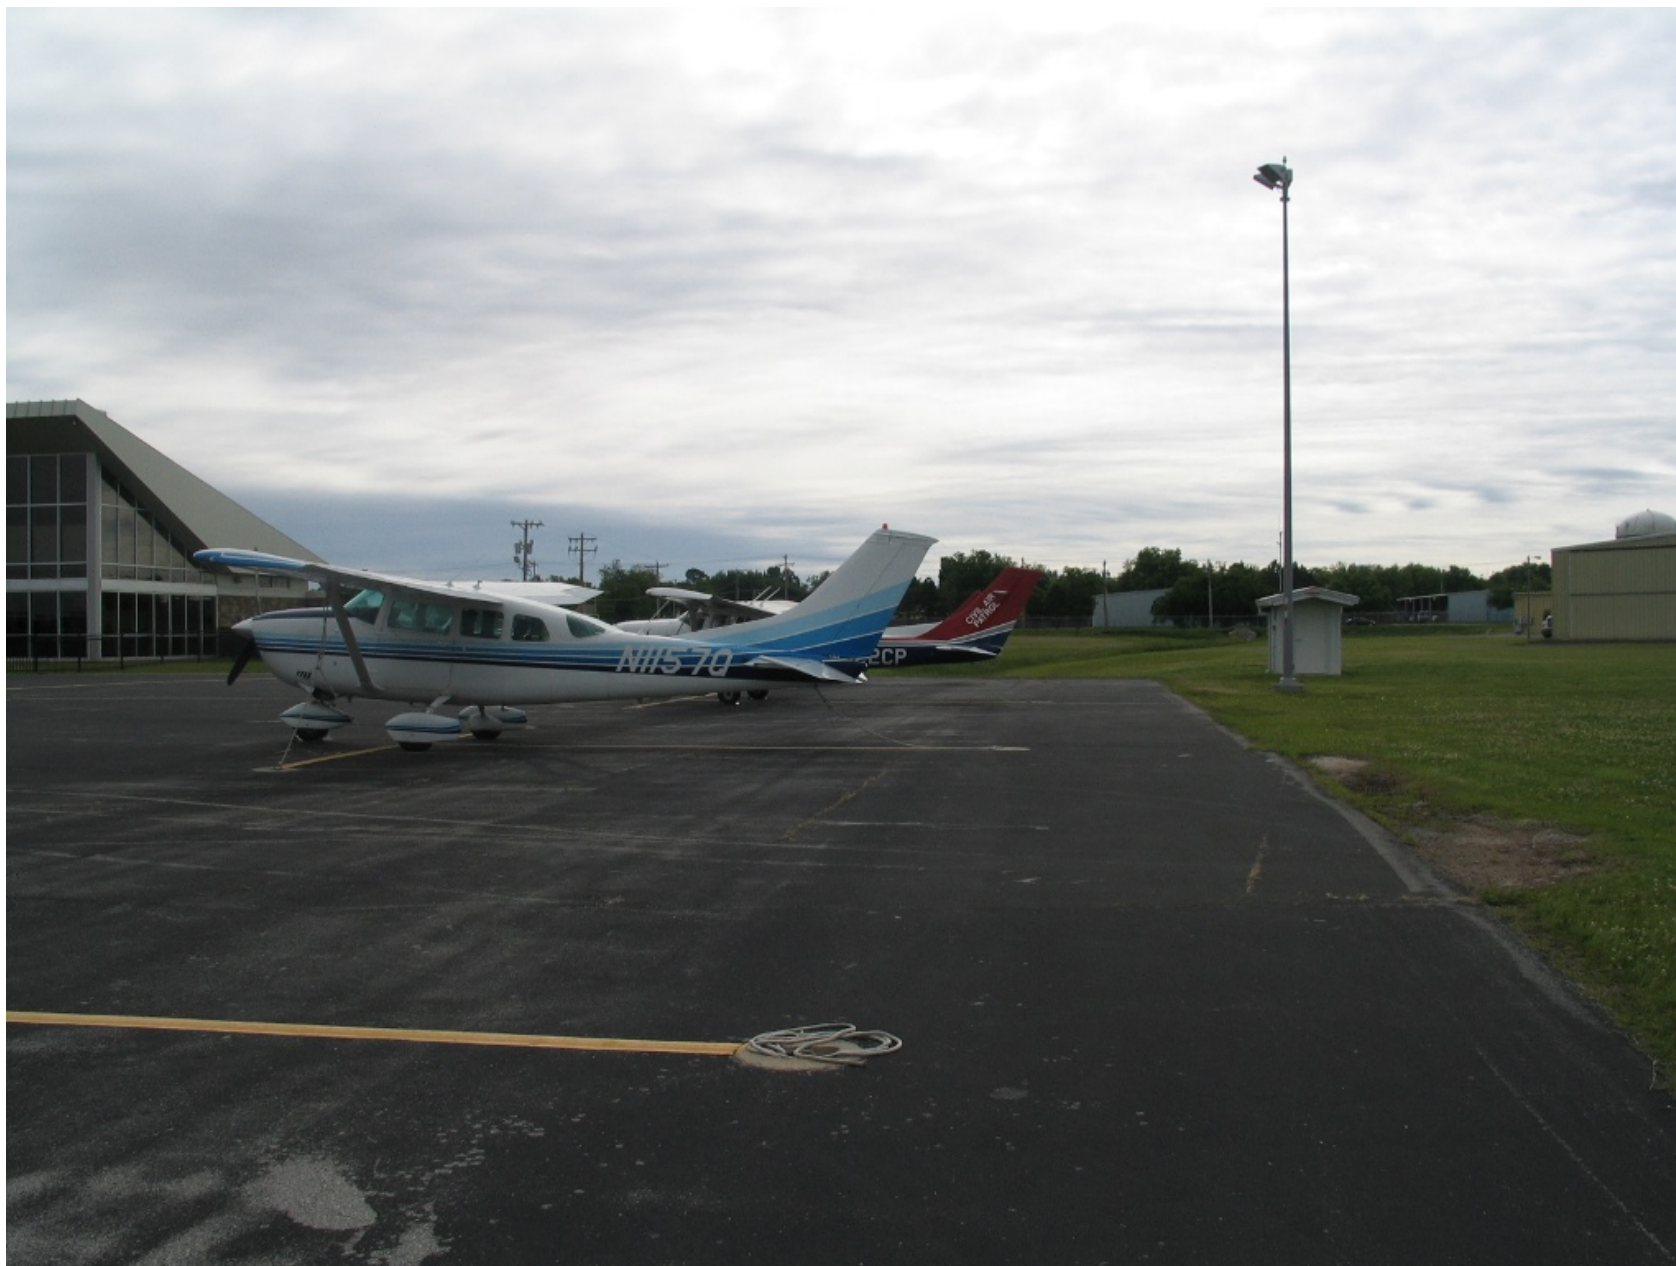
**Photo 2 – View of light pole distance from asphalt (Courtesy of FAA)**
